(2013) - Seventh International Conference on
Case Histories in Geotechnical Engineering

Geotechnical Failures Caused by Human Errors

Marek Tarnawski

West Pomeranian Technical University, Szczecin, Poland

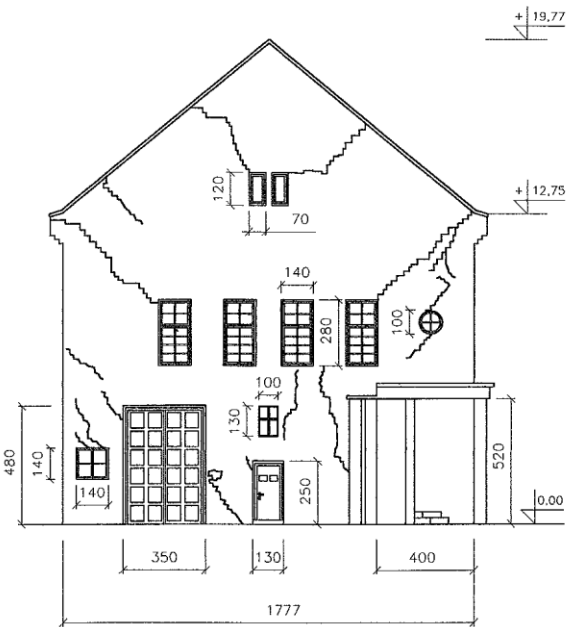
- the structure is founded on loose fill (Bartnik, Bukowski 2007) sometimes underlain by organic soils (Kujawiński 2001; Fig. 3) or straight on such soils (Wojtasik, Troć 2001), or at too shallow depth (Mikołajczak et al. 1979, Pająk et al. 1994),

Fig. 3. Cracks seen in a gable wall of industrial building founded on a weak substratum (Kujawiński 2001).

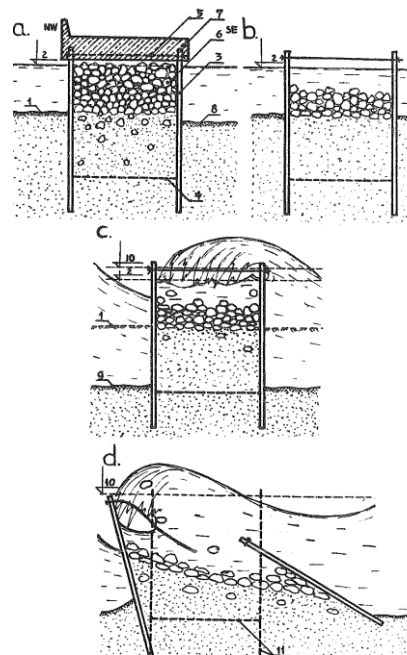
Fig. 4. A breakwater of retaining wall type: a finished structure (a), structure under construction described in the text (b) and the mechanism of the failure (c, d) (Haurykiewicz 1980).

Breakwater is an alien in marine environment. Taking this into consideration means, among others, assessment of possible depth to which the sea bottom (1) can be washed away by breakwater's walls and rational evaluation of the possible working periods (without a storm). As storms are random phenomena one should take into account their possible effects not only when the structure is ready but also when it is under construction. This example shows a connection of unfavorable weather conditions and too optimistic design assumptions. The result is a disaster of one section under construction (Fig. 4b). Storm waves washed out soil 2 m deeper than it was assumed (9) and much deeper than the designed bottom of harbor dock (8). Soil resistance diminished then and the waves, filling easily the section (as sea condition rose from the average "2" to the stormy "10", in Beaufort terms), increased water pressure from inside. Together with stone layer pressure it overcame the diminished resistance (Fig. 4c). The waves attacking upper parts of walls caused a bilateral level effect. Both walls leaned coastward. The tie tore off and the breakwater section had been destroyed (Fig. 4d). A sudden water accumulation in a limited area and the failure of sheet wall piling under construction is also described in another paper (Mazurkiewicz 1999). Flood tides or changes in current arrangement may wash the bases of bridge pillars and their tilt or catastrophe (Łączkowski, Podhorecki 1988). There are known (Mazurkiewicz 1996) destructive results of currents produced by driving devices (propellers) of modern ships or ferries, specially the ones designed for quick mooring and leaving a quay and a harbor without tugboat assistance. They cause erosion of the bottom and destroy normal protection (mattresses, concrete slabs etc.). Structures situated on the beach are exposed to damages or destruction by storm waves (Ostapiuk, Wichtowski 1989). A common denominator for all of the described cases is a maladjustment of structure protections to extreme impacts which may happen in sea or river environment.

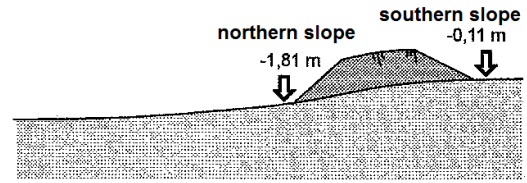
Fig. 5. A sketch showing results of mining exploitation on motorway embankment (Gryczmański, Sternik 2005).

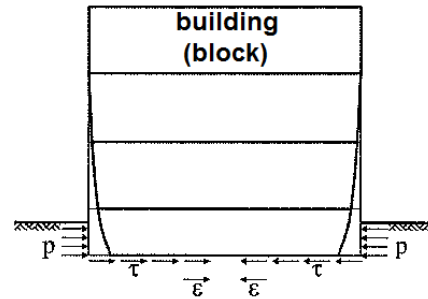
Fig. 7. A scheme of building damages caused by horizontal terrain deformations (Kawulok 2009).

Mining damages are common where a large scale underground exploitation of mineral resources is carried on. Hence a lot of various methods protecting (and repairing) structures have been developed. Typical damages of buildings presented schematically on Fig. 7 are repaired by wall extension as high as necessary to eliminate tensile stress zones. Reinforced, wall supporting frames or rectangle nets made of steel profiles can be used as well (Kawulok 2009).

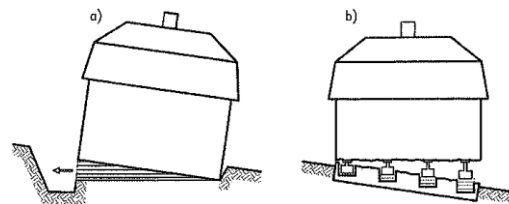
Tilt of building structures is obviously an often phenomenon in the areas of mining exploitation. Strong structures may not be damaged then, but when inclination exceeds 25 mm/m their further use is impossible both due to reduction of their serviceability and overall safety. However, tilt can be eliminated. Rectification can be carried out by removing soil from under higher positioned part of the structure (Fig. 8a) or by lifting the lower part by lifts (Fig. 8b).

Fig. 8. Schemes pf basic methods of inclined structures rectification (Gromysz, Niemiec 2007).

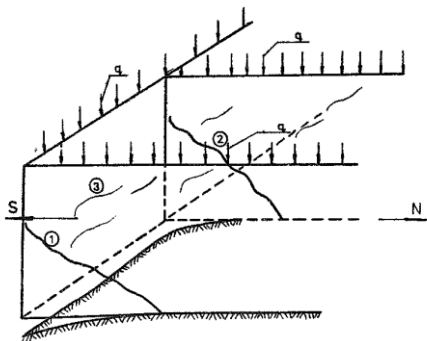
Tertiary clays which occur in many places in Poland are usually bearing soils of stiff or hard consistency. But these expansive soils change their volume under influence of drying up or getting wet. Shrinkage or swelling processes often start as a consequence of human errors. Differentiated settlement may be the result of foundation of the structure on both local peaks of top of clays and in sandy (ie. less compressible) background. When shrinkage is added, the differences grow (Fig. 9).

Fig. 9. A characteristic layout of cracks of suspended wall.
The reason: shrinkage of dried up clays (Klin 1978).

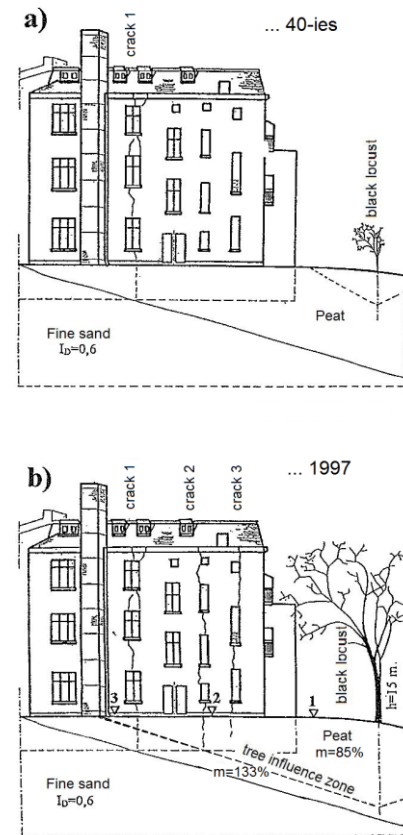
To end with probably the most astonishing case let us present this one. Three-storey outbuilding broke more or less in half soon after it had been built. A vertical rift (Fig. 10a) with an opening widening upwards extended from the cellar as high as to the roof (Jež J., Jež T. 2001). Tilt of the right side of the building stabilized after some time. The building was repaired and populated. Fifty years later the gable right side of the building separated from the whole and leaned. Another crack appeared a few years later. The damages looked similar when the elevation view was considered (Fig. 10b). However they appeared different in horizontal projection. The first crack was more or less perpendicular to longer walls of the outbuilding. The subsequent ones formed larger and smaller circular arcs with the centre of this circle occupied by ... a black locust (*Robinia pseudoacacia*). Geotechnical investigations carried out afterwards(!) revealed that slightly wet, medium dense sands (not much compressible soil) occurred under the left side of the building and compressible peat under the right side. This was the reason of differentiated settlement and breaking of the building. The later stability period followed the end of peat consolidation process. As time was passing by the root system of black locust was increasing. It absorbed moisture from peat during dry periods. Peat was shrinking. When the tree influence zone reached the building substratum the settlement process was resumed and the successive cracks were the consequence of it. Peat shrinkage tests confirmed this hypothesis.

Fig. 10. The development of damages (cracks) of the building described in the text (Jež J., Jež T. 2001).

Natural processes which can be described as „grass-roots” forced additional peat consolidation and overlapped the result of a building art error: direct foundation on differentiated in respect of compressibility substratum without its identification and without any strengthening of subsoil or construction.
