Foundation Reinforcement of the Ipanema Beach Offshore Sewage Pipeline

Jayme R. C. Mello

Nelson Szilard Galgoul

FOUNDATION REINFORCEMENT OF THE IPANEMA BEACH OFFSHORE SEWAGE PIPELINE

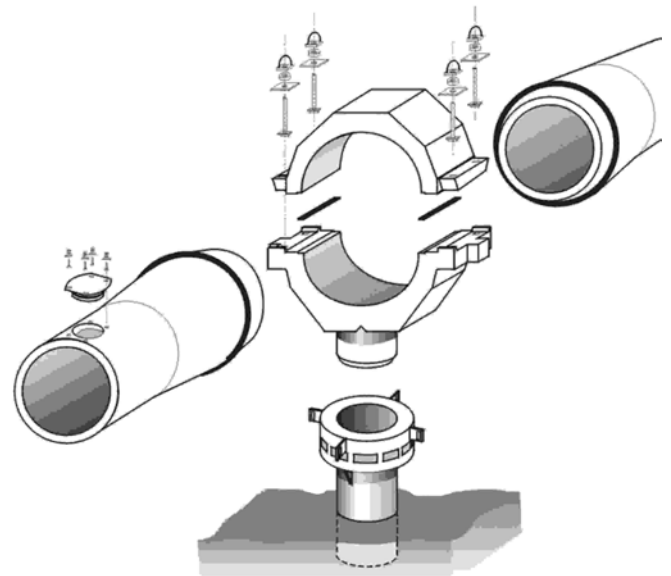
Fig. 1. Double Split Concrete Joint Configuration

The sewage collected from the southern districts of Rio de Janeiro City, flows through a 4.3km long offshore pipeline. The sewage is launched at 31m water depth offshore the Ipanema Beach. In order to survive the breaking wave zone the initial part of the pipeline is buried, but beginning a few hundred meters from the beach the pipeline is supported by discrete 1.4m o.d. by 3/8" wall thickness steel open-ended pipe piles. A total number of eighty piles were driven up to 25m penetration in heterogeneous soil deposits that vary from soft clay to dense sand, keeping the pipeline up to 4m above the seabed. A split concrete double joint was used to make the connection between the concrete pipes and the foundation piles as shown in fig. 1.

After twenty years in use one of these piles broke, dropping both adjacent tubes onto the seabed. This same problem occurred again on three additional supports. Fortunately for the environment the pipeline never opened, thanks to the flexibility of the rubber O-ring connection and neither was there any damage to any of the concrete parts, so the steel piles were consistently identified as the weak part of the system. It was recognized, however, that a major environment hazard would be the result of such an accident in which the pipeline did open, so future accidents had to be avoided at any cost. In order to assure this, Rio de Janeiro's State Water Supply and Sewage Agency (CEDAE) contracted, in addition to the repairs of the fallen supports, the design of an overall foundation strengthening for the remained supports. A new soil investigation campaign and a geophysical survey (fig. 2)

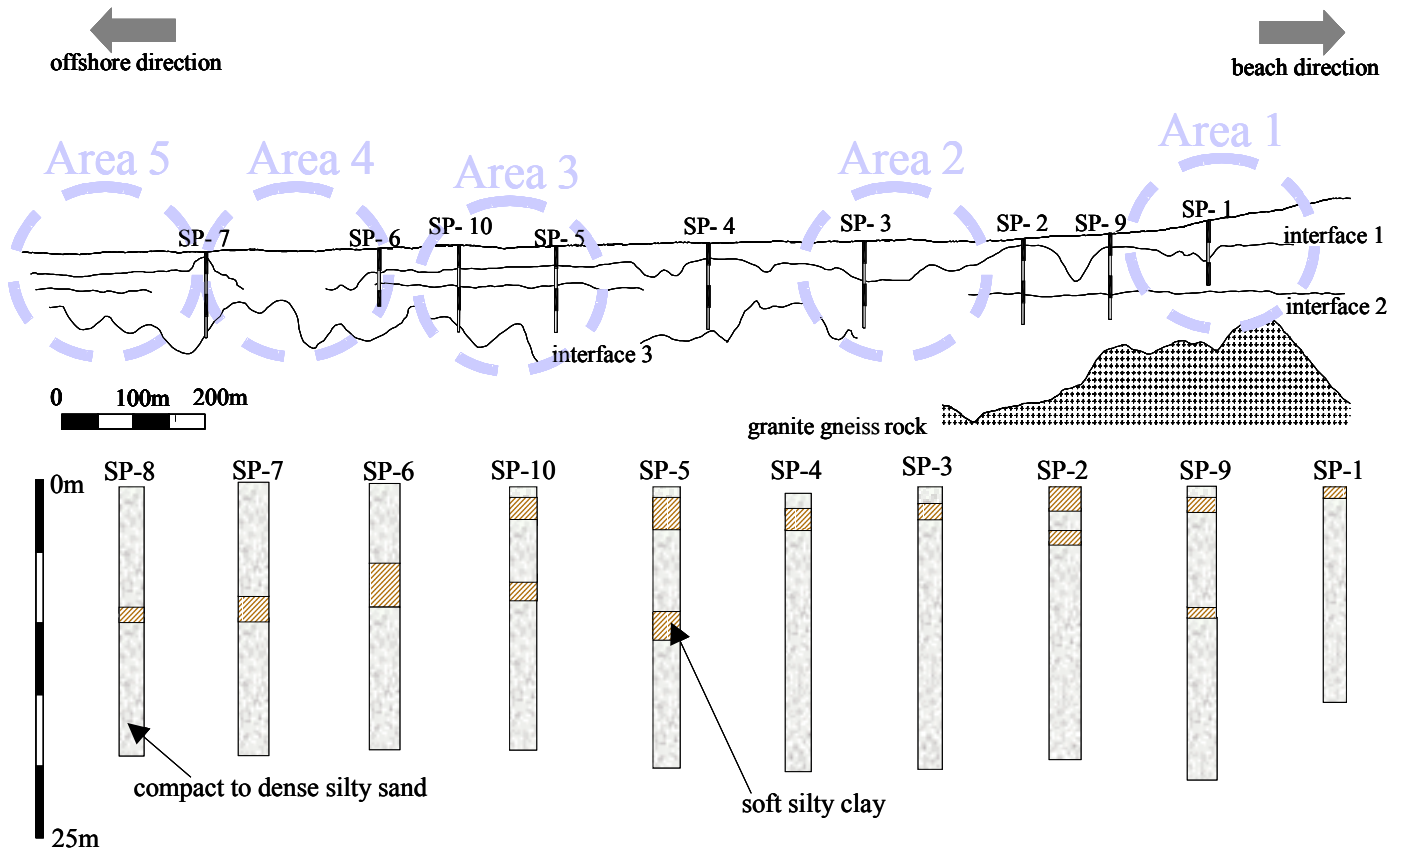
Fig. 2. Stratigraphy Identified in the Geotechnical Boreholes and in the Seismic Survey

When the piles of these repairs were driven, it was verified that the soil boreholes in the locations were not representative. These piles crossed stratigraphies totally different from those presented in the borehole logs. With this updated information the designer and CEDAE chose to change the reinforcement concept to driven piles, a more flexible solution than that posed by the suction piles, which require more refined and reliable data. Less than two years after the installation was started all planned supports had been strengthened.

All cited areas are identified in fig. 2. Figs. 8a to 8e shown records of piles driven in each one of these areas (supports #405, 515, 539, 552 and 607, respectively).

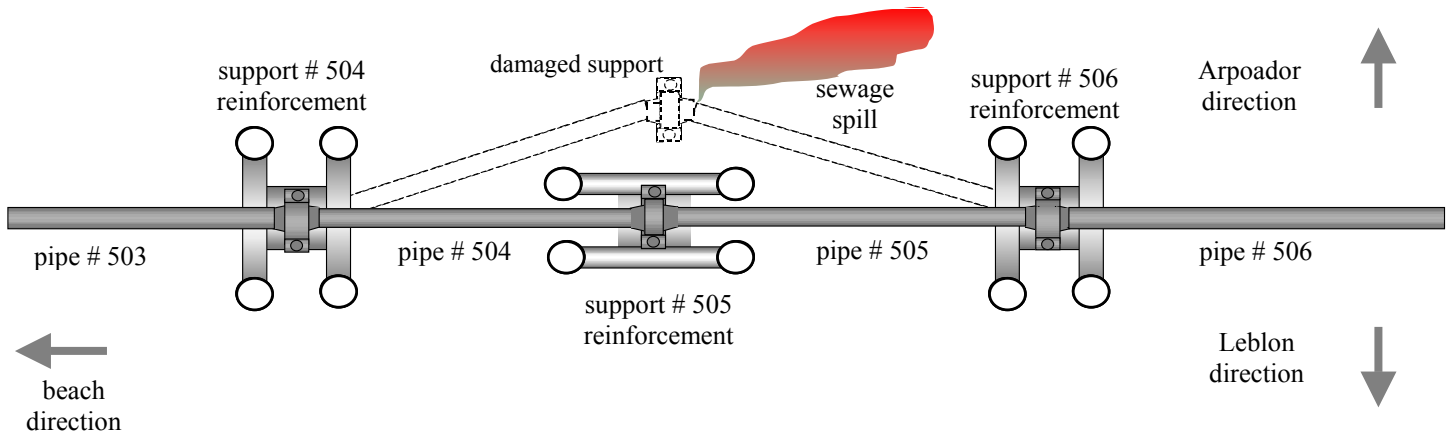
Fig. 4 - Support #505 Area Before and After Repair

Immediately after the winning bidder for the suction project was declared, but just before the corresponding service order for the contractor was issued, support #505 (located only 900m away from the beach) in 23m water depth, collapsed. Immediate repair was required, but the urgency to start construction of the proposed strengthening solution made it clear that an alternative design using the available material would have to be undertaken, even if this meant doing so at a higher cost.

Figs. 4a and 4b show a sketch of the support #505 area before and after the intervention.

- first a four piled strengthening structure (with grouted sleeves), used also for the supports #504 and 506, would be installed close to the former position of the #505 pile;
- a spare base of the concrete joint (called a "chevretre") would be mounted on top of this structure;
- on a day with ideal sea conditions, the damaged joint would be opened and the two 50m concrete pipes lifted from the mudline;
- before transferring the pipes to their new support the old 10m long rubber O-rings would be replaced by new ones;
- with both pipes placed on the new "chevretre", the top part of the concrete joint ("chapeau") would be recovered from the mudline to close the new joint.

Due to the summer storms, the large barge motions, the reduced pipe connection clearance (the gap between adjacent segments inside the pipe joint was only in the order of 20 to 50cm) and finally, because the repair had to be performed in less than 24 hours (the limiting time to accumulate sewage in the onshore storage tanks), it was decided that the job had to be carried out with the aid of a fixed structure. A 20 ton steel jacket, fixed to the mudline by four 30" driven piles, was designed, fabricated and installed specially for this job in less than one month. To control the maneuvering of the two 50m concrete pipes on their way to the new support, an 80 ton capacity constant tension winch was mounted at the top of the jacket.

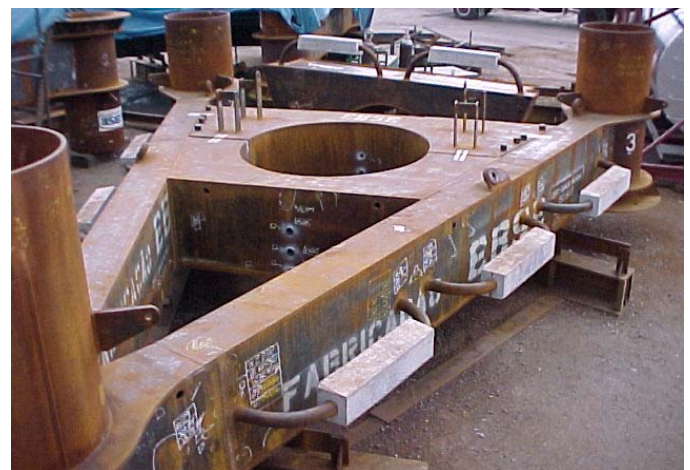
Fig. 5 - Reinforcement Structure

- the two halves of the strengthening structure installed at supports #504 and 506 should be able to remain in the upright position during the interconnection to the original pile. The fact is that they fell over very easily, making this step a time consuming item;
- the 45 tons vertical load and 3 tons horizontal load transferred to the four piles were low, but the 30" o.d. by 1" wall thickness piles could not be reduced, because this

- diameter was governed by geometric limitations, high stress developed during installation and also due to the bond strength of the grouted connection used to transfer the load from the sleeves to the piles;
- the bolted connection of the two parts of the reinforcement structure were difficult for the divers to adjust, which also turned out to be time consuming.

Based on the items pointed out an improved 19 ton steel structure with only three open-ended piles was conceived (fig. 5). The advantage of this concept is that it could be set directly into position without tipping over. In addition, instead of connecting two heavy halves it required just a small 1 ton add-on piece used to brace the original pile, thus making the bolting operation much easier for the divers, besides weighing considerably less than in the emergency design.

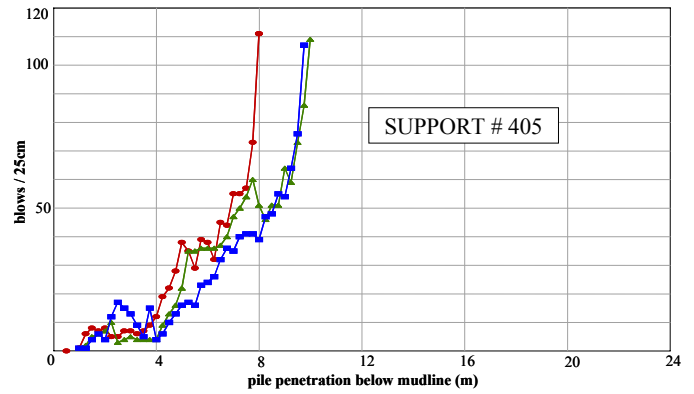
Fig. 8a - Typical Blowcount Records of Area 1

- Area 1, the closest to the shore (approximately 500m), around 20m water depth, where after a 1m self-weight penetration the piles were driven in compact to very dense sand layers, with a blowcount linearly increasing to around

100 blows per 25cm from 4m penetration to the final penetration of 8-10m below the mudline. The seismic survey identified two intermediate interfaces (the shallowest at 5 to 10m and the other at 15m) and a granite-gneiss rock at less than 30m from the seabed;

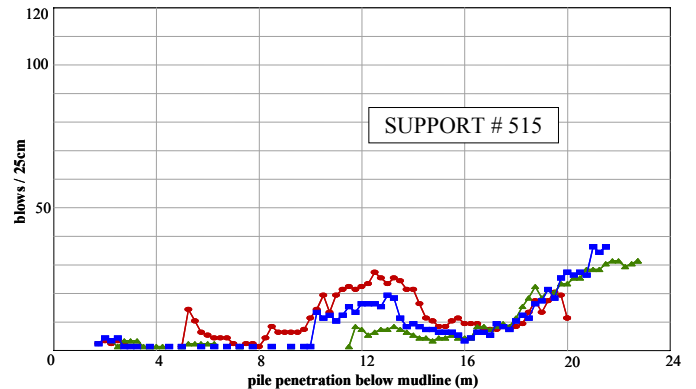
Fig. 8b - Typical Blowcount Records of Area 2

- Area 2, at 26m water depth, is approximately 1,200m away from the beach. The piles were driven up to 20-22m penetration below the seabed reaching 20 to 40 blows per 25cm. They penetrated practically due to self-weight for up to 10m (possibly in very soft to soft clay soils). From 10 to 14m a compact sand deposit was found. According to the geophysics, as the distance from the shore increases the rock deepens and along a 300m extension the second interface even vanishes from the records (the first interface varies between 3 to 10m);

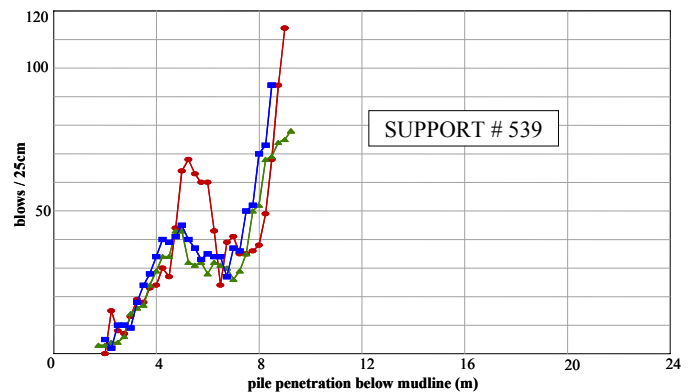
Fig. 8c - Typical Blowcount Records of Area 3

- Area 3, around 29m water depth, approximately 2,200m from the shore. In that location the piles were shorter than in the other parts. After a 2m self-weight penetration, between 4 to 8m penetration the blowcounts remained constant at around 30-40 blows per 25cm. Suddenly they increased to approximately 80 to 110 blows per 25cm at 8-9m penetration below the seabed. The soil profile below 2m seems to be a compact to very dense sand. The seismic survey identifies three interfaces, at 5m, 10m and below 20m (this deeper interface possibly represents the same rock identified in Area 1);

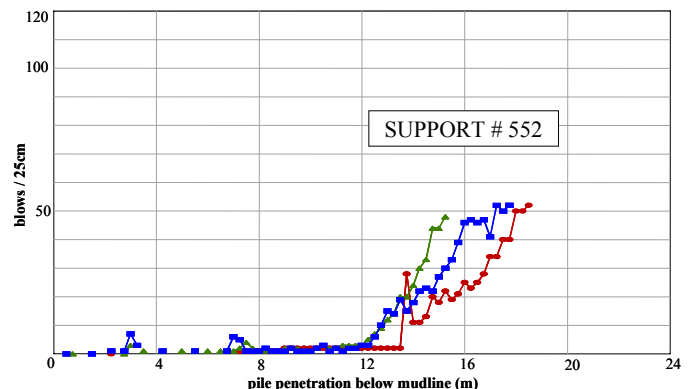
Fig. 8d - Typical Blowcount Records of Area 4

- Area 4, around 29m water depth too, approximately 2,800m away from the beach. This is the area where the presence of soft clay deposits becomes more intense. Self-weight penetrations of up to 12-13m were observed. After that the blowcounts increased to as much as 50 blows per 25cm at 15-18m penetration below the mudline (possibly in compact to dense sand). The geophysics showed just the third interface, varying between 12-25m (the two shallower interfaces disappeared along a length of 200-400m);

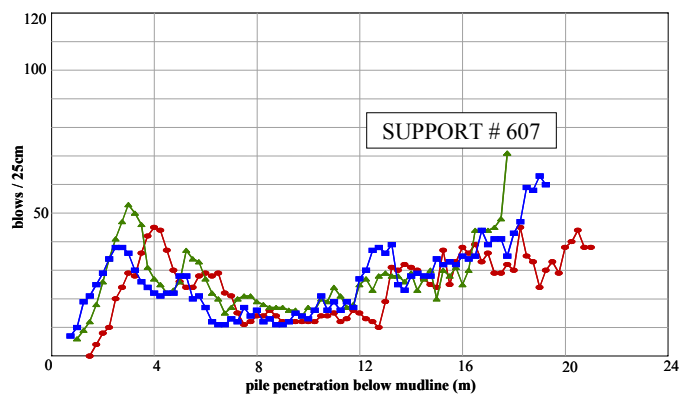
Fig. 8e - Typical Blowcount Records of Area 5

- Area 5 is the pipeline diffuser zone. This is the most distant area from the shore, at 31m water depth. Pile penetrations varied from 18 to 21m below the seabed. No self-weight penetration was verified. The driving possibly happened entirely through sandy layers. In the superficial layer the blowcount reached 50 blows per 25cm (dense to very dense deposit), but at 6-7m it decreased to the level of 10-20 blows per 25cm (medium compact to compact granular deposit). As penetration increased so did also the blowcount reaching 40-70 blows per 25cm at final penetration. The seismic survey identified the three interfaces at 5m, 10m and between 15 and 25m.
