## Failure of Railway Embankment

**J. Christodoulis**  
Geotechnical Engineer, Soil Research Lab, Athens, Greece

**SYNOPSIS:** This article deals with the failure of a railway embankment in North Peloponese. The geotechnical investigation that followed aimed to specify the causes of the failure. The results of the above investigation are presented, an evaluation of the causes of failure is discussed and the remedial measures which have been taken are thoroughly described.

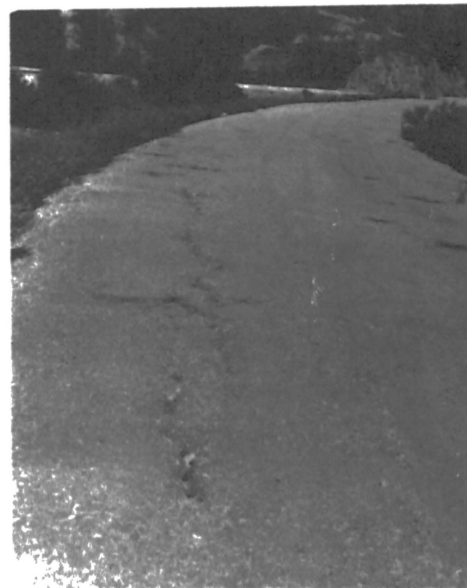
Next summer (1986) on the top of the embankment, longitudinal cracks appeared, along the axis, having length 2-3m and width varying from mm to 3cm ( Fig 1). After this occurrence and before the lining of the rail steel bars, Public Works Research Laboratory-Soil Division, was asked by the inspector supervising the works, to proceed a geotechnical investigation, in order to identify the causes of the failure and propose measures to restore the embankment.

Fig. 1. Longitudinal cracks on the embankment.

From the linear shrinkage, the x-ray diffraction, the swelling percent and the swelling pressure tests, was revealed that the fine portion of the fill material contained swelling clay minerals. In this area there are remarkable sequences of wet and dry seasons (Fig.3). After the impregnation of the embankment during the wet season, intense shrinkage of the material followed, during the dry period, caused the appearance of cracks (Fig.1). In order to avoid the rainwater percolation, through the cracks and fissures, which would cause the material to swell and slake, the following remedial measures have been taken.

The top three meters of fill material were removed by a bulldozer D8 and carried away by trucks loaded by a tyred shovel tractor. For the next layer, the first 25cm were removed and kept in place. The other 25cm were scarified by a grader ripper and mixed with five percent lime (Fig.4).

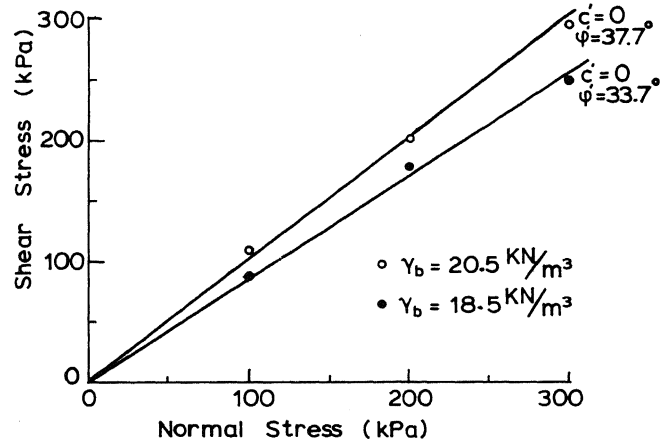
The material of the embankment contained a large proportion of coarse grained fraction (gravel and cobbles), which made the use of conventional tri-axial and direct shear box testing apparatuses extremely difficult or even impossible. In order to overcome this problem and model the actual field conditions, as closely as possible, it was decided that the large shear box apparatus, (300mm square by 160 mm thick), mainly used for testing aggregates, offered a great advantage. Two series of tests were performed on prepared specimens with different water content and densities ( $\gamma_b = 18.5 \text{ KN/m}^3$ ,  $\gamma_b = 20.5 \text{ KN/m}^3$ ). Field densities and water content were previously determined in situ at different points and depths. The results from these shear tests are shown in figure 2.

Fig. 2. Shear Strength Envelopes of fill material

Slope stability analyses were performed on a typical cross section of the embankment, using as shear stress parameters the results of the large shear box tests. In the analyses we considered circular failure surfaces. The slope stability analyses were carried out for sixty-four possible centers of rotation and various slip circles. Different radius for each center were used. Factors of safety in excess of 3.0 were computed, indicating adequate factor of safety against slope stability failure.

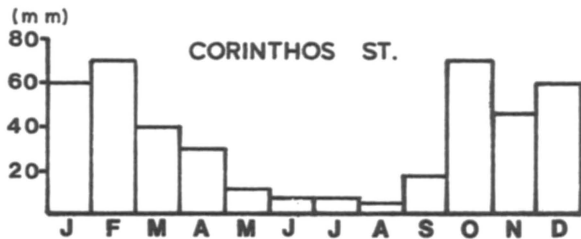
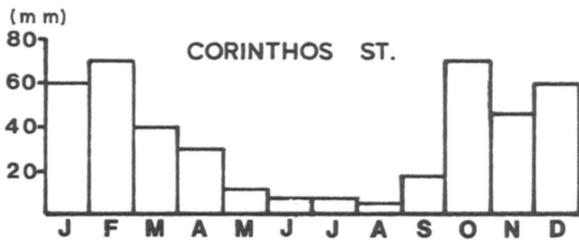
Fig. 3. Average Rainfall of Decade 1970-80

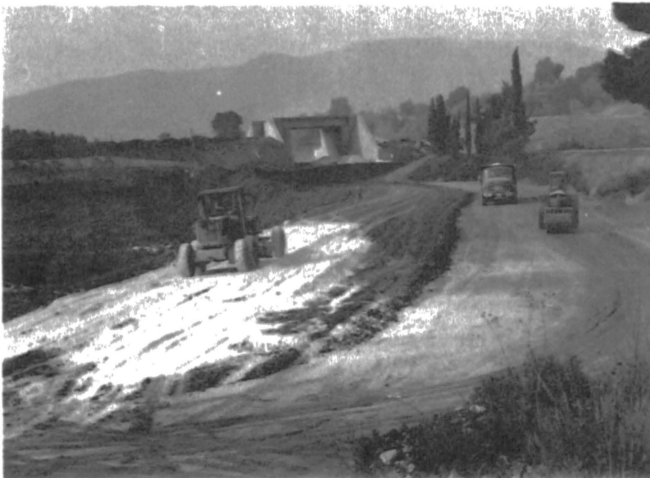
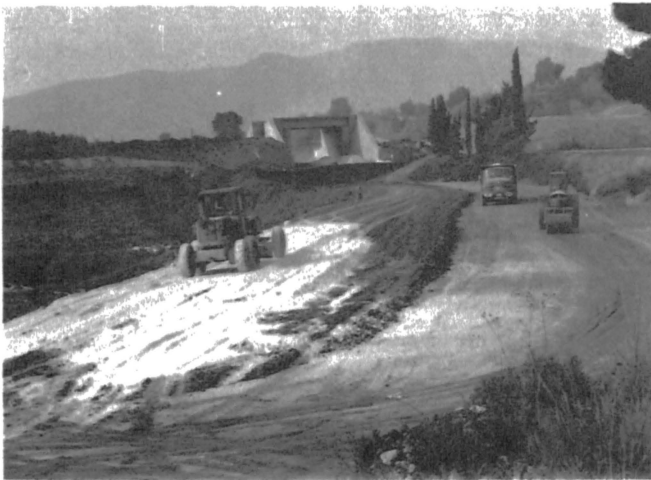
Fig. 4. Soil-Lime Mixing by Grader

To obtain uniform mixture a disc harrow pulled by a tractor was used in eight passes. After the first pass, it was noticed that an amount of lime was taken away by the wind. So it was decided to stop the mixing and wet the layer up to optimum. Dry unit weight of the material plus lime was  $19 \text{ KN/m}^3$ , optimum moisture content 13 percent. For this, six water tanks per layer were used and then the mixing by the disc harrow ought to

be continued. Afterwards each layer was turned over by a grader Cat 14. For this, each layer was separated longitudinally in two strips, starting from the middle towards the edges. In order to succeed good mixing, thirty five passes of grader were necessary per layer. During the mixing several plasticity index tests were carried out in our project laboratory, until the material had achieved a non-plastic index.

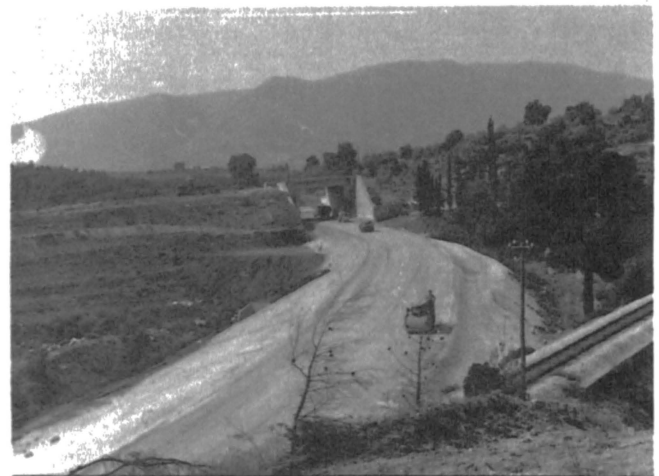
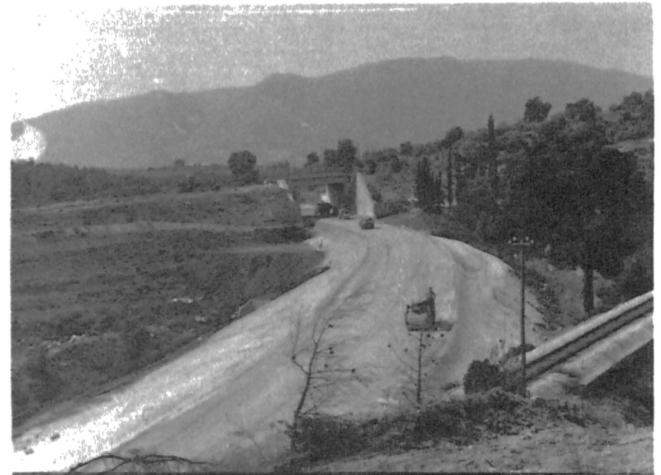
Fig. 5. Final Leveling of Embankment with Selected Crushed Material

Each layer was compacted by a roller Galion(14T) and one vibrating roller Hamm-Asdag (35T). In order to achieve hundred percent Mod AASHTO density, fifteen passes per layer were necessary. The ASTM sand-cone method was used to test the compaction of each layer. The rest of the fill, up to the top, was substituted with selected crushed gravel, having dry unit weight  $22-23 \text{ KN/m}^3$ , optimum moisture content 6-7 percent, and fine material passing US N200 sieve 5-7 percent. The material was hauled by trucks, spread by a grader to layers 30cm thick, wetted to optimum, scarified for better mixture with water and compacted by six passes of the vibrating roller, to hundred percent of Mod AASHTO density (Fig.5).

After the final level was reached, the full length of the embankment was protected from water percolation and moisture changes. For this, the surface was covered by a membrane of hot petrol emulsion ( $3.5 \text{ lit per m}^2$ ) and then an asphalt membrane was applied by a man-carried springler ( $7 \text{ Kg per m}^2$ ). Finally because the whole structure was too dark in colour, a thin layer of crushed stone ( $0.0-5.0 \text{ mm}$ ) was spread and stuck on top of the asphalt membrane. The above remedial measures are outlined in figure 6.

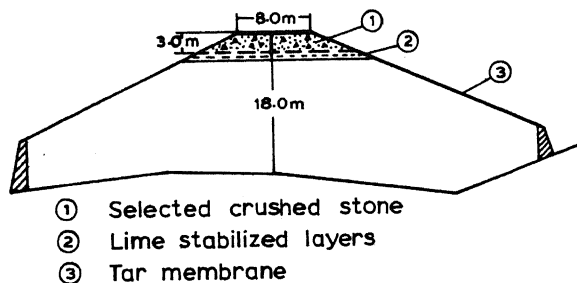
Fig. 6. Cross Section of Embankment after Remedial Works.

After the final level was reached, the full length of the embankment was protected from water percolation and moisture changes. For this, the surface was covered by a membrane of hot petrol emulsion (3.5 lit per m<sup>2</sup>) and then an asphalt membrane was applied by a man-carried springler (7 Kg per m<sup>2</sup>). Finally because the whole structure was too dark in colour, a thin layer of crushed stone (0.0-5.0 mm) was spread and stuck on top of the asphalt membrane. The above remedial measures are outlined in figure 6.
