(2013) - Seventh International Conference on
Case Histories in Geotechnical Engineering

EXPLORATION, DECONSTRUCTION, AND REPAIR OF A DISTRESSED MSE RETAINING WALL IN SAINT PAUL, MINNESOTA

Joseph G. Bentler, P.E.

American Engineering Testing, Inc.
St. Paul, Minnesota-USA 55114

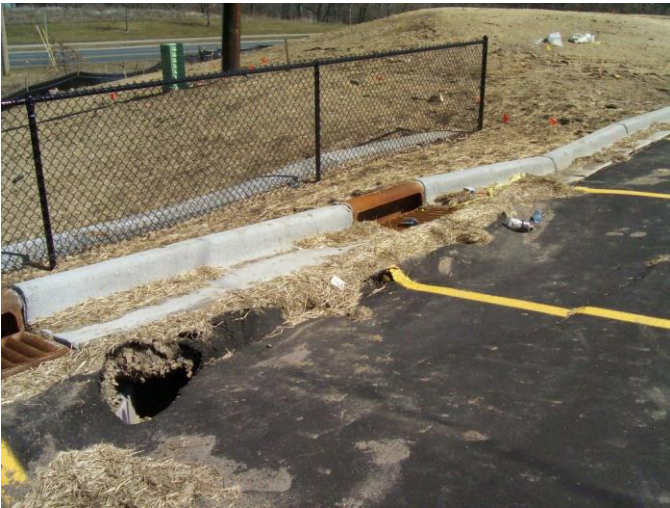
Fig. 3. Subsidence and openings in pavement near catch basins located within wall backfill. Settlement of the wall facing blocks (behind chain-link fence) is also apparent.

During the following spring, pavement subsidence on the order of several inches to up to a foot occurred near two catch basins located several feet behind the face of the retaining wall (Fig. 3). Displacements of the pavement were great enough that cracks and openings in the pavement adjacent to the catch basins could allow water to infiltrate into the wall backfill and thereby circumvent the planned drainage from the parking lot surface into the catch basins. In that area, the retaining wall facing blocks also underwent downward movements of several inches to a foot. At that point in time (early April 2009), geotechnical consultation was sought from American Engineering Testing, Inc., at which time the author began his involvement in the project.

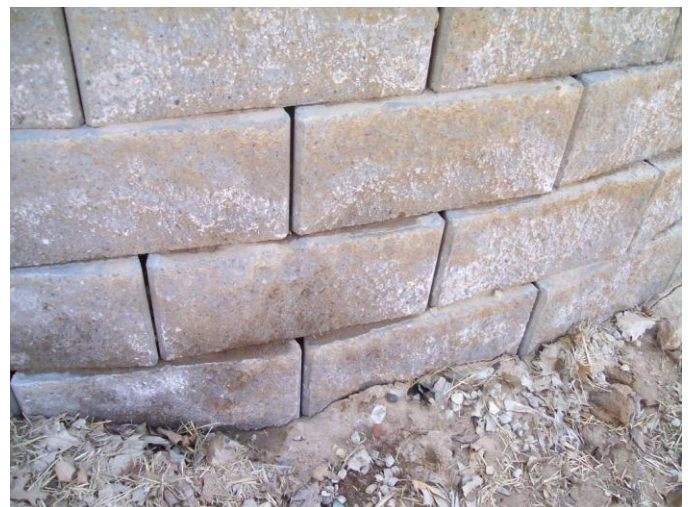
5. Some facing blocks had cracked near the northwest corner of the wall.
6. Fines (i.e. silt and clay) were visible on the “ledges” of the courses of wall facing blocks in the general area where the parking lot pavement was distressed, as well as below the drain tile outlets (Fig. 4). The brown color of the fines would match that of the backfill soil (as encountered by a soil boring discussed later), but not the light tan color of the drainage aggregate.

Fig. 4. Silt and clay deposited on and below facing blocks by migration of fines out of backfill and through joints in facing.

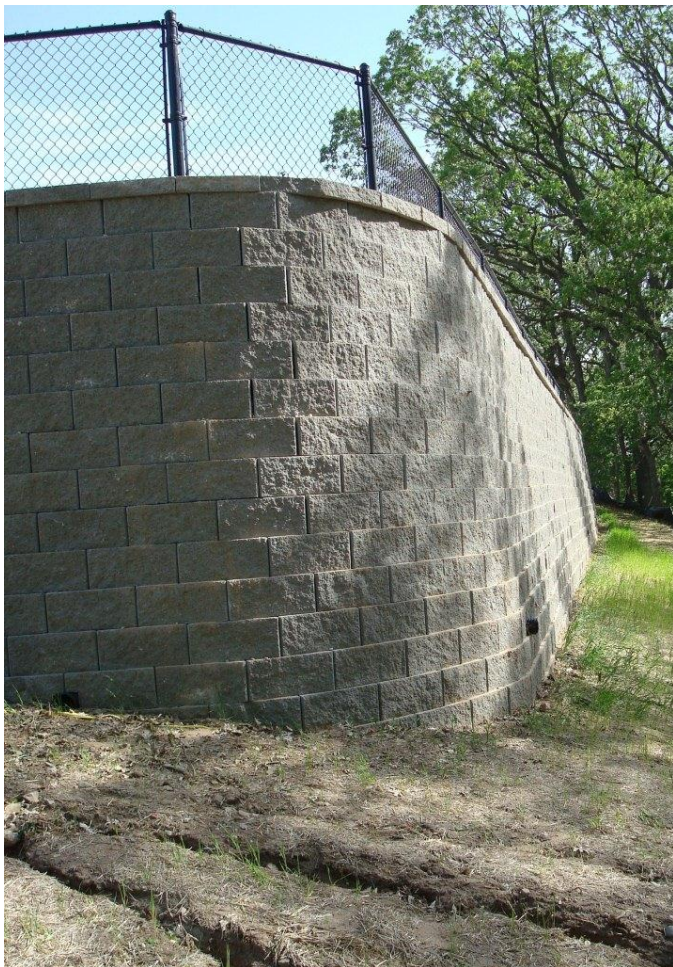
4. A slight bend in the wall alignment was visible along the west side of the retaining wall, at about 20 feet south from the northwest corner of the wall.

7. Drainage pipe outlets were installed above the ground surface at the toe of the wall, as much as two feet above design elevation (Fig. 5). The design drawings showed that the drainage pipes should be located at the bottom of the first course, daylighting through the soil cover. This was not the case.

Fig. 5. View looking south from northwest corner of wall, showing drain pipes located above bottom-of-wall, and bend along west line of wall. Surface erosion due to overtopping of wall is present in foreground.

4. Drain tile outlets should daylight at bottom-of-wall elevation.

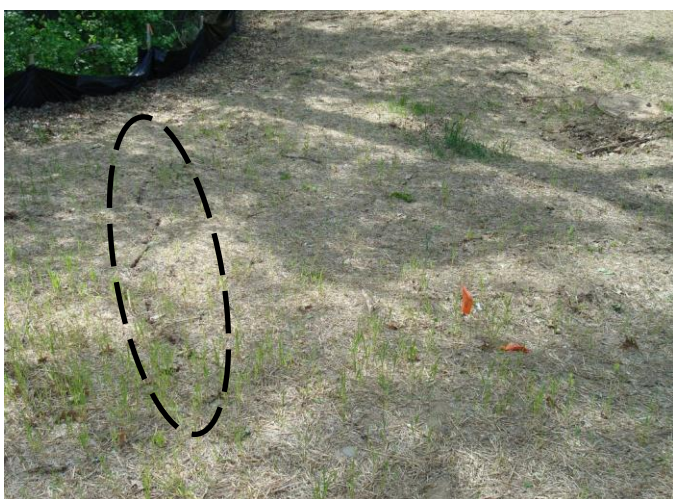
9. Cracking of the soil surface was visible at a distance of about 20 feet on either side of the storm sewer near a manhole located to the west below the wall (Fig. 6).

Fig. 6. Surface crack along south (lefthand) edge of backfilled storm sewer trench.

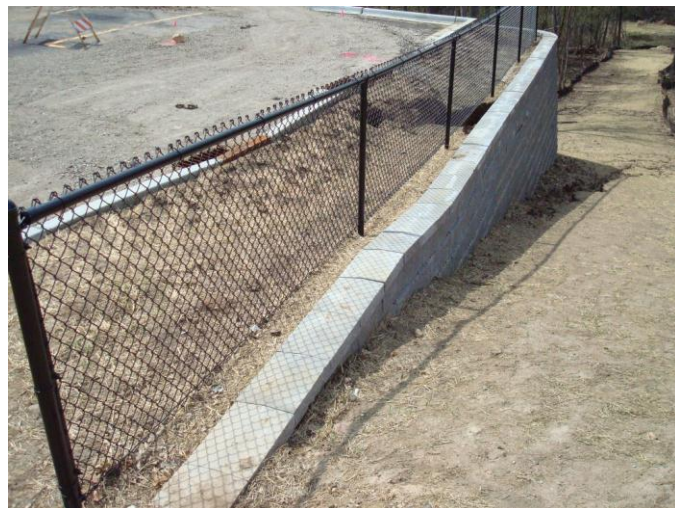
1. The elevation of the northwest corner of the wall was 0.19 feet below that of the east end (top-of-wall elevation was to be constant according to the design).
2. The low point along the north side of the retaining wall (in front of the catch basins) was almost 7 inches lower than the east end of the wall, and 6 inches of that elevation difference occurred in a horizontal distance of about 6 feet (Fig. 7).
3. The west catch basin was tilted toward the east and an average of 1 inch lower than design elevation, the east catch basin over 4 inches lower than design elevation, and the northwest corner of the parking lot over 8 inches low.

Fig. 7. Subsidence of facing blocks along north side of retaining wall (view is opposite that shown by Fig. 1).

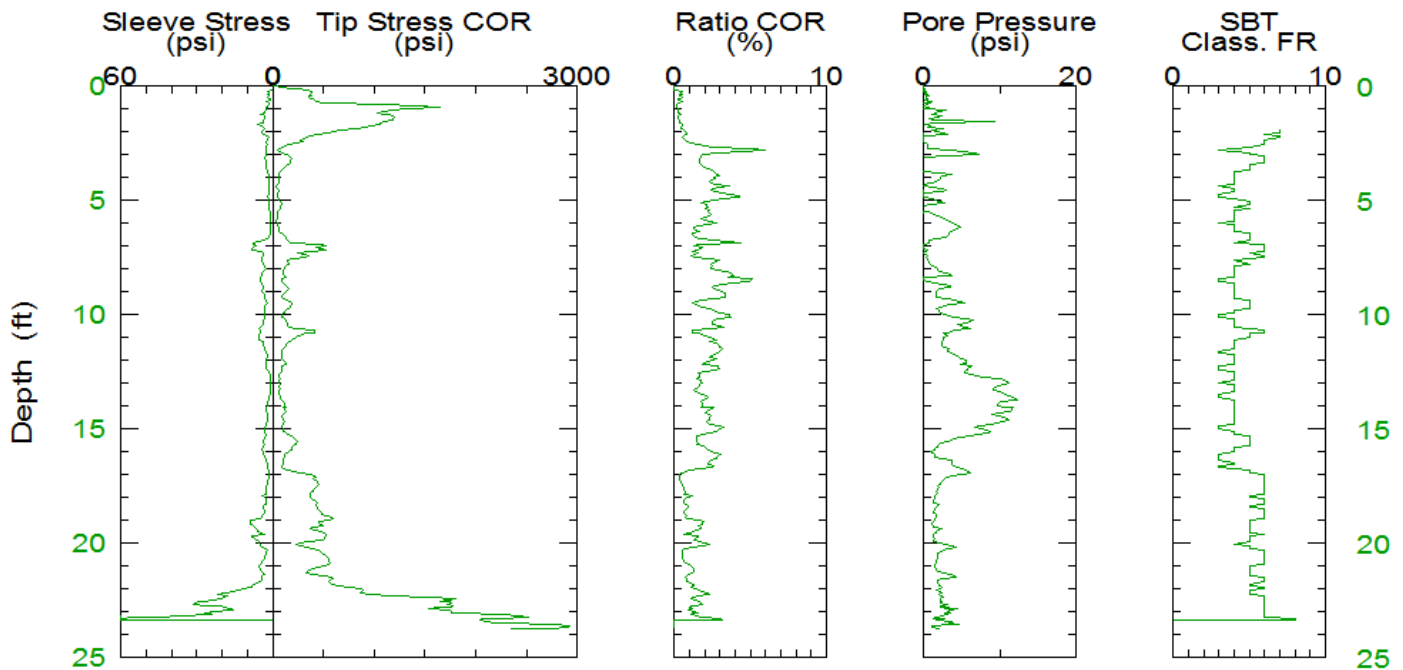
Fig. 9. Results of CPT sounding performed adjacent to soil boring, through wall backfill. Soil Behavior Type (SBT) in the far right column is based on friction ratio (Robertson 1990).

From Figure 9, it is apparent that the CPT sounding adjacent to the soil boring corroborated that the backfill material was not nearly as competent as the in-situ silty sand glacial till soils located below a depth of about 17 feet. The soil behavior type of the fill soils based on normalized friction ratio (Robertson 1990) was typically Type 4.

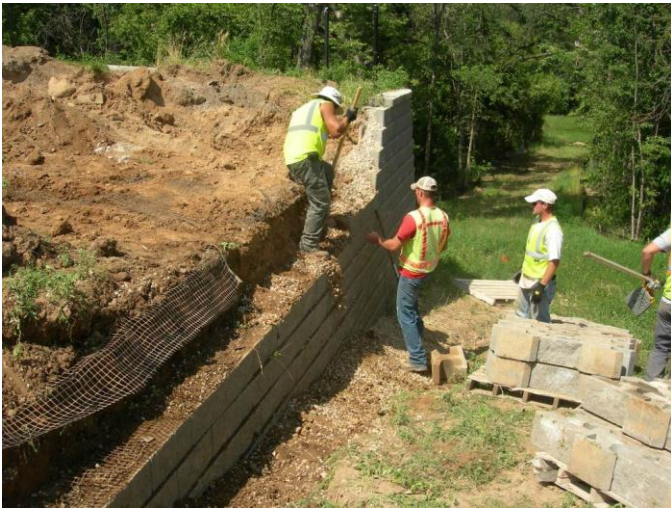
Fig. 10. Early stage of MSE wall deconstruction. Note drainage aggregate within blocks, but not extending 12 inches behind facing blocks per design.

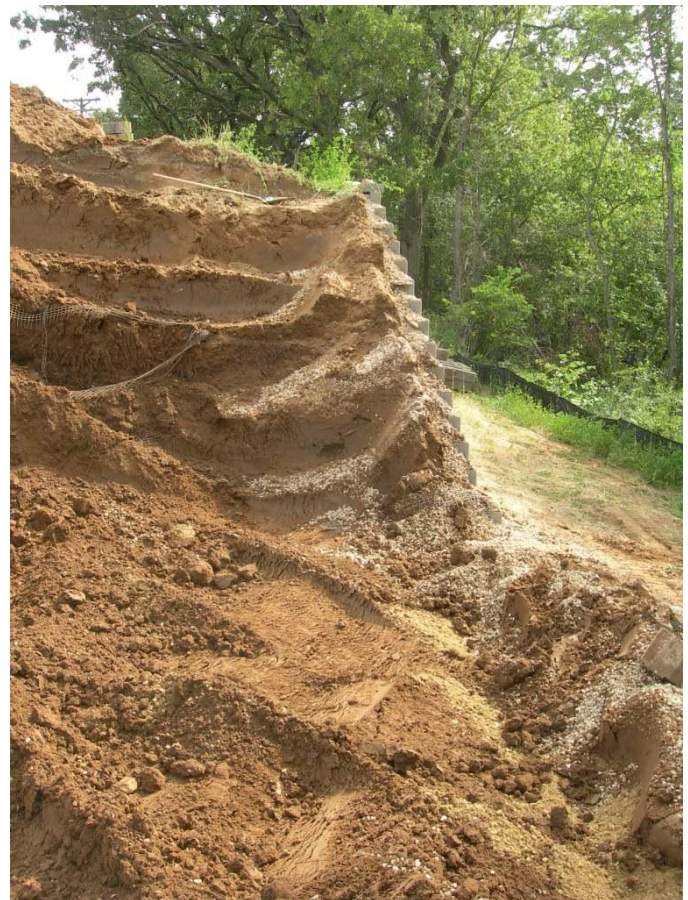
1. If anything, samples of the backfill soils were typically higher in fines content and more clayey than the soil boring and CPT soundings had indicated. Significant amounts of sandy lean clay were also encountered.
2. The minimum 12 inches of “free draining aggregate” to be placed immediately behind the back of the facing blocks was not observed. Because the “H”

shape of the facing blocks required placement of aggregate within the blocks to lock them together, it is possible that the wall subcontractor erroneously believed that this “interlock” aggregate satisfied the design requirement (Fig. 11).

3. No horizontal drain tile line was present (Fig. 11), meaning the drain tile outlets were simply short pieces passing through the wall, but connected to nothing (analogous to weep holes).
4. Seven density tests were taken at different elevations during wall deconstruction. Six tests had compaction levels below 95%, and one at 97% (recall 98% was specified for wall backfill); these confirmed the tube densities of samples recovered from the boring.

Fig. 11. Wall partially deconstructed, with relative lack of drainage aggregate and no horizontal drain tile or geotextile filter fabric observed.

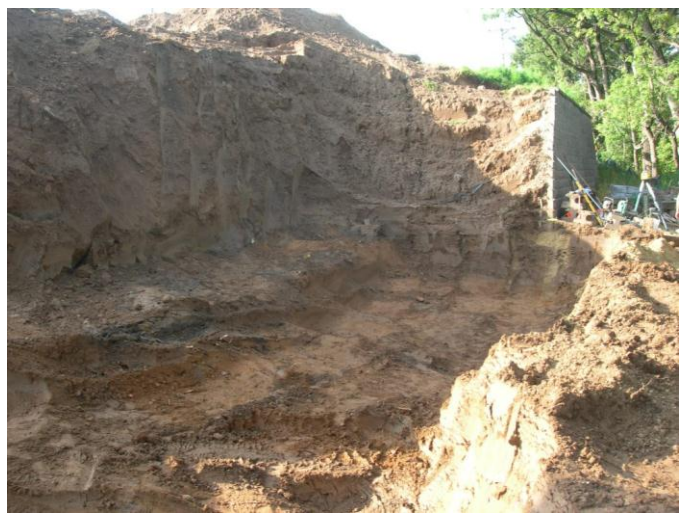
Fig. 12. Overexcavation was performed below bottom-of-wall elevation, based on field judgment (and field density test results) showing marginal density of in-place fill soils.

Reconstruction of the MSE wall began once a competent excavation bottom was reached—additional overexcavation was performed below the wall following field judgments by AET’s on-site engineer that the exposed soils were wet, soft, and had low bearing capacity (Fig. 12), including below the area of greatest settlement shown in Figure 7. Up to four feet of overexcavation was performed, and this was backfilled with clean sand, capped by at least 1 foot of a well-graded crushed limestone aggregate base (Fig. 13).

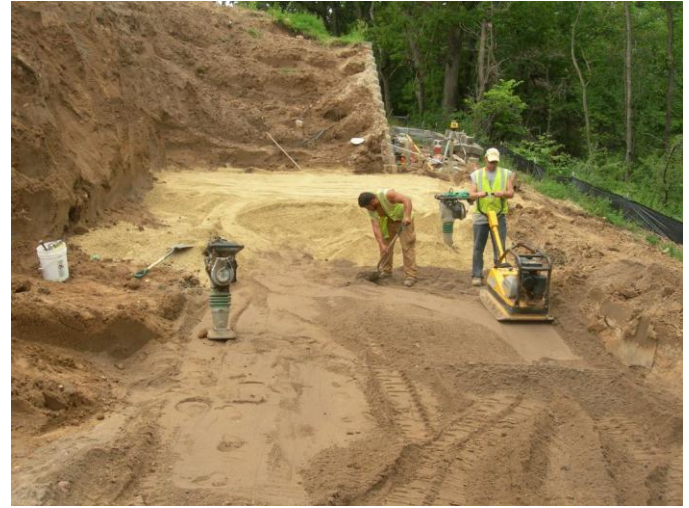
Fig. 13. Clean sand capped with well-graded crushed limestone aggregate base material across the entire base of the MSE wall.

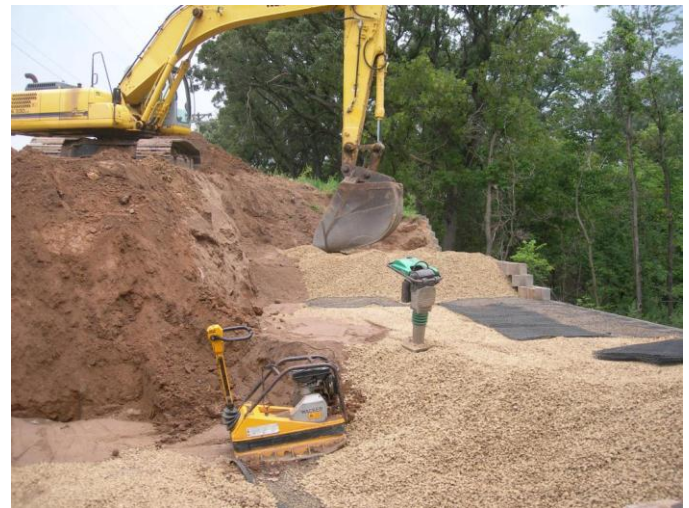
Fig. 14. The reconstructed MSE wall was backfilled with a well-graded gravel filter material, with a three-foot wide well-graded sand filter zone behind.

The three-foot wide well-graded sand filter zone behind the wall backfill separated the crushed rock backfill from the silty and clayey retained soils (Fig. 14). Sieve analysis tests showed a D_{15} for the crushed rock backfill to be 6.9 mm, whereas d_{85} for the sand filter was 2.0 mm—this is a ratio of about 3.5, less than the maximum recommended ratio of 4 to 5 between a sand base soil and a gravel filter.

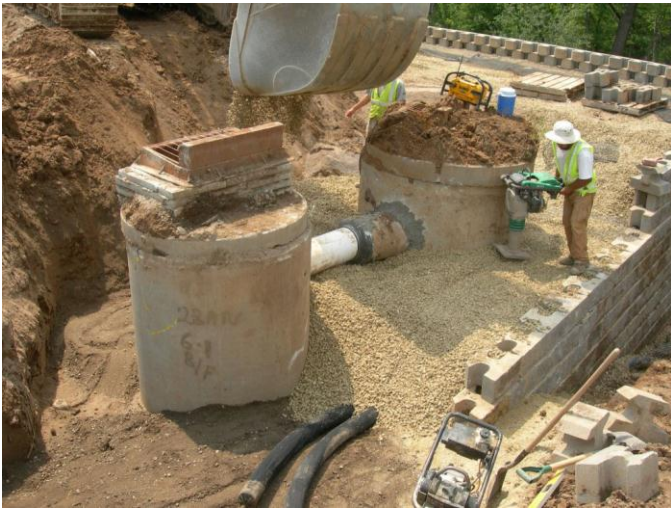
Fig. 15. Compacting gravel backfill around catch basin risers. Geotextile-wrapped filtered drain tile is also visible.

No compaction tests were performed on the crushed rock wall backfill, although visual observations allowed judgment of when sufficient compactive effort had been applied. The material type itself greatly facilitated compaction. This is particularly evidenced in Figure 15, for which it is difficult to imagine clayey backfill being well-compacted around the two catch basins.
