Evaluation and Repair of a Subterranean Parking Garage to Resist Hurricane Flood Levels

EVALUATION AND REPAIR OF A SUBTERRANEAN PARKING GARAGE TO RESIST HURRICANE FLOOD LEVELS

Matthew E. Meyer, P.E.
Senior Associate
Langan Engineering & Environmental Svcs.
Miami Lakes, FL - U.S.A

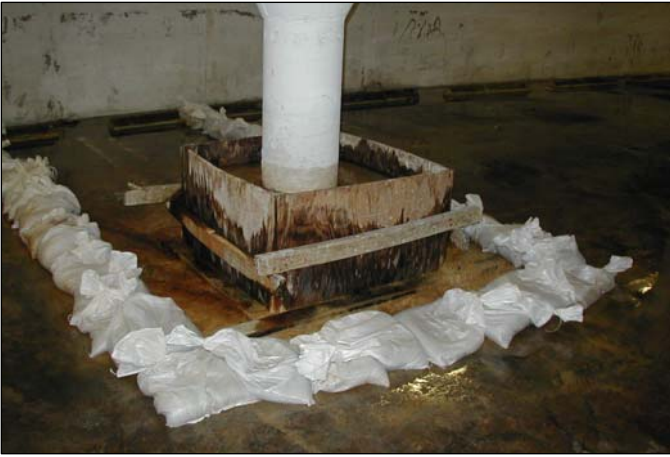
In late 2001, the authors' visited the subject project site and observed the conditions of the subterranean parking level. Extensive cracking and bowing-heaving of the ground floor slab were observed throughout the subterranean level. Additionally, the underside and exposed surface of the elevated concrete deck had extensive cracks. Ponded water was observed throughout the lower level and flowing water was observed through cracks within the slab and at the interfaces of the slab to the footings.

Photograph D – Observed seepage within subterranean level

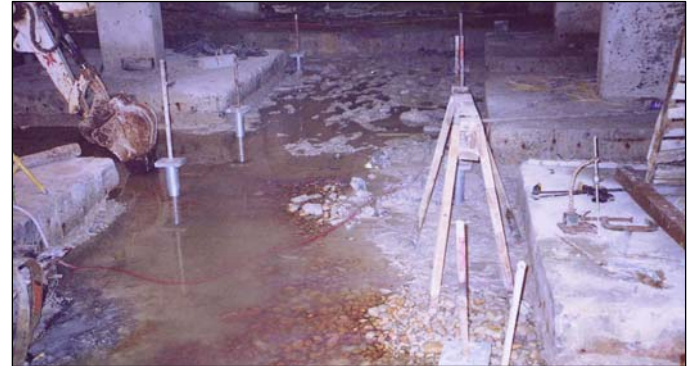
Photograph E – Rock anchor head assemblies

way, top and bottom (2) locally thickened slab sections to facilitate connection of anchors (3) one hundred three (103) 22-ton (196 kN) 5 ½ inch-diameter (14cm), double corrosion protected 1-inch-diameter (2.54cm), grade 150 ksi (1,000 MPa) Williams bar rock anchors, and (4) bentonitic waterproofing beneath the ground floor slab. See Photographs E and F of the completed anchors and waterproofing.

The rock anchors were installed into the Miami Limestone bearing layer and consisted of a passive rock anchor system with an 8 ft (2.4 m) bond length and 2 ft (0.6 m) free strength length (smooth sleeved PVC) resulting in a total anchor length of 10 ft (3m). The double corrosion protection system consisted of a pre-grouted 1-inch-diameter (2.54cm) bar within a corrugated polyethylene tubing. Because of headroom restrictions, all of the rock anchors were spliced in the field and connected via a coupling, and subsequently corrosion-protected prior to heat shrink wrapping.

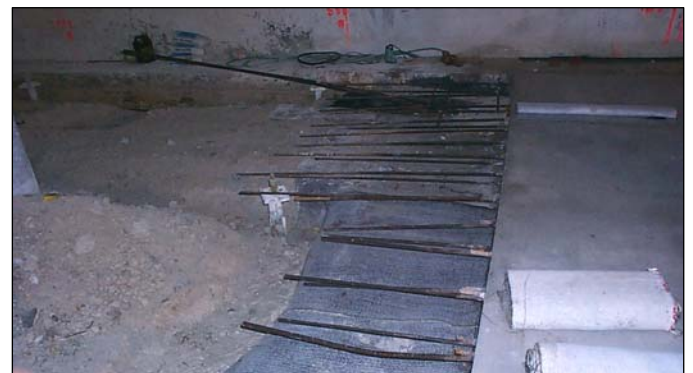
Photograph F – Underslab bentonitic waterproofing

An evaluation of the sub-slab drainage system versus the tie-down hydrostatic slab was performed. Because of the high hydraulic conductivities of the subsurface materials, a continually pumped sub-slab drainage system was not considered. An intermittent hydrostatic relief system, which only provided relief of water pressure during times of seasonal high groundwater levels or hurricane flood conditions, was also considered; however, this system would have resulted in a wet slab condition or inundated slab condition numerous times throughout the year according to historical groundwater information. Ultimately, the water-proofed, hydrostatic-resistant slab with a tie-down system was selected as the preferred alternative. The subsequent sections provide the details of the selected geo-structural systems as well as a discussion of the construction of the slab replacement.

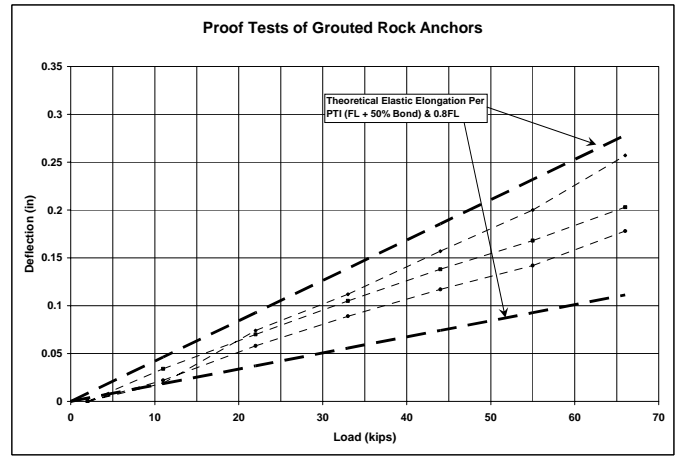
All production anchors were proof-tested prior to construction of the replacement slab. Typically, the rock anchors were proof-tested three days to seven days after installation. The results of the proof testing showed the anchor movement averaged 0.2 inch (0.5 cm) under the maximum test load. Ninety percent of the anchors tested moved less than 0.25 inch (0.64 cm) under the maximum test load. No excessive creep movement in excess of PTI guidelines was observed for the majority of the anchors during the ½ minute to 5 minute hold period. Where anchors moved excessively upon application of the test load (1.5 times the design load), replacement anchors were installed. See Fig. 5 for a graphical representation of the proof tests.

Fig. 5 – Plot of typical proof tested anchors

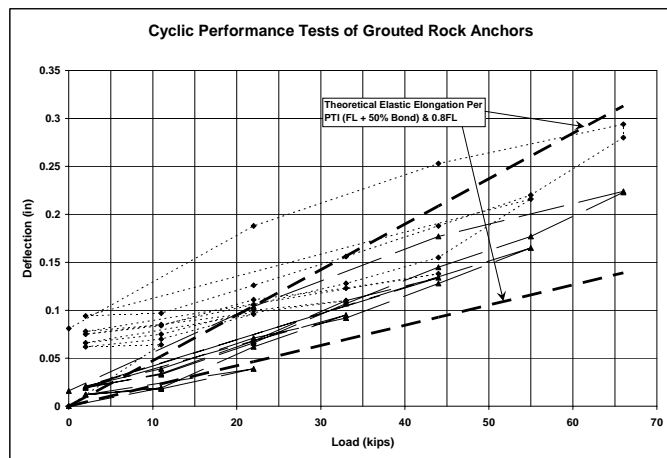
Four rock anchors were installed, prior to installation of production anchors, and performance tested to 1.5 times the design load. See Photograph J. Creep tests (i.e., 50-minute hold under maximum test load) were also performed under the maximum test load. The measured deflection of the top of the bar ranged from 0.176 inch (0.45 cm) to 0.369 inch (0.94 cm). Under the maximum test load, the anchors were observed to creep between 0.001 inch (0.0025 cm) to 0.014 inch (0.0356

cm) during the 50-minute hold period. A graphical presentation of three of the performance load test results is presented in Figure 4.

Fig. 4 – Plot of performance tested anchors
