## Landslide Mitigation on the Sonoma Coast in Northern California

## LANDSLIDE MITIGATION ON THE SONOMA COAST IN NORTHERN CALIFORNIA

Heavy rains in late December 2001 and January 2002 caused approximately 100 meters of roadway to settle approximately 0.5 meters within a week along Highway 1 on the Sonoma County Coast (Post Mile 30.3). This area has a complex landslide history involving two active landslides. These landslides coalesce on a narrow section of Highway 1 approximately 130 meters above the Pacific Ocean. A tieback wall, sheet piles and a lightweight fill embankment had previously been constructed at this location to try to stabilize and maintain the roadway. The subsurface material at the site is composed of a matrix of very weak and extremely fractured shale and mudstone with the inclusion of sandstone blocks and fragments. The landslides are mainly driven by erosion at their base caused by storm related flows in Timber Gulch Creek and wave action undermining the slopes below the roadway.

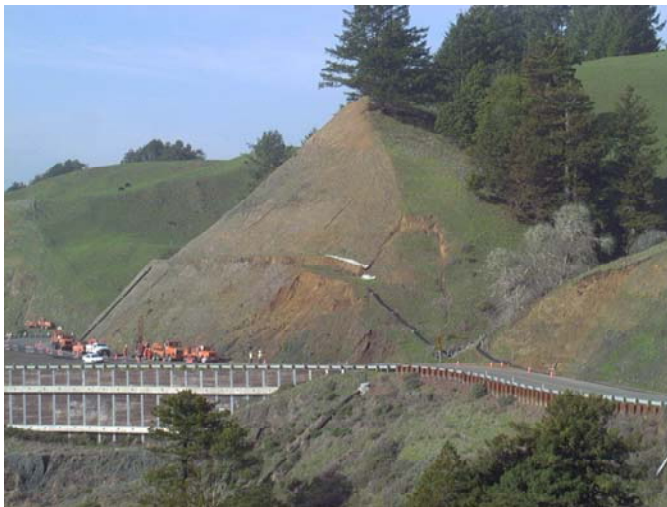
location. At site 2 (PM 30.16) a slide developed adjacent to the outside shoulder of the road for approximately 90 meters (300 feet). The scarp adjacent to the southbound roadway shoulder was approximately 4.6m to 6.1m (15'-20') in height. A tieback wall was constructed in 1995 to temporarily stabilize the slide (See lower left of Photo 1).

The heavy rains in December 2001 and January 2002 caused the landslide to reactivate causing approximately 100m of roadway to settle approximately 0.5m within a week. If the rains had continued the roadway would most likely have continued to settle and eventually forced the roadway to be closed. Because the rains slowed the roadway remained open to the public with the help of some maintenance work. However, the slide remained an imminent threat to the roadway.

Photo 1. Slope Failure on January 2002

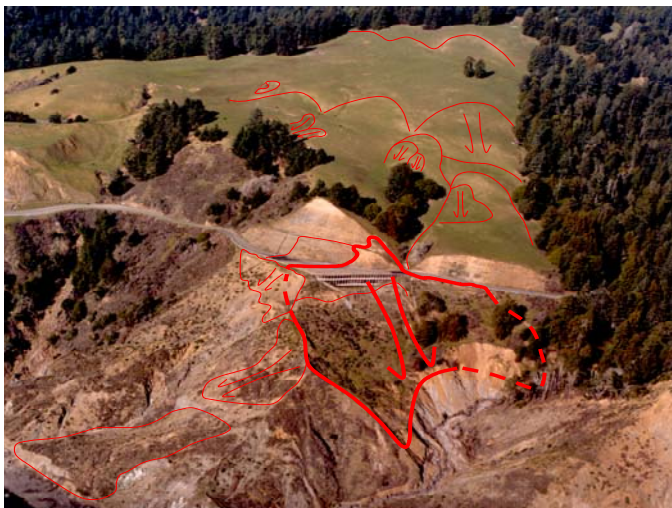
Directional movement vectors were calculated from the SI data. These movement vectors indicate that there are two separate and distinct landslide movements at roadway level (See slide mapping on Photo 2). The northern slide is shallower and

moving in a South-Southwesterly direction towards the Ocean. The southern slide is larger and appears to be moving in a southeasterly direction towards Mill Gulch. Field observations of spring seeps verify the apparent depth of these landslides.

Photo 2. Interpreted Mapping of Recent Slides

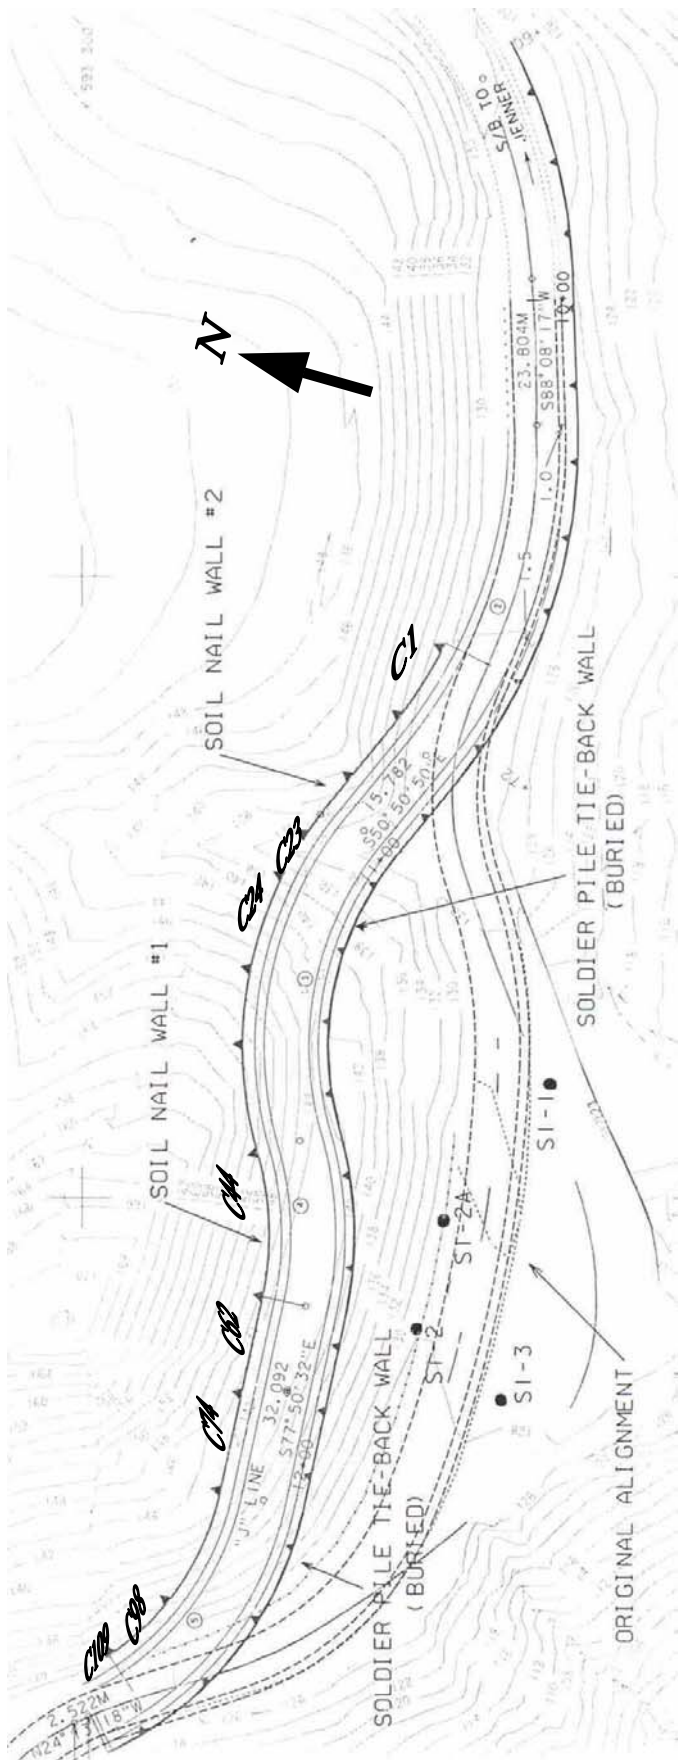
The limits of the soil nailed and the soldier beam tiebacks walls are shown in Figure 2. The soil nail columns were labeled from 1 to 109 northerly. The soil nail column numbers at various locations along the soil nail wall are shown in Figure 2 for reference. The wall is at its maximum height between C44 and C62.

Figure 2. Site Plan Showing Both Wall Alignments

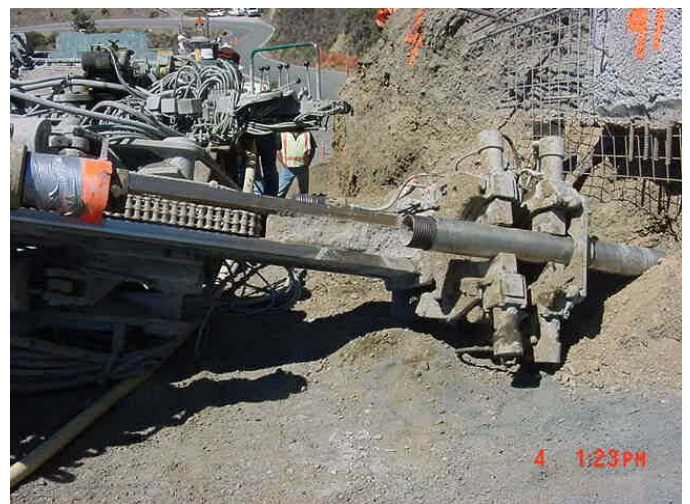
Photos 3 through 13 demonstrate the representative construction activities. The soil/rock condition toward the north side of site consisted of silty clayey gravel of low shear strength. Most of the soil nail drilled holes in that area were cased (Photo 7).

Photo 7. Drilling on north side of Soil Nailed Wall Using Casing

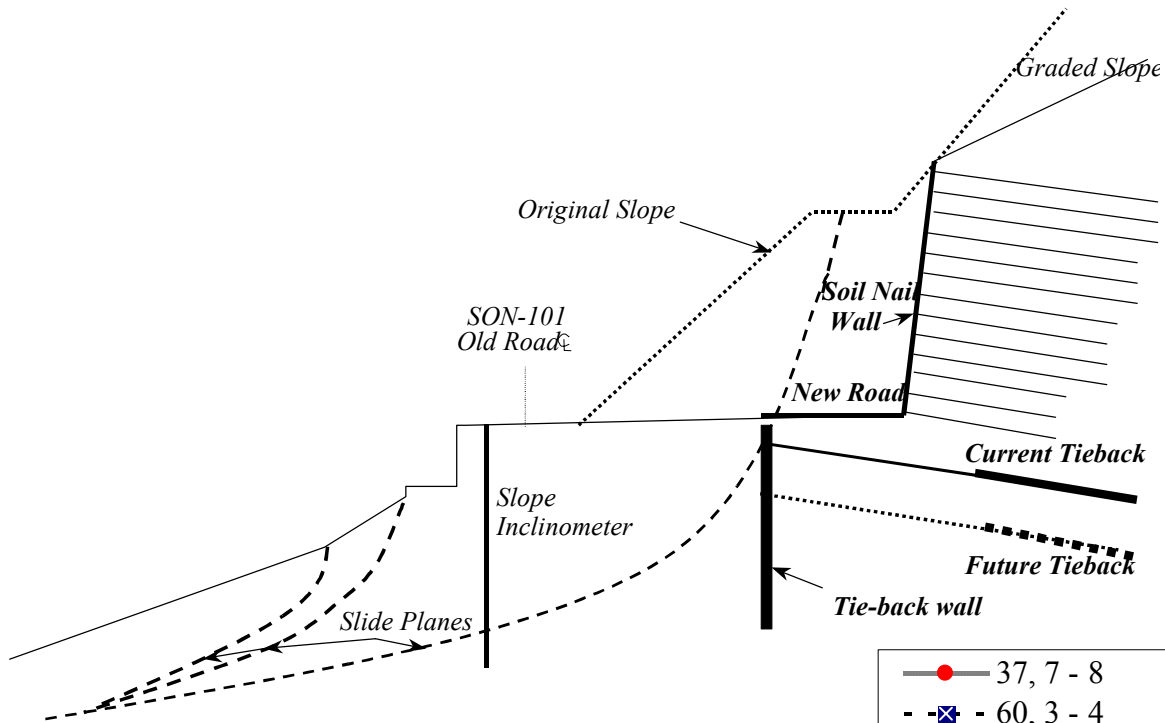
These values were used to determine how far the roadway had to be moved in order to get behind the slide plane (See Figures 2 and 3). A soldier beam tieback wall was designed at this location to withstand a 6 m cantilever.

Figure 3. Slope Cross Section

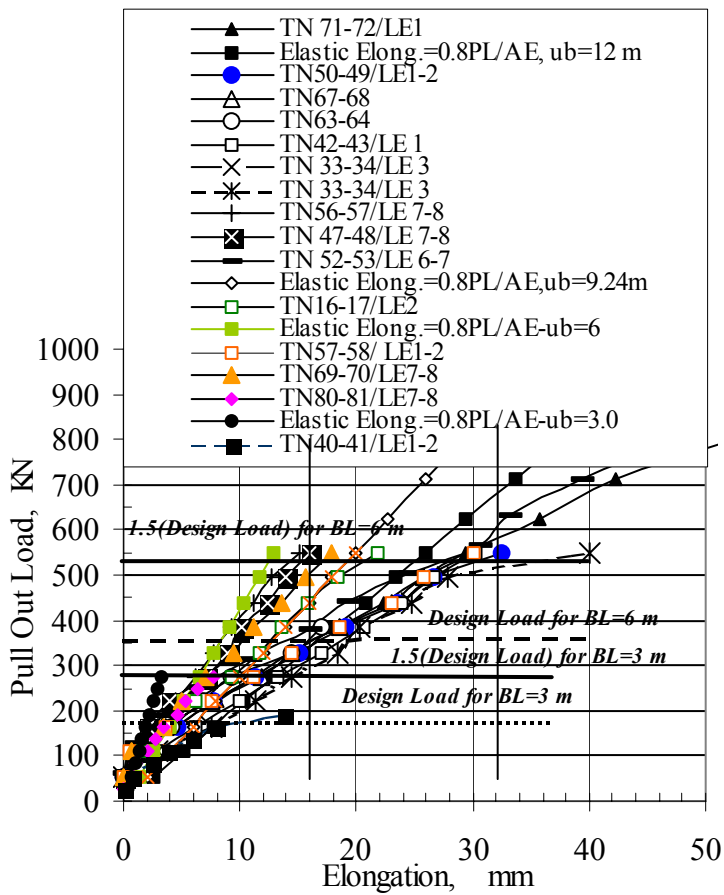
The results of some of the pull out soil nail tests are shown in Figure 4. Each test defined by TN (top of the nail) followed by the nail column and the row level close to the nail. Two tests TN40-41, LE1-2, and TN 33-34/LE3 were failed near the design load at about 15 mm and 40 mm elongation, respectively. However, an additional test performed adjacent to those test locations met the approval criteria. The grout intake was mostly higher than the theoretical value and based on the contractor, grout topping was required for most holes, which were due to the fracturing of the rock and groundwater seepage. All of tieback proof and performance tests met the approval criteria

Figure 4. Soil Nail Pull Out Test Results

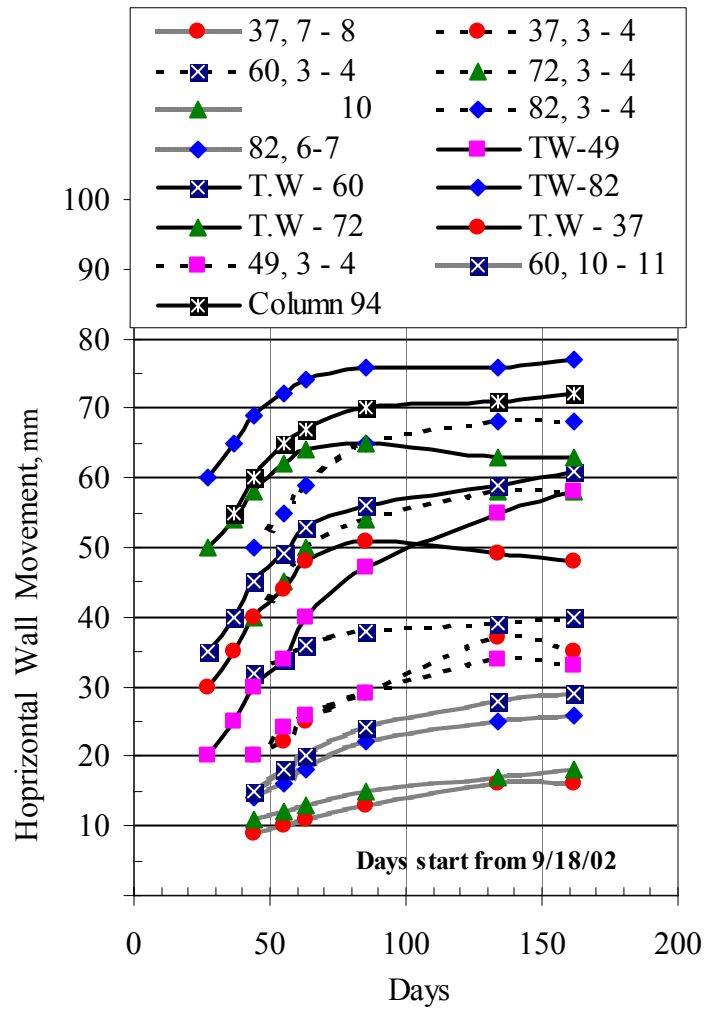
The regular survey of the wall was initiated on September 18, 2003 when the wall reached 10<sup>th</sup> row of the soil nails at the maximum height. Based on occasional wall survey conducted before this date, the wall horizontal movement ranged between 10 to 60 mm with higher movements occurred toward the north end of the wall. Figure 5 shows the horizontal wall movements surveyed at the several locations along the top and the wall face between September 18, 2002 to February 27, 2003. As shown, the wall movement was higher toward the north end of the wall due to poor soil conditions and steeper backfill slope (1V: 1.5H or steeper). During November, some additional and longer nails were installed from Column 90 to the north end of the wall to help reducing the wall movement at that area. As shown the rate of all recorded movements with time have been very small to negligible since January 2003. In May, the survey points were abandoned and Teflon reflectors were installed on the wall facing and the survey of the wall is scheduled to continue using Total Stationing survey method. The differential wall movement at the reflectors near the top of wall between 2/27/03 and 5/27/03 varied between 2 to 6 mm.

The horizontal wall movements have exceeded the 0.3% times wall height criteria considered on normal projects. However, the recorded movements appear to be acceptable since the wall movement has stabilized and no sign of distress has been observed on the wall facing or the sloping ground above the wall.

Figure 5. Recorded Horizontal Movements of Soil Nailed Wall
