Subsidence Movements and Structural Damage Related to an Abandoned Coal Mine

SYNOPSIS: An area in southwestern Illinois has been experiencing surface and subsurface movements with associated damage to surface structures. The area is underlain by an abandoned, partially extracted room-and-pillar underground coal mine. Instrumentation included TDR (Time Domain Reflectometry), Inclinerometers, Sondex, Tiltplates, and precision land surveys. This paper presents the results of a 16-month cooperative study between the Department of Mining Engineering at SIUC and a local coal company.

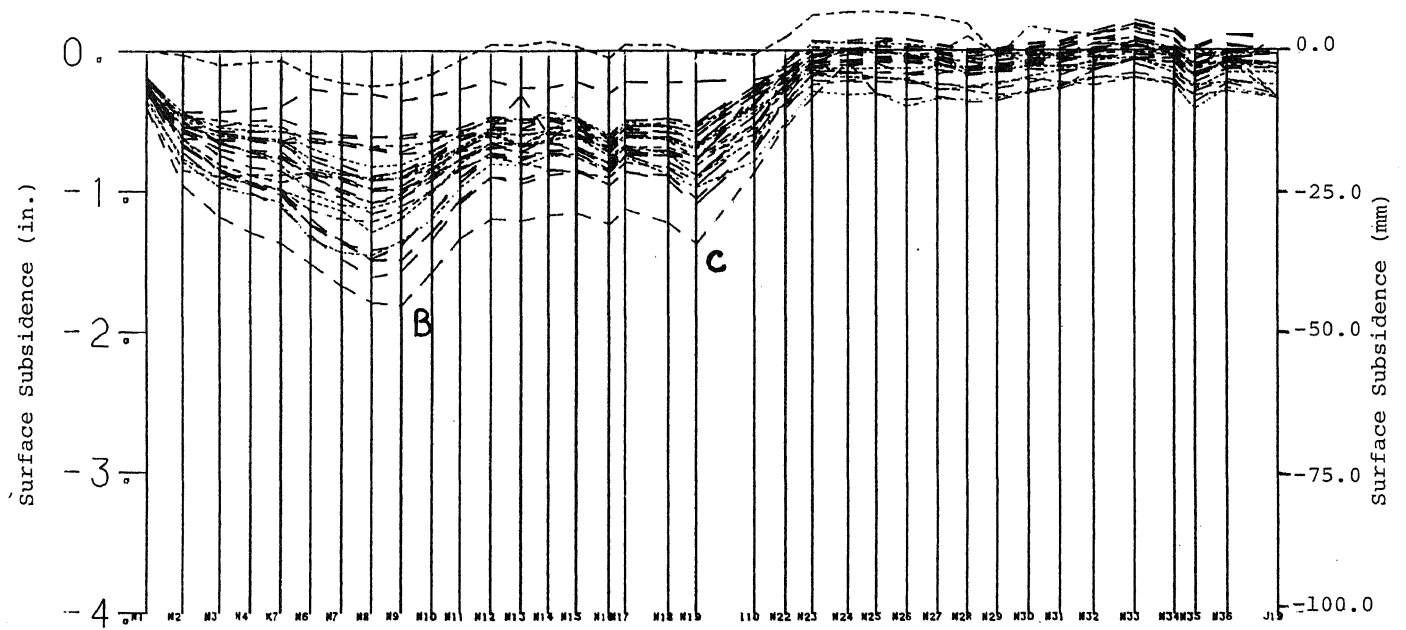
Figure 6. Surface Subsidence Cross Section Along N Grid

Typical crosssection and contour plots of vertical surface subsidence movements over the study area are shown in Figures 5 and 6. Based on an estimated precision of 7 mm (0.3 in.) in elevation surveys, two types of subsidence movements are identified: (1) gradual relatively uniform subsidence of the entire study area, and (2) localized areas (A, B, C, in above figures) of large movements in the form of a trough over a 60-80 m (200-250 ft) area. Movements appear to occur very rapidly in some cases for latter type of subsidence events. Most of the localized subsidence events appear to occur in areas of a bedrock valley (Figure 7) where the proportions of the surficial to bedrock overburden are very large (100:30, 110:20, 120:10 etc.).

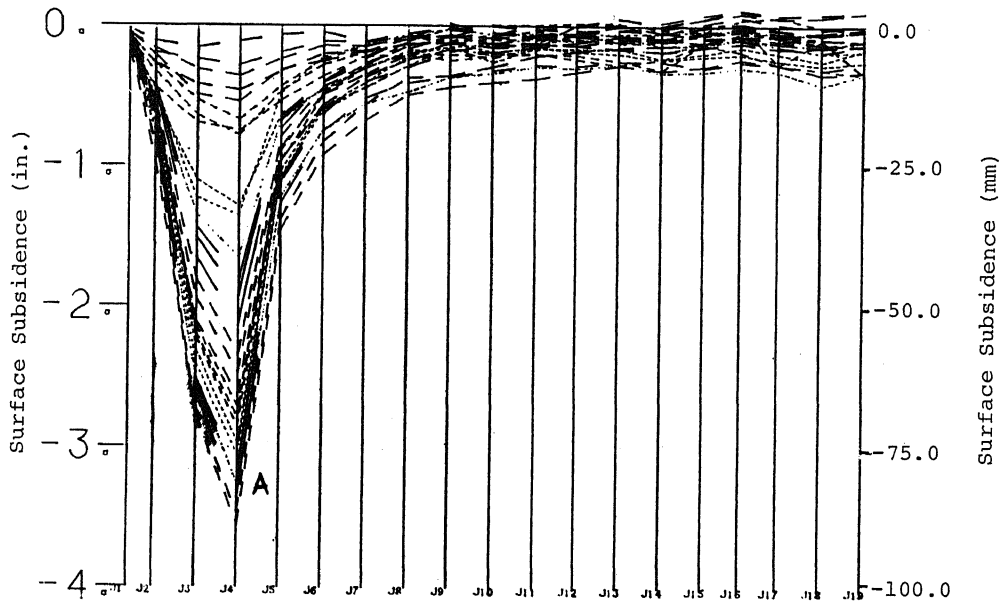
Figure 5. Surface Subsidence Cross Section Along J Grid

1. Vertical surface subsidence movement data (Figure 5) show gradual downward movement with time over the entire area. Surface movements over mine openings and coal pillars are approximately the same except near the barrier pillars where movements are somewhat smaller. Subsurface vertical movement data from Sondex instrumentation in boreholes over the coal pillars (Figure 8) also show downward movement in lower portions of the pillar near the claystone floor. Over the 16-month study period, approximately 12 mm (0.5 in.) of compressional settlement is noted in the area.

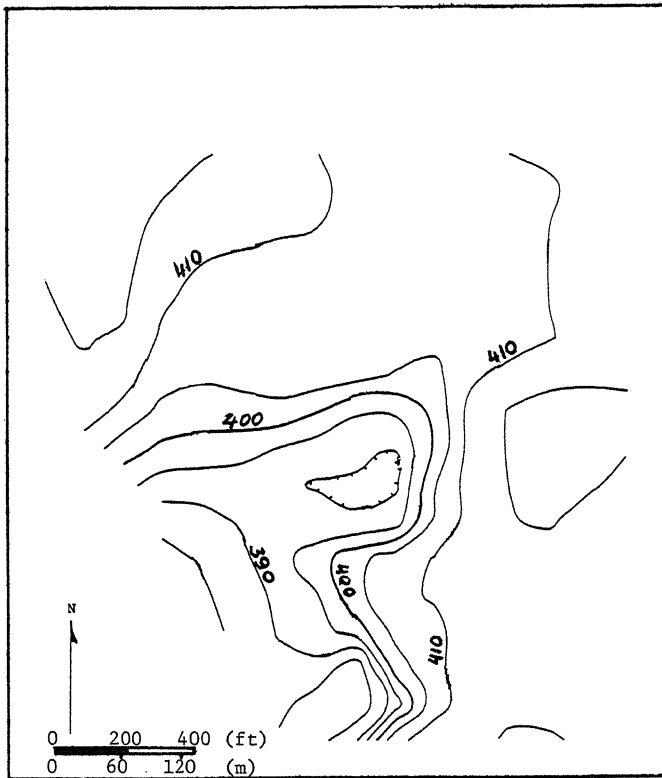
Figure 7. Bedrock Structural Elevation

1. A bedrock valley approximately 9 m (30 ft) deep is observed in the area (Figure 7). The thickness of the bedrock overburden in this valley is only 3-11 m thick (10-35 ft) while the thickness of the surficial overburden varies 24-34 m (80-110 ft). A cross-sectional map of the boreholes revealed the absence of the Bankston Fork Limestone in the bedrock valley. Thinly bedded immediate roof strata and the absence of the competent limestone bed in the roof together form favorable conditions for roof falls and localized rapidly occurring subsidence events such as A, B, C, and D.

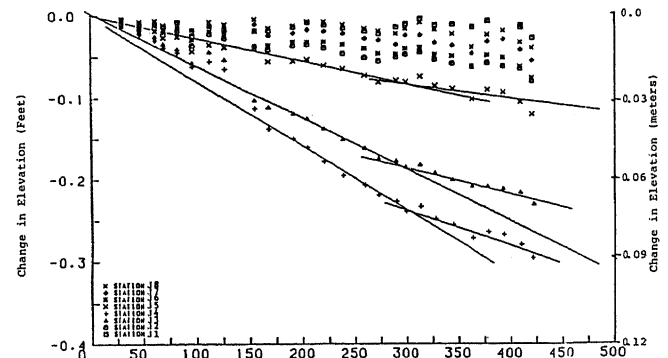
Figure 9. Subsidence Rate of Selected Stations on J Grid Line

The settlement is continuing even after a decade of mining although its rate seems to be decreasing (Figure 9). The expected vertical settlements due to this mechanism will depend upon claystone thickness, overburden pressure, percent extraction, and deformability of claystone. Over a long period of time, these movements may be large enough to cause differential coal pillar settlements and roof falls leading to surface subsidence. Consolidation and compression of claystone floor may be enhanced by the presence of water. In this mechanism, surficial overburden which is at or above its plastic limit (Figure 10) moves downward slowly as pillars settle. No extension strains are expected in the overburden since settlement rates are very small.

Settlement rate due to sag subsidence appears to vary 5-7 mm (0.2-0.3 in.) per month and shows slightly decreasing trends (Figure 9) over the last six months of the study period. Borehole T.V. camera observations in several of these areas showed relatively intact roof, floor, and coal pillars. It is difficult to predict the maximum possible amount of settlement and the rate at which it will occur. Both will be enhanced in the presence of water. Since there are no indications of floor heave or otherwise filling up of void areas underground, additional subsidence movements are possible. These may or may not, however, result in damage to structures on the surface since movements are small and should occur very slowly in the absence of water. If the area was to get flooded, the magnitude and rates of these movements may result in damage to surface structures.

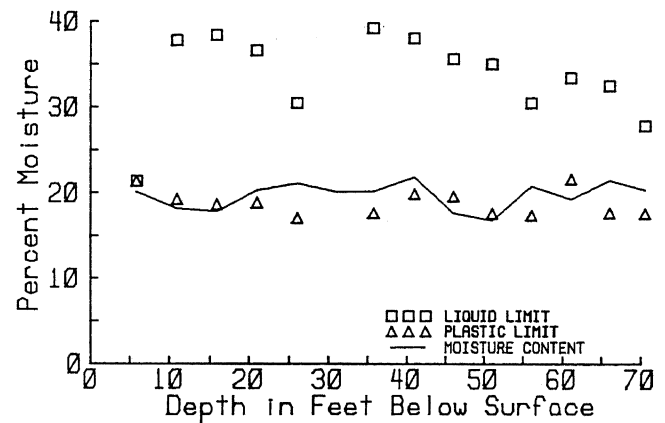
Figure 10. Comparison of Moisture Content, Liquid Limit, and Plastic Limit

- 6) Surficial overburden is above its plastic limit, it has an average moisture content of about 20% and it is relatively independent of the depth below the surface (Figure 10). Unconfined compressive strength of soil overburden varies from 75-925 kPa (11-134 psi) and it generally increases with depth below the surface. An elastic-perfectly plastic material behavior is indicated by stress-strain curves.

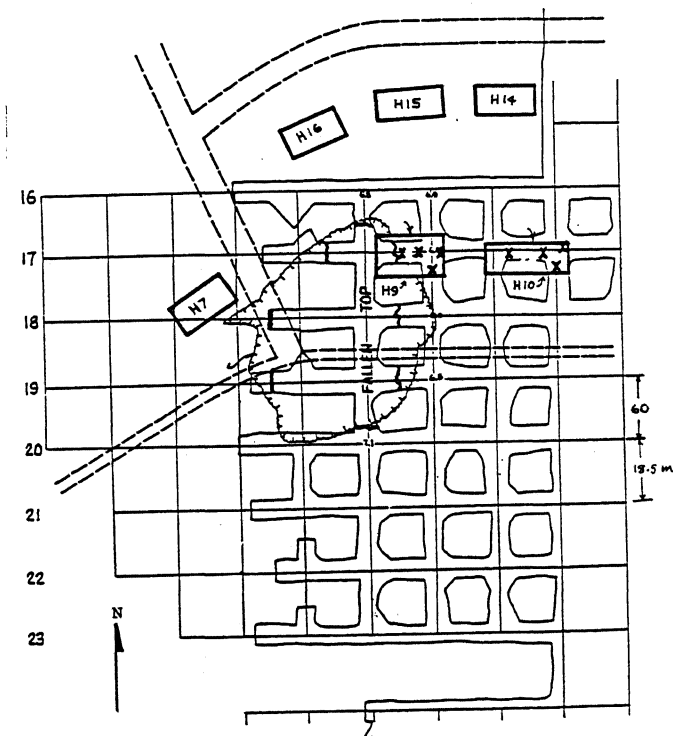
Figure 12. Limits of Surface Cracking from First Report of Subsidence, Dec. 1979

The first report of subsidence occurred in late December of 1977. A circular depression formed on the surface bisecting house (Figure 12) in the study area. Even though mining was terminated and supports were installed underground, subsequent surface settlements continued to occur and house 9 had to be moved due to damage to the foundation. Houses 7 and 10 also showed tension cracks in the foundations which were repaired in 1983. To monitor progressive movements of both these houses, tiltplates were installed in the Fall of 1983. In house 7, 3 tiltplates were installed on the foundation walls to monitor the movement on both sides of the major cracks in the foundation and floor. Based on the tiltplate data with a precision of

± 4 seconds, the southern portion of the house is tilting most to the southeast, toward the center of the first depression, while the north side of the house is tilting toward the east but its magnitude is less than that of the southern portion of the house. A typical plot of the tilt is shown in Figure 13. A maximum horizontal displacement 2 mm (0.08 in.) is observed in the foundation since the tiltplates were installed. In house 10, 3 tiltplates were installed; one on the west side and two on the east side. The largest movement occurred on the west side of the house, with a tilt of 46 seconds to the west. This corresponds to a horizontal displacement of about 8 mm (0.32 in.).

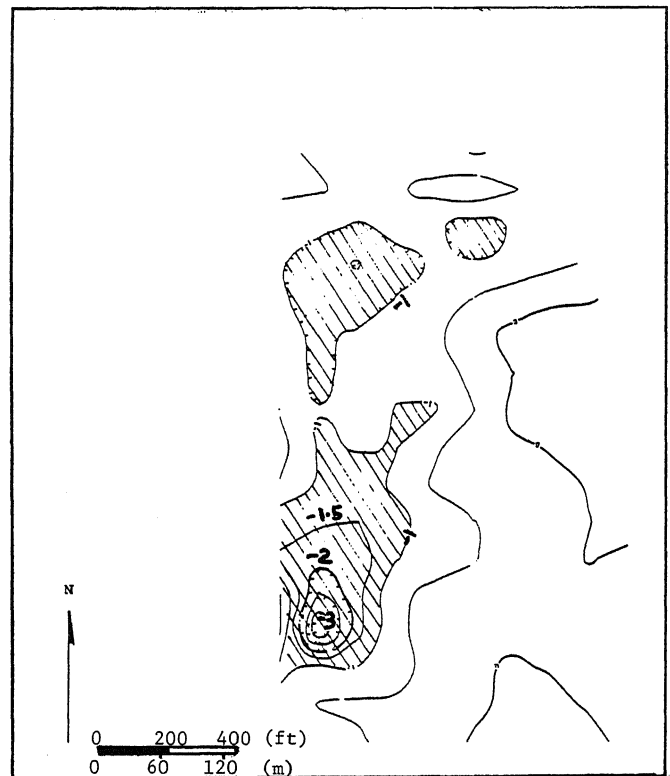
Figure 14. Localized Areas Currently Subsiding

7) Localized areas on the surface are continually undergoing subsidence (Figure 14). Most subsidence is observed adjacent to House 7 with a total vertical movement of about 89 mm (3.5 in.).

4) Areas that may be affected by subsidence movements in the future have been outlined in Figure 14. Monitoring of these and other areas should continue at regular intervals to develop a stronger database for future subsidence studies.
