Pile Driving Adjacent to Municipal Drinking Water Storage Facility

PILE DRIVING ADJACENT TO MUNICIPAL DRINKING WATER STORAGE FACILITY

ABSTRACT

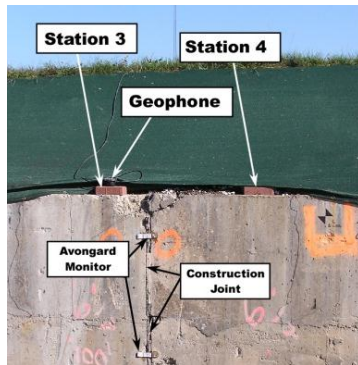
Fig. 5: Geophone monitoring blocks and Avongard strain gauges at the West reservoir wall construction joint (center).

Six monitoring locations were established on the West reservoir wall using bricks, with Geophone receptors epoxied to the reservoir wall as shown in Fig. 5. At the center of the reservoir wall, two monitoring blocks are shown (Fig. 5), with Station 3 on the left and Station 4 on the right, one on each side of the construction joint. Also, note the two Avongard strain gauges that span the construction joint. A Geophone is installed on monitoring Station 3 (the left side (North) of the construction joint).

As pile driving progressed to the South, one of the major concerns was the differential elevation between Stations 3 and 4, which were located approximately 3 feet apart as shown in Fig. 5.

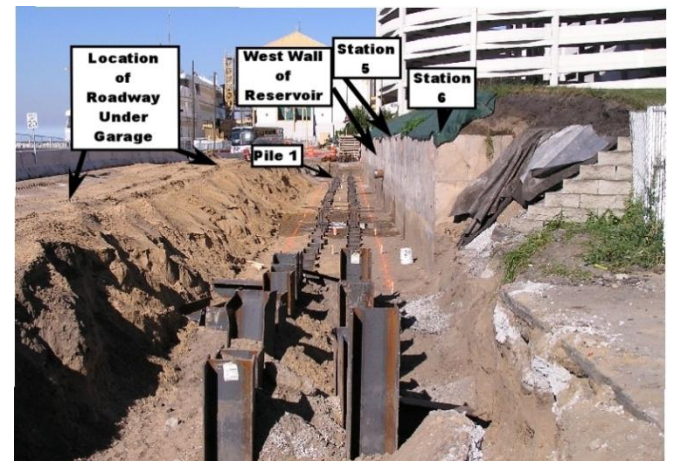
Fig. 7: Driven piles and West wall of Water Reservoir.

Figure 7 shows the driven 122 H-piles and the West wall and South West corner of the water reservoir. The old parking garage is visible behind the reservoir; the office building is behind the piles. It should also be noted that the top of the water tank has approximately 3 feet of soil for frost protection.

As shown in Fig. 7 and Fig. 9, not all seepage was eliminated from the wall. However, seepage was reduced in the majority of the cracks. At the construction joint in the center of the wall there is both vertical and north-south differential movement between Stations 3 and 4.

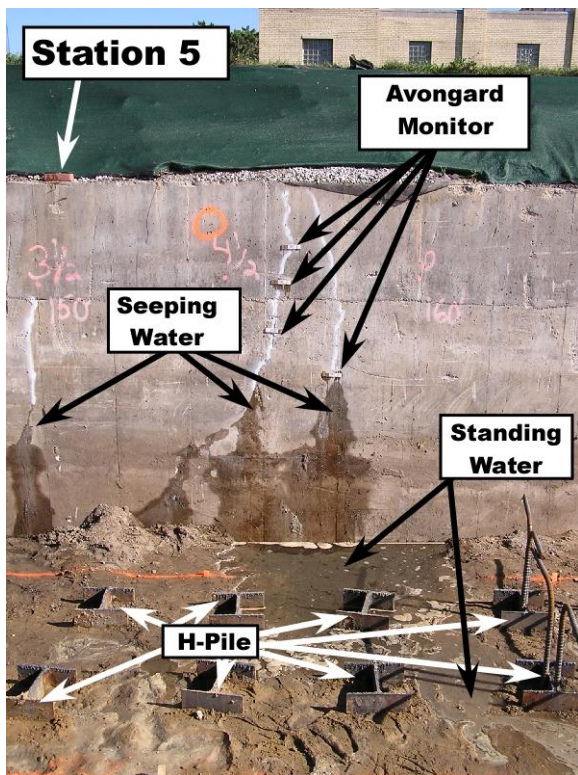
Fig. 9: Monitoring Station Number 5, 150 feet South of North end.

Figure 9 shows Station 5 at the center of the south half the West reservoir wall. Three pre-existing cracks with crack monitors are highlighted with white paint; these cracks are spanned by Avongard crack monitors. Water is seeping from the cracks and ponded adjacent to the wall (driven piles are visible in the foreground).

The uplifting of the West Wall appeared to be within tolerable limits, with no adverse impacts noted until September 10, when water was observed seeping from one of the cracks at Station 5 (Fig.9). It was also noted that there was approximately 1/10 of an inch vertical and horizontal (North-South) differential movement across the construction joint (Stations 3 and Station 4).

With both the differential elevation changes and water seeping from the West Wall of the reservoir, discussions were held with the owners engineer representative and eventually the owner. Based on these discussions it was decided that the most pragmatic approach to correcting the problem was to alter the pile driving sequence so that the middle and South end of the southern half of the reservoir would be raised more uniformly.

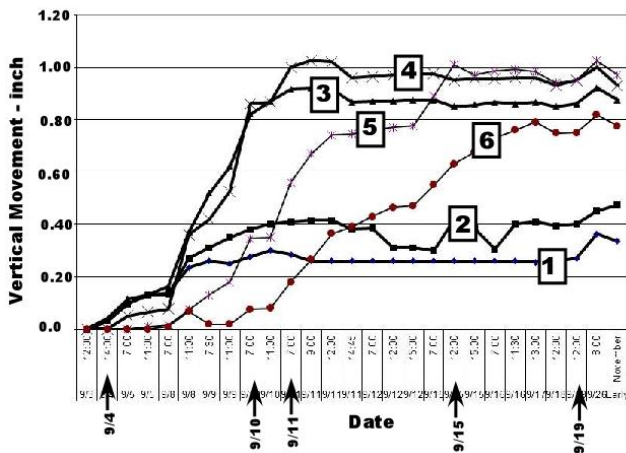
Fig. 10: Changes in vertical elevations of the six Monitoring Stations on West Wall of water storage reservoir.

Figure 10 shows changes in vertical elevations of the six monitoring stations during pile driving. Note that five explicit dates from September 4 through September 17 are highlighted on Fig. 10. These response dates are used in Fig. 12 to show the changes in the structures response that were achieved.

There are several things to note in Fig. 10. First, note that all stations on the West reservoir wall were raised as the result of the pile driving. Second, Station 1, at the far North end remained at essentially the same elevation after September 9th. Third, Stations 3 and 4(also shown in Fig. 5) moved in tandem until September 10, when they begin to show approximately 1/10 of an inch height differential that continued to the end of the project. Next, Stations 5 and 6 on the South half of the reservoir wall lagged behind the movement of Stations 3 and 4. Last, the North end of the wall was raised first, and after September 11 essentially remained unchanged.

At no point was the differential movement between any of the points greater than 1 inch which means the structure of the tank had a Δ/L ratio of $< 1/1200$ which was acceptable to the owner's structural engineer.

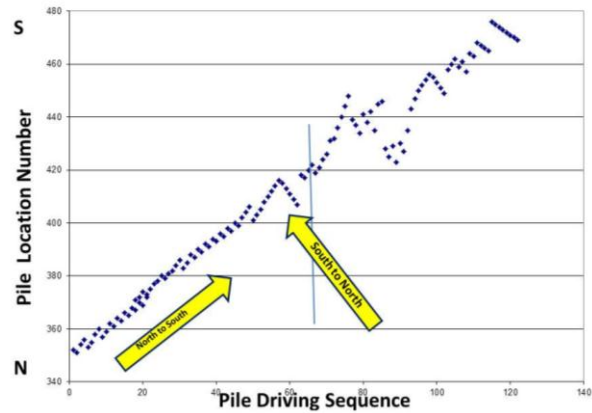
Fig. 11: Pile location versus driving sequence.

Figure 11 shows the pile location number versus the driving sequence. The nearly linear line on the left side of Fig. 11 for piles 1 through 60 represents the effort prior to September 10. The scattered driving sequence in a much less linear fashion on the right side of Fig. 11 for piles 60 through 122 shows the corrective driving sequence.

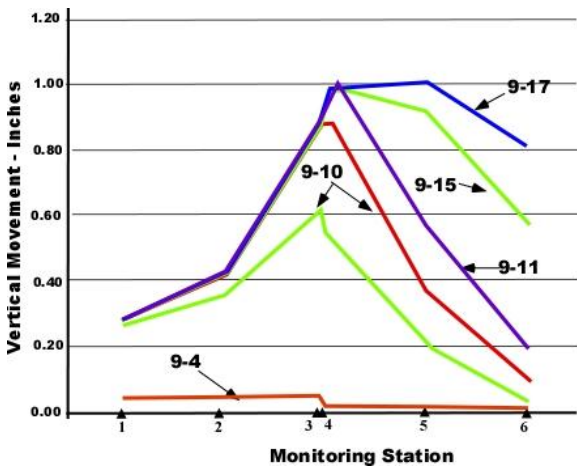
Figure 12: Wall monitoring station elevations at the beginning, middle and end of project.

The effects of altering the driving sequence shown in Fig. 11 are shown in Fig. 12 where the monitoring station locations are plotted against the wall elevations for five dates. Stations 3 and 4 are approximately 3 feet apart, while the other stations are each 50 feet apart. At the beginning of the project, as shown in the bottom line for September 4, the three monitoring stations on the North half of the reservoir wall had risen, while none on the South half had risen. Station 3 was approximately 1/20 of an inch higher than Station 4. On September 10, when the seepage began, Station 1 had achieved its maximum height change. Station 2 was very close to its maximum height change, and Station 3 has a greater elevation change than Station 4.

After the altered pile driving sequence began on September 10 the impacts can be seen in the upper September 10 line shown in Fig. 12. Station 2 has reached its maximum elevation change, Stations 3 and 4 are nearly equal in elevation change. Stations 5 and 6 are both moving up, and the sharpness of the curvature of the representative line is less than it was before the pile driving sequence was revised. On September 11, Station 4 has reached its maximum elevation change, and the three stations to the North remained constant. Both Station 5 and Station 6 moved upward and the line between Stations 3, 4, and 5 is increasingly straight.

On September 15, Stations 1, 2, 3, and 4 show no change, while both Stations 5 and 6 have nearly 4/10 of an inch of elevation change. The curvature of the line between the stations on the South end of the wall is now upward. At the completion of the pile driving on September 17, Station 4 and Station 5 both have approximately 1 inch of elevation change. Station 6 has an elevation change of slightly more than 8/10 of

an inch. At the construction joint, there is a differential elevation change of approximately 1/10 of an inch between Station 3 and Station 4.

The North end of the tank was raised approximately 3/10 of an inch. There is nearly 7/10 of an inch differential between the North and South Ends of the wall. A differential is to be expected since, the North 30 feet of the tank had no piles driven adjacent to it, and the piles extended approximately 30 feet beyond the South End of the wall. A more interesting question is: Why was the southern end of the tank, Station 6, only raised 4/10 of an inch, when the piles extended 30 feet beyond the South End?
