Slope Stabilization Measures for Kirkwood Penstock, Early Intake, California

SYNOPSIS: Kirkwood Penstock, located in a deep, steep-sided canyon near Yosemite National Park, California, is an integral part of the Hetch Hetchy system, which conveys water from the Sierra Nevada mountains to the city of San Francisco, California. A heavy rainfall approximately 17 years following construction of the facility triggered settlement of the foundation. Measures undertaken to arrest this settlement included consolidation grouting, construction of facilities to divert surface runoff away from the penstock, and installation of a geomembrane to prevent infiltration of rainfall and snow melt in the vicinity of the penstock. No evidence of further settlement has been detected since completion of the remedial work.

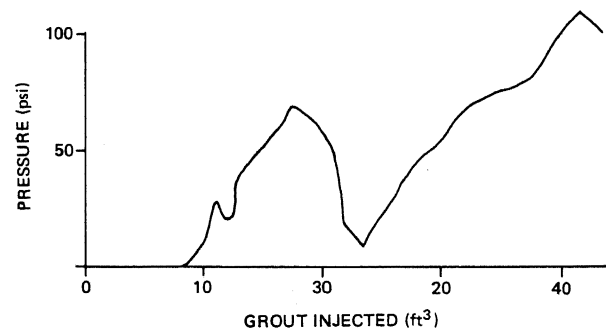
Figure 1. Pressure Behavior at Constant Injection Rate

The injection pressure commonly would build up to two or more peaks during the grouting of an interval, and then would drop off before building back up again. This behavior, an example of which is presented on Figure 1, is ascribed to the grout pushing loose talus blocks aside and exposing additional voids. These pressure peaks were not necessarily high as compared to the refusal pressure for the stage; as is shown on Figure 2, injection of intervals deeper than about 20 feet was more commonly halted on the basis of grout take than of excessive pressure.
