International Conference on Case Histories in Geotechnical Engineering (2008) - Sixth International Conference on Case Histories in Geotechnical Engineering

Forensic on Construction Induced Failure of Pipe Pile Foundations

FORENSIC ON CONSTRUCTION INDUCED FAILURE OF PIPE PILE FOUNDATIONS

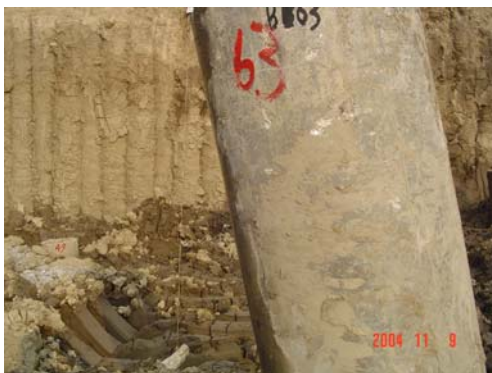
(a)

Upon the accomplishment of foundation installation, construction activities proceeded which included excavation for ground grading with backhoes (Fig. 2a). Severe inclination of pipe piles, however, were observed at a number of locations during the excavation process. The construction activities were halted after observing these excessive inclinations. The inclination of pipe piles continue

Fig. 2 Severe inclination observed during excavation a) photo during construction; b) illustration of pipe pile inclination

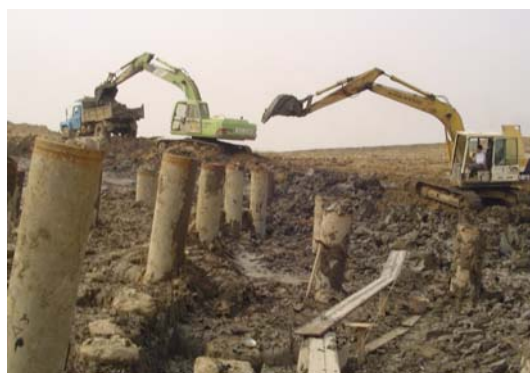
(b)

to increase slightly until it reaches a stable condition. Figure 2b gives an example photo showing the inclination of individual pipe pile. Result of post-accidental survey indicated that the maximal lateral displacement at the top of pile reached as large as 2.6m. A statistics of the magnitude of pipe pile inclinations is listed in Table 1.

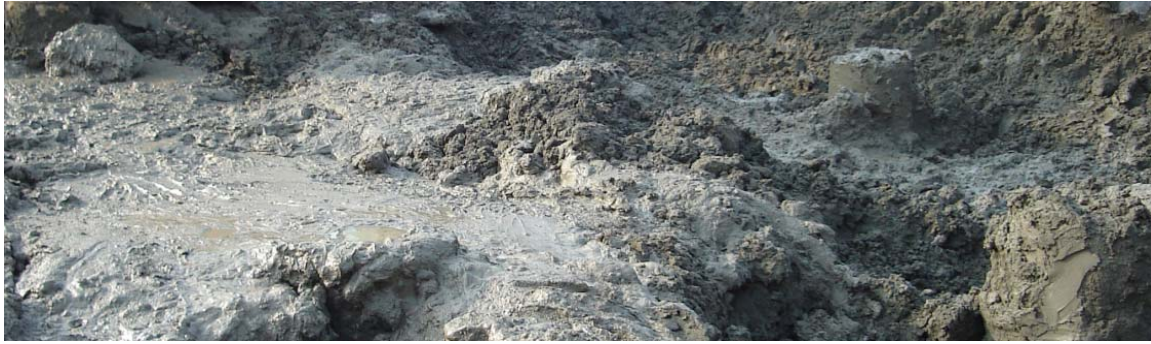
Ground vibration due to motion of construction equipment caused the sludge layer into a semi-liquified condition. Figure 3 shows a photo of the status of sludge to indicate effects of construction

vibration on the sludge behaviors. As can be seen from the left hand side of this photo, the construction vibration caused the sludge to behave like a liquid.

Fig. 3 Effects of construction vibration on sludge

In conjunction with this effect, the differences in elevation due to excavation caused sludge to flow gradually under gravity. These subsequently applied a significant amount of unbalanced lateral force on pipe piles. As the consequent, the soil layer offered insignificant amount of lateral resistance. This unbalanced lateral force together with the lack of lateral support caused large bending moment action on the pipe piles, which was sufficiently large to cause the failure of splices in many cases. Among the factors led to the accident, the internal factor is the thick soft sludge layer with high

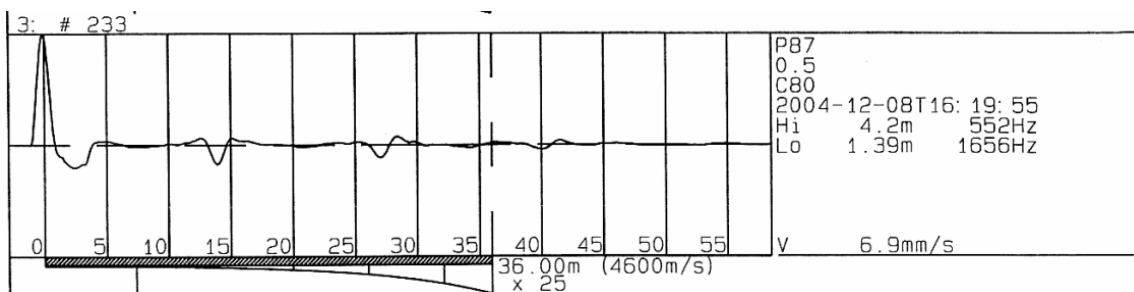
As part of the forensic study, both Pile Integrity Tests (PIT) and inclination measurement were performed on the failed pipe piles. 164 such tests were conducted altogether. Example of measured results is shown in Fig. 4. Both the PIT signal and inclination data imply that the pipe pile fails at around 11m, which is close to the location of the last splicing. Similar failure pattern was observed on other pipe piles.

Fig. 4 Example of PIT and inclination measurement on pipe pile

Based on assessment of the load bearing conditions of the failed pipe piles, it was determined that most of the failed pipe piles could not be utilized for foundation support. Foundation at the location of failure was redesigned with new large diameter piles to ensure the bearing capacity and settlement criteria. The economic loss caused by the foundation failure was estimated to be around 20M Yuan.

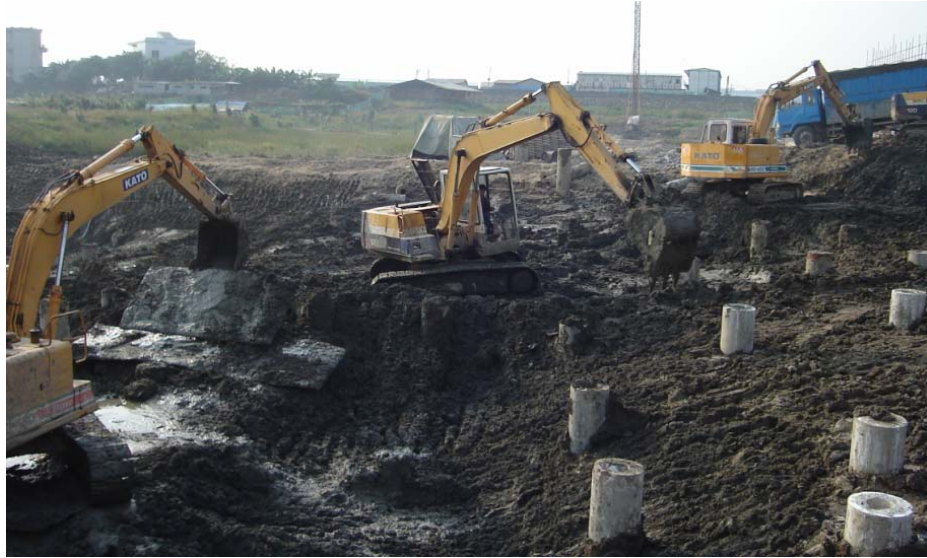
recommendations were followed during the rehabilitation construction as well as during other similar projects. No failure was observed during these projects. An example of field photo taken during the construction at a similar site is shown in Fig. 5. The field monitoring data indicate the amount of inclination of these pipe piles are all controlled within the allowable limits. The successful experience validated the results and recommendations of the forensic study.

Fig. 5 Photo of construction activities following the recommendations

Based on the forensic study, the following recommendations were made to prevent construction vibration and excavation induced pipe pile failure at similar sites, i.e., 1) to reduce the difference in excavation elevations. Properly deploy the construction equipment to avoid the formation of steep slope during excavation; 2) to reduce the effects of construction vibration on soils by placing pad under the construction equipment; 3) to apply field monitoring program to provide warning on potential triggering factors. These
