Accumulation of Rainfall in the Permeable Fill Behind a Soil Nail Wall

ACCUMULATION OF RAINFALL IN THE PERMEABLE FILL BEHIND A SOIL NAIL WALL

ABSTRACT

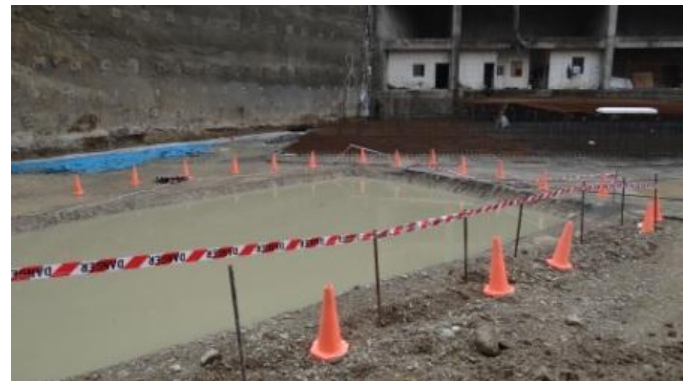
Fig. 25. Accumulation of precipitation water in an excavated pond

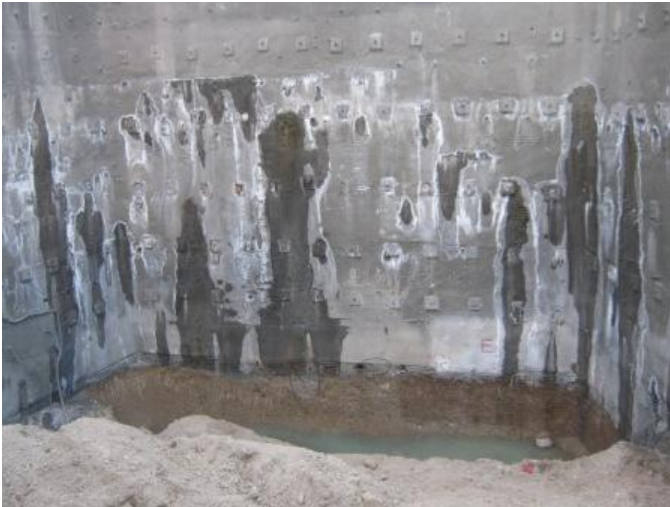
Moreover, the initial concern that there might be localized intrusion of ground water into the excavation pit proved to be correct and water marks began to form on the surface of the shotcrete on some of the soil nailed walls.

At this point the drains incorporated just above the bottom row of soil nails did not seem to function as expected. It appears that the lower permeability of the intact cemented soil and existence of pockets of permeable materials conducts the water towards the shotcrete facing without allowing water pressure dissipation through the lower drains. Fig. 26 shows

water marks formed on the surface of the E4 soil nail wall.

Fig. 26. Water marks on the surface of the E4 soil nail wall

The quicker relief of water trapped behind the shotcrete facing was accomplished by scratching the surface of the shotcrete at the location of the large water marks for drains to be installed. Fig. 27 and Fig. 28 show the parts of the shotcrete that were scratched and the finished temporary surface with the drains installed.

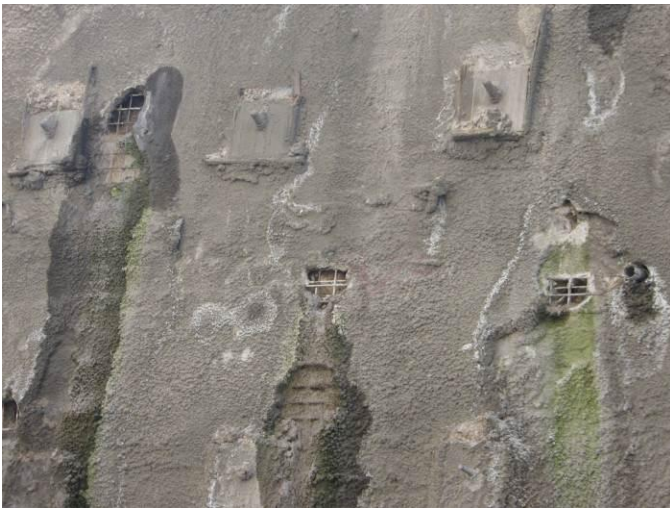
Fig. 27. Shotcrete scratched at the location of the water marks

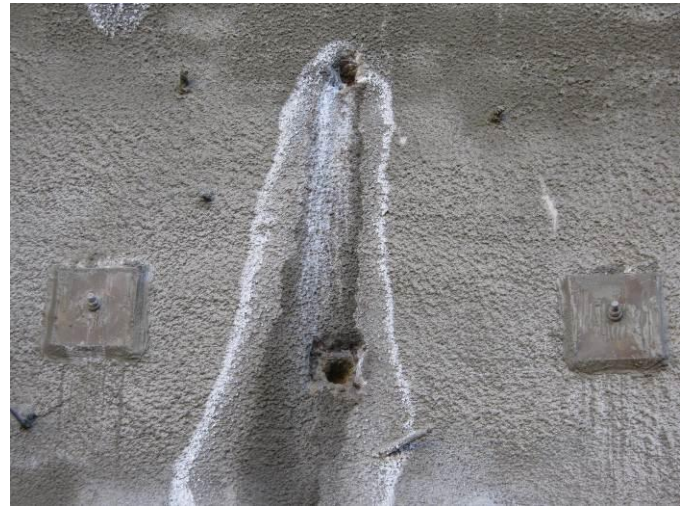
Fig. 28. Finished surface after installing the drains

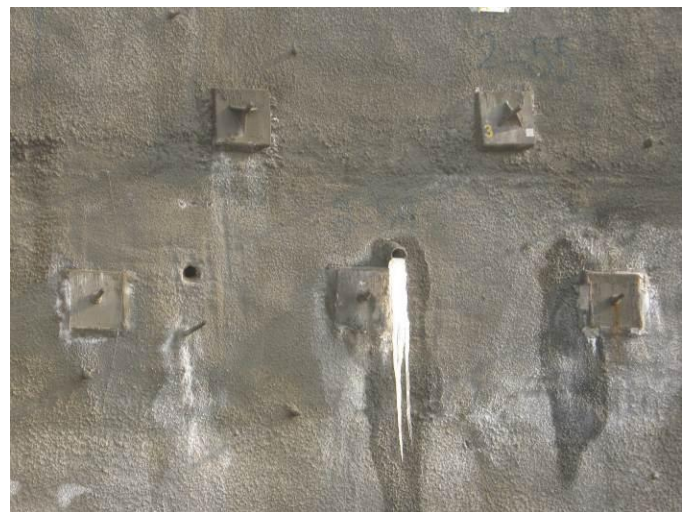
Fig. 29. Frozen water at the tip of a drain pipe installed on the soil nail wall (the drain was installed at this location after the water marks appeared on the shotcrete facing)

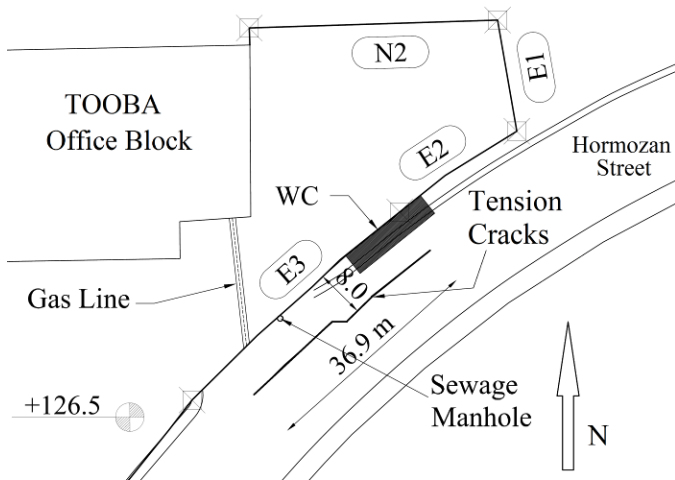
indicated that there is a high pressure gas pipe to the south east of the TOOBA tower which supplies the tower. Fig. 30 shows the position of the gas pipe the crack and their relative positions to the E3 soil nail wall and the TOOBA tower. The gas pipe has held in place using a strut system since the beginning of the excavation as shown in Fig. 30. In this picture, water marks are also evident on the shotcrete surface of the E3 soil nail wall.

Fig. 30. Positions of the subsurface infrastructures near the excavation pit

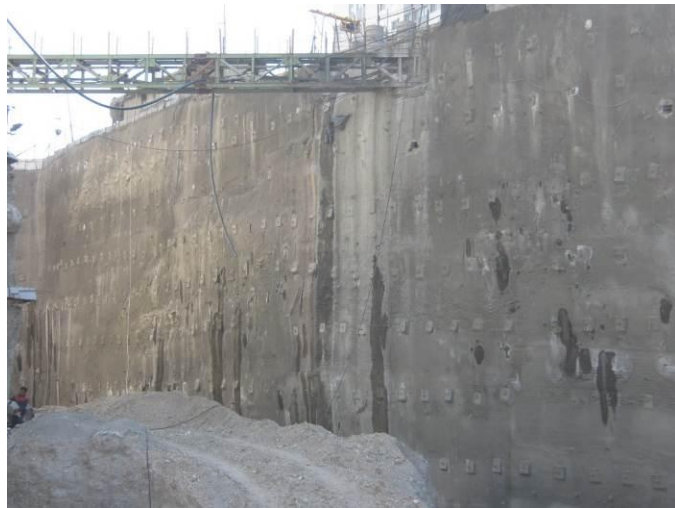
Fig. 31. Strut holding the gas pipe between the E3 soil nail wall and the TOOBA tower

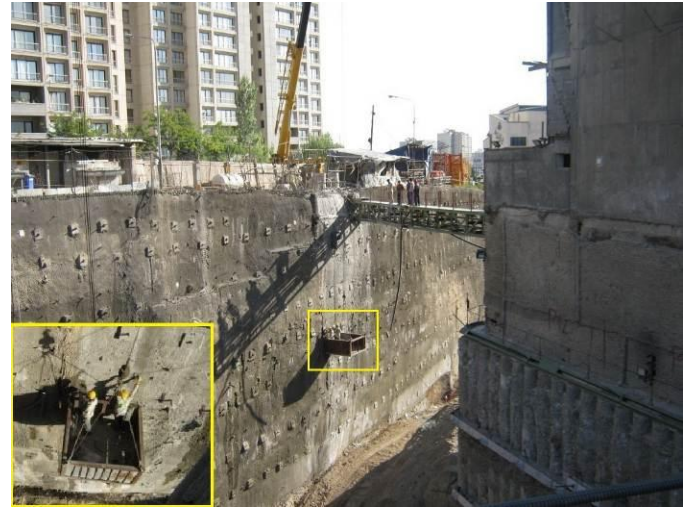
Fig. 34. Workers installing the drains on the locations where water marks have appeared on the surface of the shotcrete

The scratching of the shotcrete at the location of watermarks alone allowed that some of the accumulated water behind the wall to dissipate quickly. However, 6 meter long handmade drains which consisted of a grooved PVC pipe wrapped inside a geotextile cover were installed to help dissipate the rest of the water possibly trapped inside permeable deposits behind the wall. Fig. 34 shows the strut from a different angle while workers are installing the drains on the locations where water marks have appeared on the surface of the shotcrete.

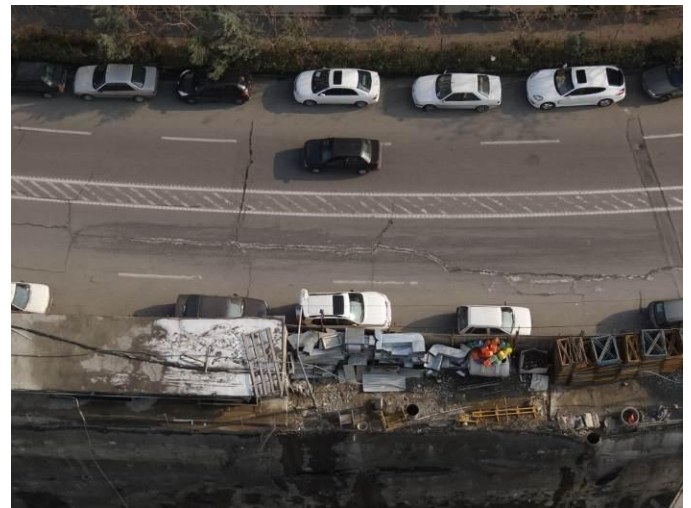
In August 29, 2011 following a three-day rainfall a tension crack suddenly opened on the surface of the road at the eastern side of the excavation site, just behind the E3 soil nail wall. The maximum width of the crack at the surface of the tarmac was 3 cm. The speculation was that the actual crack width beneath the tarmac could be wider. Later reports show that the width of the crack increased to 7 cm during the next day. Tension cracks could happen in passive earth retaining structures such as soil nail walls; but, an opening to the width

of 3 cm very close to the top of the wall over the period of one night after 3 days of continuous raining was interpreted as a signal that a shallow moving block has formed.

Fig. 35. View of the crack at the surface of the tarmac captured from the roof top of the TOOBA tower

All the cracks on the surface of the road were closed with proper combination of tarmac to avoid further intrusion of water into the tension crack.
