## Lakeview Tower: Case History of Foundation Failure

# Lakeview Tower: Case History of Foundation Failure

K. R. Peaker

Geotechnical Consultant, Trow Ltd.

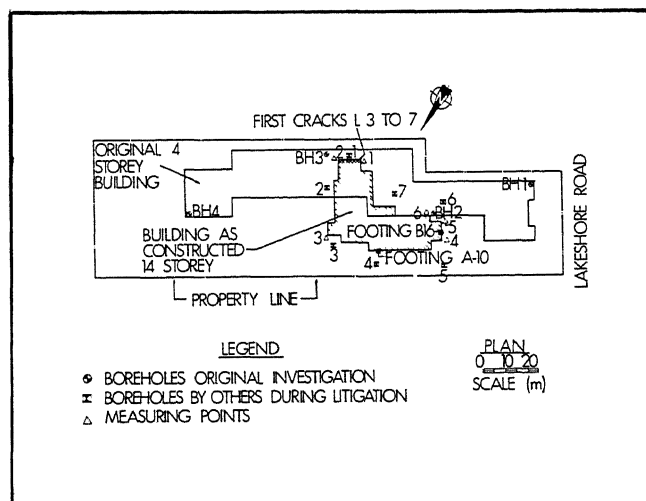
Fig. 1. Building Layout

Soon after the submission of the site investigation report the building proposed was changed to a 14 storey reinforced concrete building with brick infill, again without basement. The building shape altered considerably and extended beyond the original site investigation. Fig. 1. The original site investigation was considered to be adequate for the 14 storey building as the new foundations recommended were piles or caissons and little variation in subsoil conditions was evident from the four borings.

The additional soil investigation indicated a layer of soft clay reaching a maximum thickness of 2.8 m near measuring point No. 2, with zero thickness near point No. 4 (Fig. 1). This clay layer was described as soft grey silty clay having increased silt content with depth. Laboratory test results for the clay layer gave values of approximately 71 to 76% for moisture content; 71 to 72% for liquid limit; 22 to 25% for plastic limit; 15.6 kN/m<sup>3</sup> unit weight. Undrained triaxial compression tests placed the shear strength in the 16 to 19 kPa range. Consolidation tests carried out in the oedometer indicated the preconsolidation pressure at the overburden pressure.

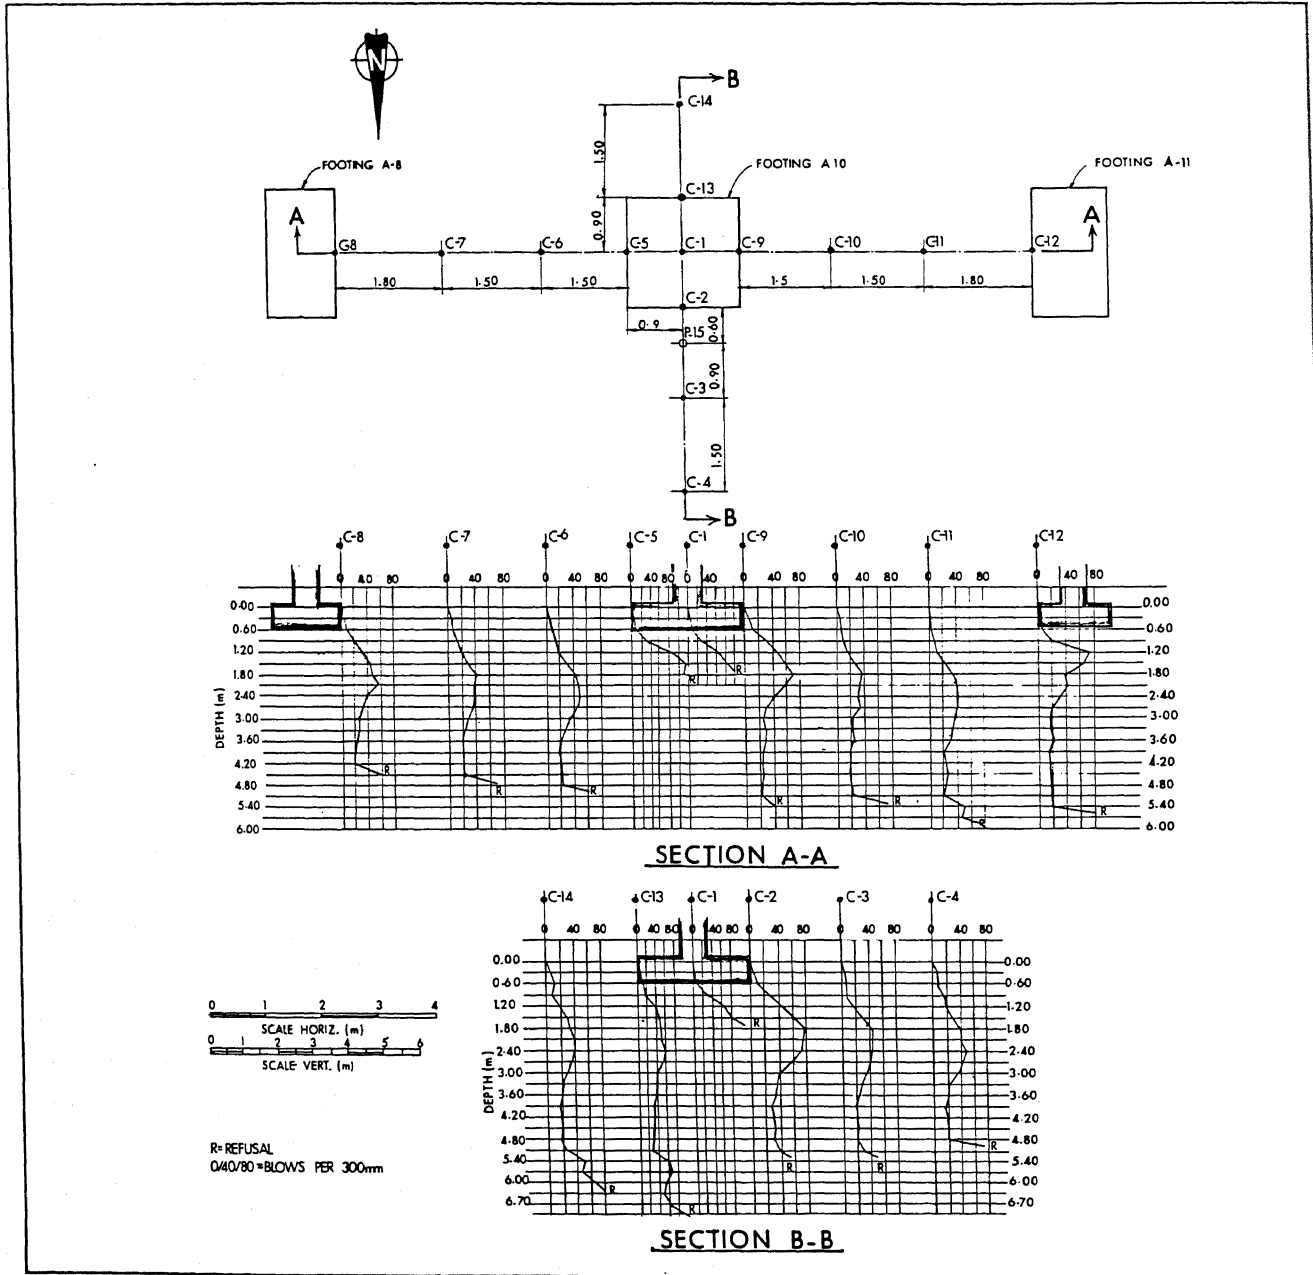
fig. 2. Subsoil Improvement Footing A 10

energy used was equivalent to the S.P.T. test, i.e. 63.6 kg hammer dropping 0.76 m. This procedure, defined locally as a dynamic cone test, has the disadvantage of friction build-up along the rods. Fig. 2 summarizes the results for footing A 10.

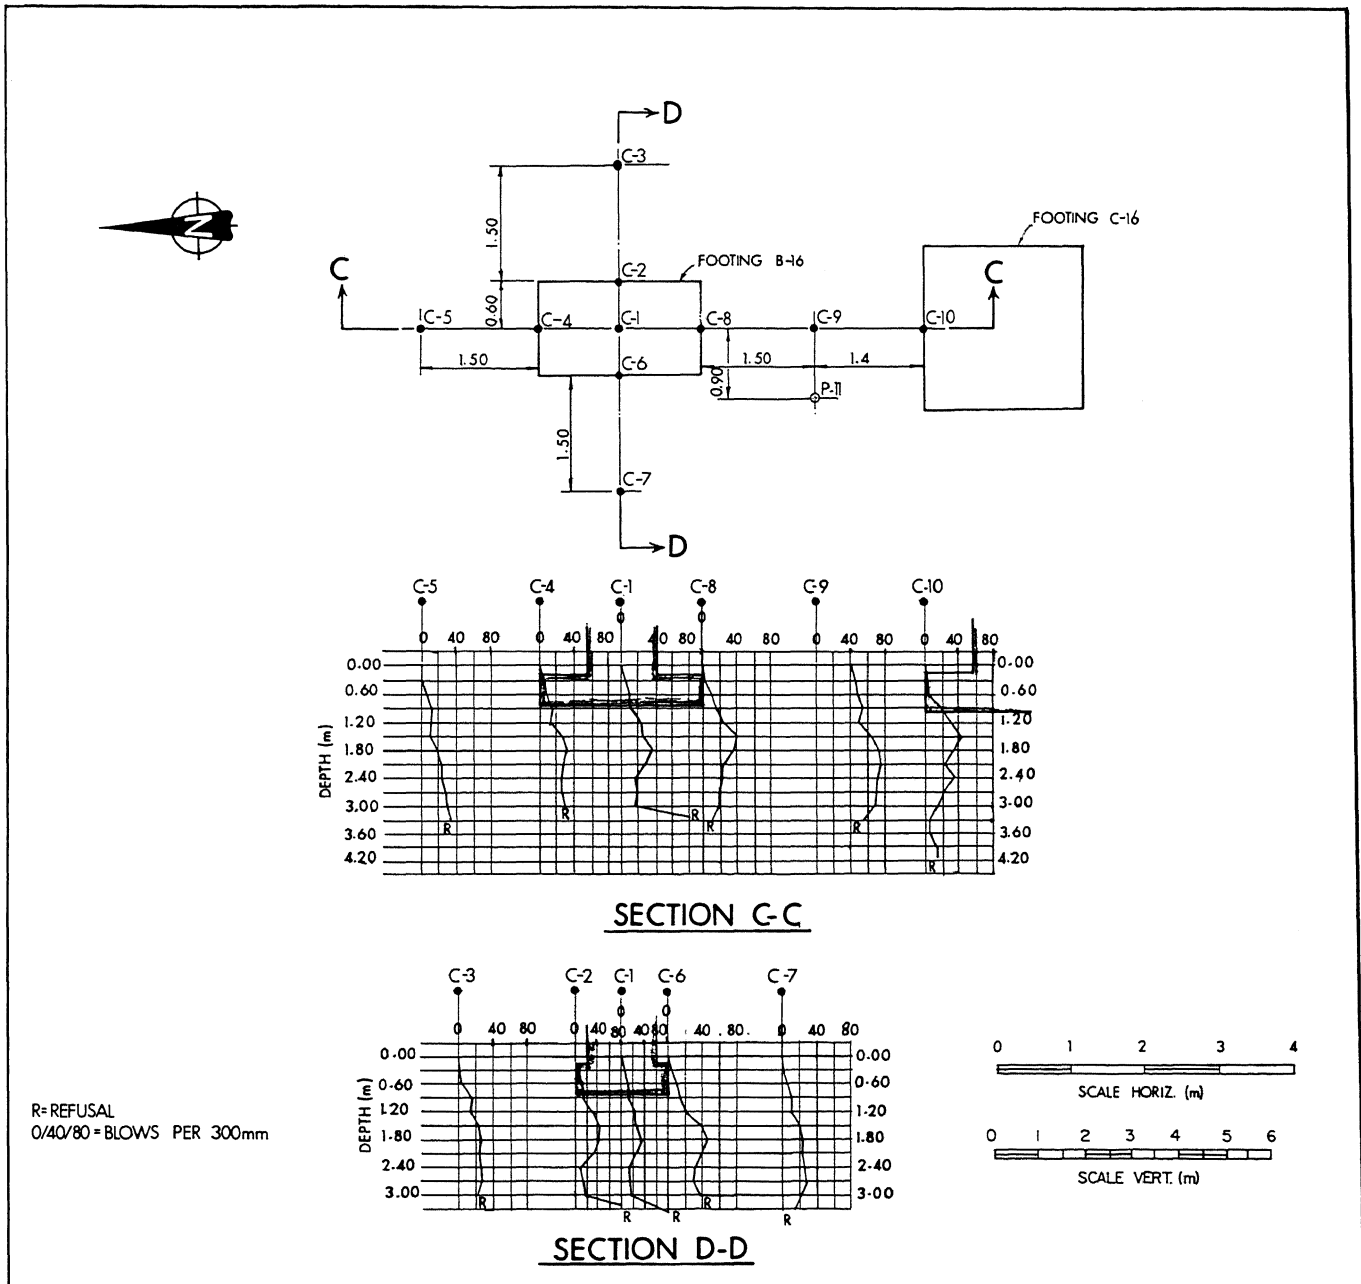
Fig. 3. Subsoil Improvement Footing B 16.

On evaluation of the test results, the soil consultant accepted the procedure of five compaction points for the larger footings despite the problem of compaction in the upper region of low confining pressure, but rejected the two compaction point procedure for the small footings. Fig. 3 shows the original results of inadequate compaction for footing B 16. The contractor agreed to increase to four compaction points for these footings and the soil consultant withdrew from the site.

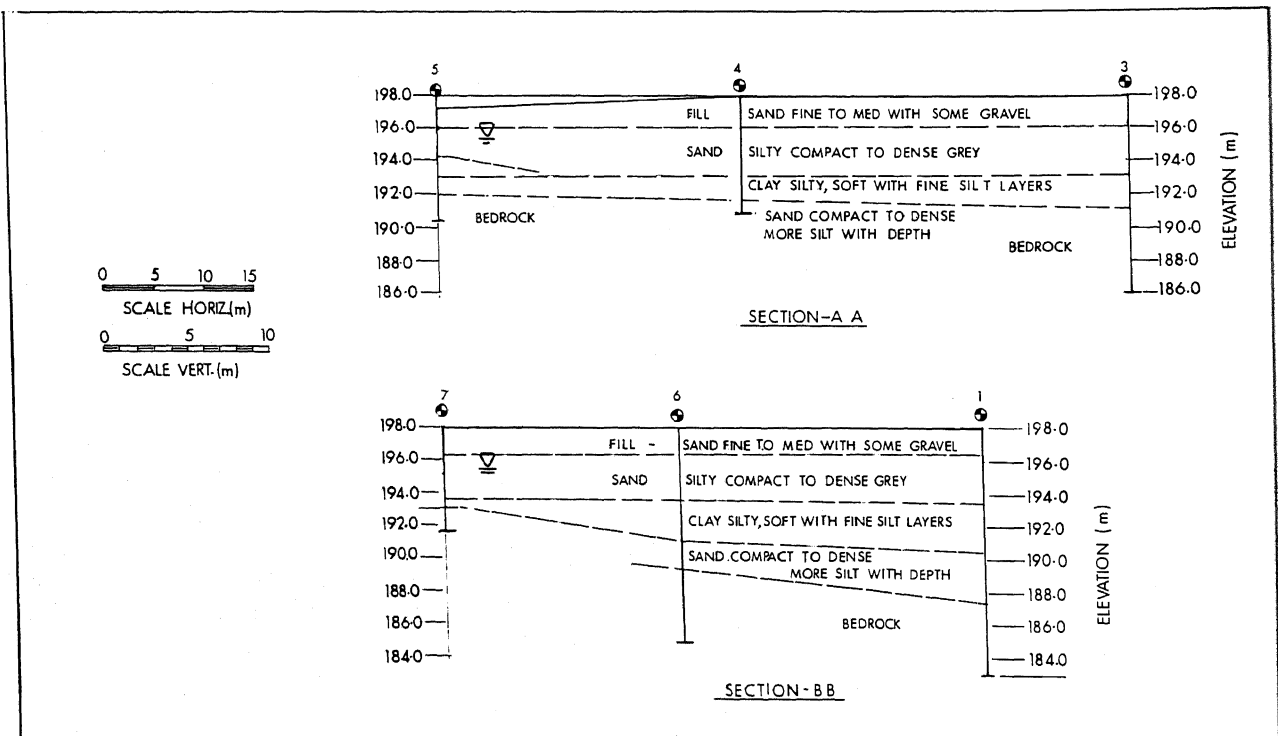
Fig. 4. Subsoil Stratigraphy

The subsoil stratigraphy for the site was now accurately known and is shown as Fig. 4.

The clay layer was without doubt the culprit in the case. The thickness of this layer, as indicated in Table I, is significant so why was it not encountered in the original site investigation? In the area of the original boreholes the depth to bedrock (refusal) was 4.3 m for two of the holes and in these areas no clay of significance is noted. The other two of the original boreholes went to 5.8 and 6.1 m depth but no samples were recovered from the lowest level - they were lost. Since the original design called for lightly loaded spread footings near ground surface and the modified 14 storey foundation was specified as piles, presumably the consultant felt this sample loss was not of a major importance.

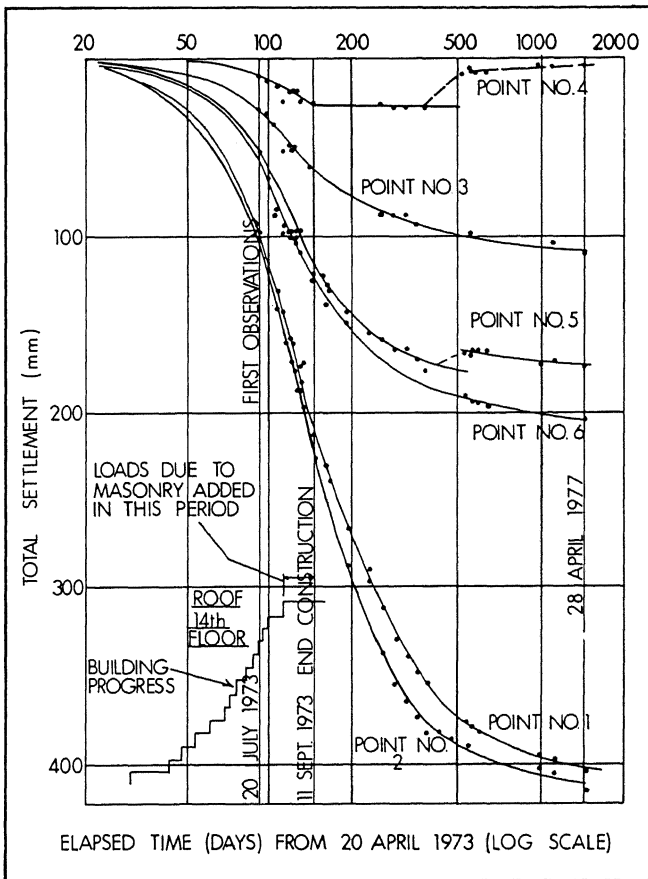
Fig. 5. Settlement Records

Settlement measurements were undertaken by a registered land surveyor using 6 points established on the building. The readings had begun July 20, 1973 and were continued until May 1977. During this period the points were moved from inside to outside the building explaining some of the curves, and several points were lost for a few months. The bench marks used for the survey were the original intended only for construction control. A brief study of one of these reference points indicated movements of 1.5 mm. The movements of the bench mark are not uncommon in this area and can be attributed to the movement of frost into and out of the ground.

The settlement of the building as recorded over the 3 year period is shown in detail on Fig. 5.

It is worth noting that for all settlement measurements the actual total settlement is unknown. The curves shown on Fig. 5 have been projected/calculated in reverse from the date of the first measurement, i.e. July 20, 1973 to the beginning of construction of spread footings on April 20, 1973. The settlement picture is complicated by the fact that 1.2 to 1.8 m of sand fill was placed in the building area in May or June of 1973. This fill accelerated the settlement in the early stages.

From a geotechnical consideration had the building been saved? People had occupied the building for 3 years. Maintenance was not a significant problem. Fig. 5 indicates the performance. Could it be said that the operation was a success but the patient died?

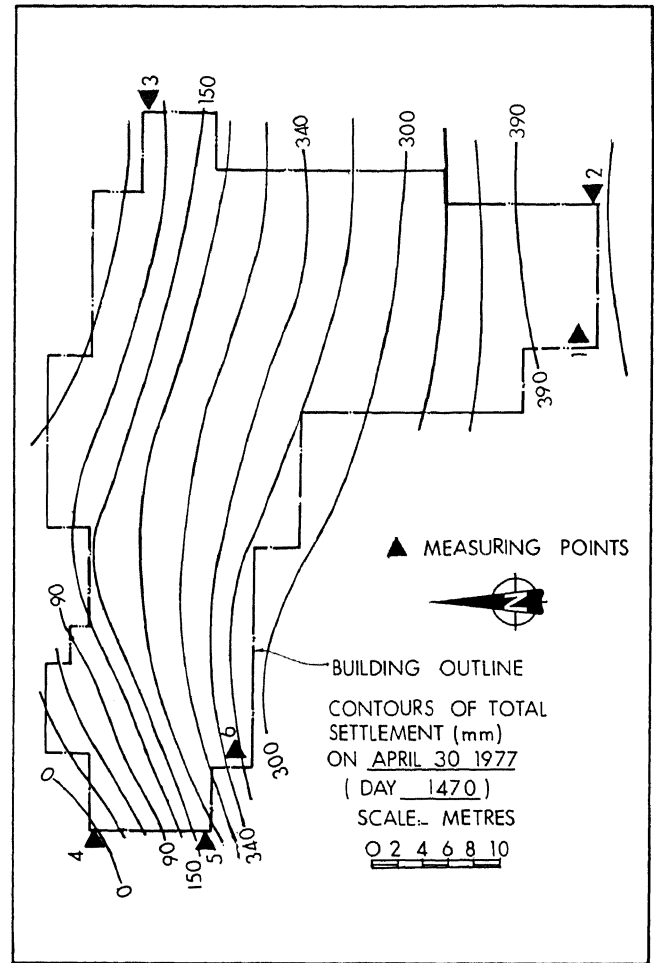
Fig. 6. Contour Drawing of Building Settlement

If it is possible to construct a settlement contour from six points, Fig. 6 provides a reasonable proposal. It is of interest to note that the settlement began virtually as construction commenced, hence the lower portion of the building settled significantly more than the roof. Fig. 7 provides an indication of the settlement for the roof and second floor. These three figures, 5, 6 and 7, summarize the performance of the building. Table I summarizes the measurements at each point.

Fig. 6 indicates a best guess at the settlement contours for the building. As drawn they show a uniform change in settlement across the building. Based on crude estimates, this project just over 300 mm of settlement across 43 m of structure.

When compared with values of Bjerrum, L. (1963) this does not seem alarming. This interpretation of the settlement helps to clarify the condition of the building - which remained excellent with little sign of major distress. Those with a keen eye reportedly could detect a lean to the south wall, this visual perception when related to the work of Skempton, A.W. and MacDonald, D.H. (1956) tends to confirm their findings if we assume a building approximately 45 m in height.

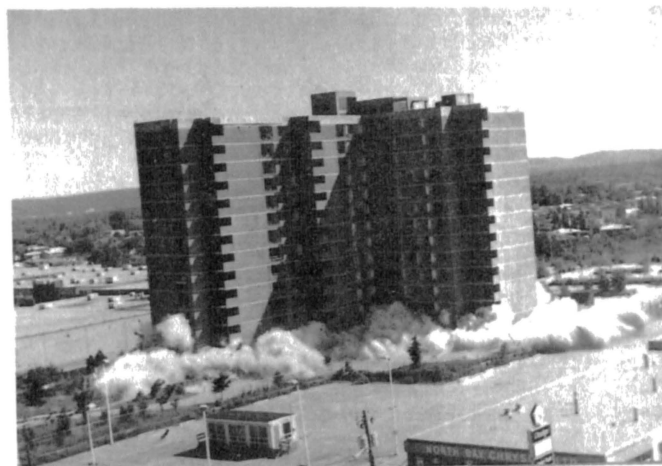
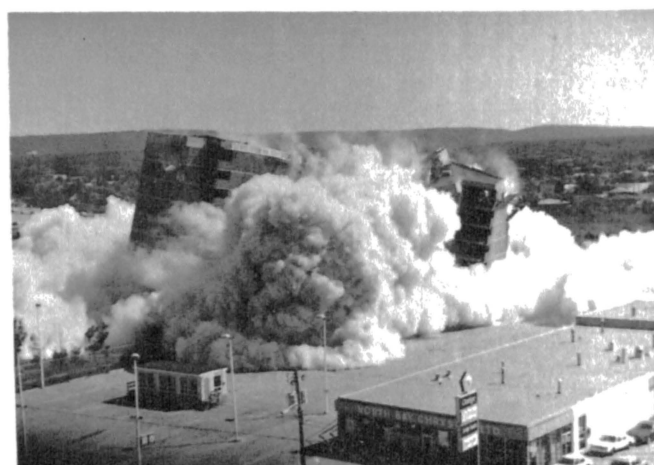
During February 1975 the owner proceeded with a court order against "all" parties claiming damages. From this point until the end of the building's life, scores of experts were involved in analysis, investigation, appraisal, etc. The final order to evacuate the building came on January 5, 1978 when the North Bay building inspector ordered evacuation. A dramatic ending took just 7 seconds on July 4, 1982 when Greenspoon Bros. Limited utilized the implosion principal to level the building. Fig. 8 and Fig. 9.

Fig. 8. Building Just Prior to Demolition

Fig. 9. Building Just After Demolition
