Non-Homogeneous Reinforced Earth Fill for Riverbank Stabilization

NON-HOMOGENEOUS REINFORCED EARTH FILL FOR RIVERBANK STABILIZATION

Mary Perlea, P.E.

U.S. Army Corps of Engineers
Kansas City, Missouri-USA-64106

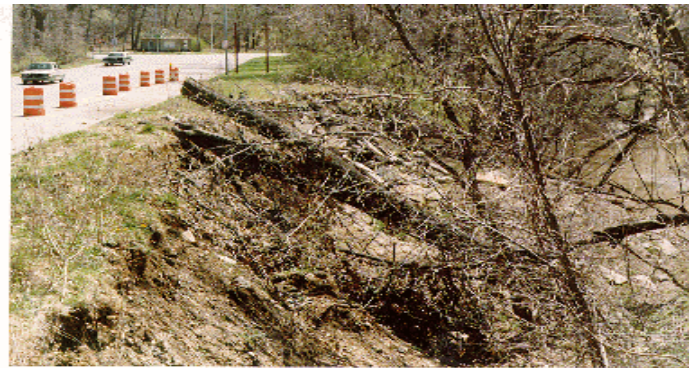
Blue River Bank Failure is located in Kansas City along the right bank of the Blue River, close to a high traffic public road (Gregory Blvd.) and affecting a City water line. The repaired slope was restricted to 1(V) on 1:75(H) due to the location of the water line and in order to minimize traffic disturbance on Gregory Blvd. The City of Kansas City requested the slope to be seeded with native grass to minimize the maintenance of a very steep slope. No apparent rock protection was accepted for environmental reasons. Figure 1 shows the failed slope prior repair.

Fig. 1 BlueRiver slope failure prior repair

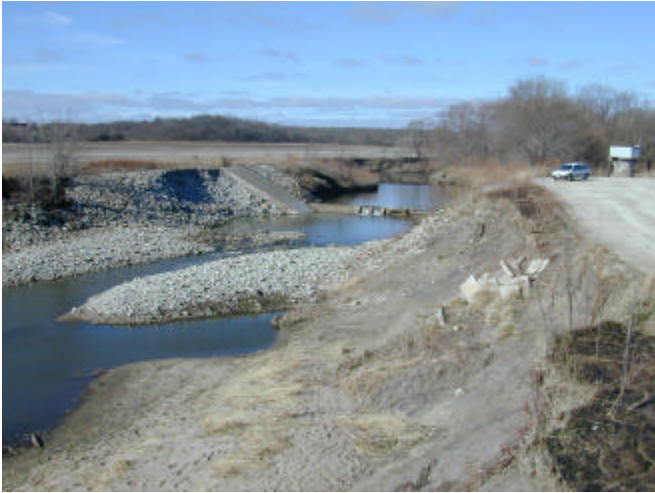
mostly after rapid drawdown of the river stage. The geotechnical and hydraulic analyses performed demonstrated that the cause of failures was a combination of subsurface conditions (the riverbank slope too steep for the weak soils in the foundation) and hydraulic conditions (erosion of the riverbank toe due to the turbulent flow immediately downstream of the concrete weir). To prevent erosion of the riverbank toe the slope protection would be 4 feet thick. To stabilize the slope reinforced earth was

considered as the most economical repair alternative. The reinforced earth with reinforcements placed in local material obtained from excavation would require excessive long geogrid layers, and consequently excessive excavation, which would reach the road or water line. Figure 2 illustrates the existing condition.

Fig. 2. Delaware River bank erosion

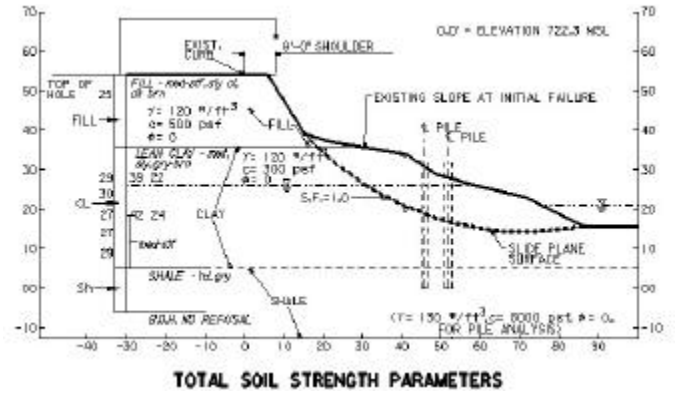
Disturbed samples for laboratory testing were collected from three borings drilled at the site. The soil strength parameters were determined from back calculations of the weakest layer conditions before repair. Figure 3 illustrates the soil parameters based on the laboratory testing, SPT, and back calculations. A sliding surface had been developed through a soft clay layer located between 20 and 50 feet from the surface. The clay layer contains lean clay (CL) material with liquid limit (LL) between 39 and 42, and with the moisture content between 27 and 30%. Back calculations indicated the shear strength $c = 300$ psf for the lean clay in the foundation. Auger cast piles were driven 5 feet into the shale located at 50 feet below the surface to stabilize the lower slope. Location of the water line and the limited construction space due to busy City road (Gregory Blvd) required a slope no milder than 1(V) on 1.75(H) for the upper bank above the auger cast pile stabilization.

Fig. 3. Blue River soil strength parameters

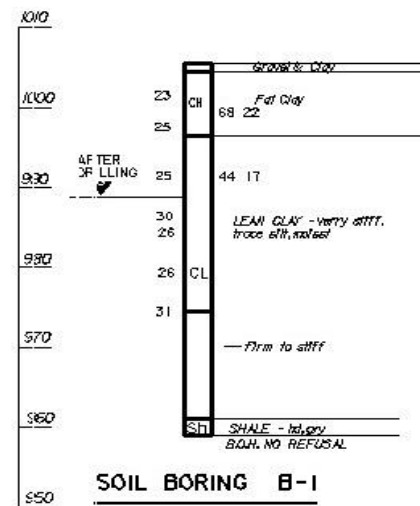
Fig. 4. Delaware River boring log

The soil in the upper 16 feet consisted of high plasticity clay material (with LL = 68) followed by a low plastic clay material

on the next 9 feet (with LL = 44). The last 25 feet to the top of the rock contained silts and sandy materials. The moisture content of the upper 25 feet from the surface varied between 21 and 30% and the degree of saturation between 79 and 100%. The dry density varied between 92 and 100 pcf, and the moist unit weight between 119 and 125 pcf. The unconfined compression strength varied between 400 psf and 3400 psf, with the weaker material between 14 and 25 feet from the surface. The total strength parameters obtained by the triaxial compression test performed on a sample collected from the depth of 15 to 16.5 feet from the surface were $F = 12.8^\circ$, $c = 600$ psf and the effective strength parameters $F' = 19.6^\circ$ and $c' = 0$ psf.

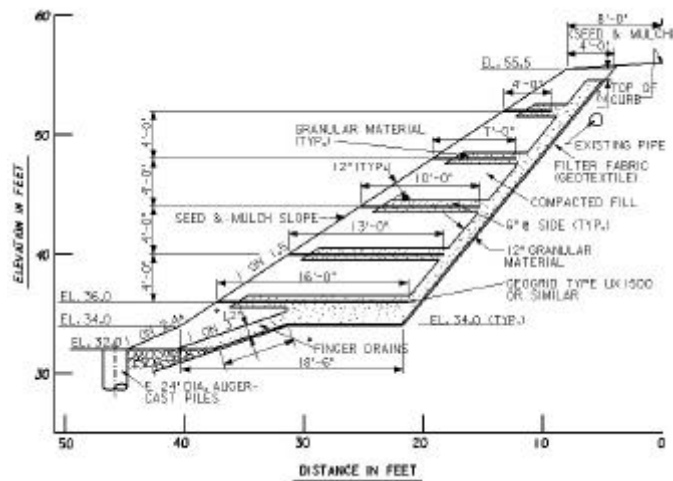
Fig. 5. Blue River bank stabilization typical cross section.

The selected alternative consisted of construction of a reinforced earth mass with the reinforcement placed within 1-foot thick layer of granular material on the top of the Auger cast piles. The reinforcements were placed at 4-foot intervals, using the locally excavated soil as additional backfill between the reinforcements. A layer of granular material was placed between the excavated slope and the reinforced earth mass to provide drainage of the reinforced earth during rapid drawdown of the river stages. The drainage layer was connected with the rockfill layer placed on the top 3 feet of the auger cast piles, above the normal river water elevation. The face of the reinforced slope was covered with 1-foot thick layer of uncompacted soil suitable for vegetation

growth, and seeded with native grass and wildflowers, for a minimum maintenance of the riverbank slope. Figure 5 illustrates the selected alternative.

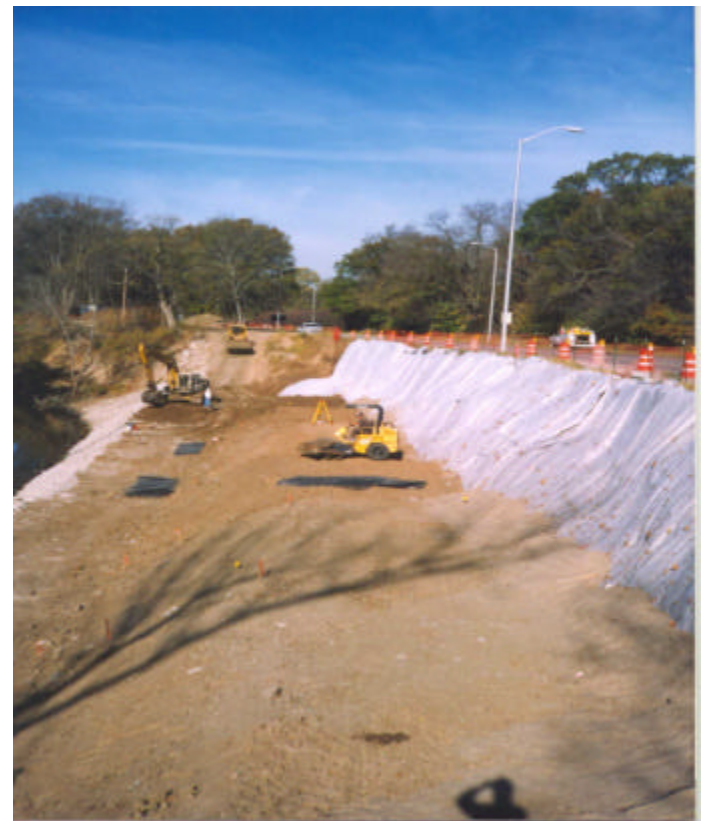
Fig. 7. Blue River construction aspects

The construction was performed above the river normal elevation. The excavated slope was covered with geotextile before placement of the granular drainage layer used as filter material. Aspects during construction are illustrated in Figure 7. A slope indicator was installed to monitor the movements of the entire riverbank. Measurements performed indicated the displacement was uniform throughout the reinforced portion, with a maximum of about 1 inch in 6 years after remediation. Figure 8 illustrates the Blue Riverbank 4 years after the restoration.

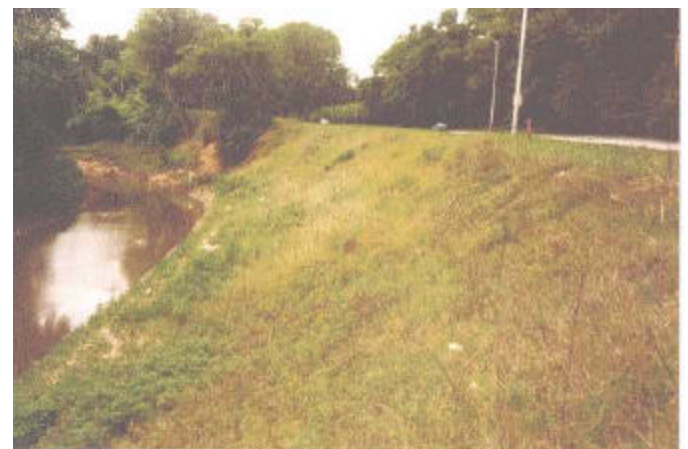
Fig. 8. Blue River 4 years after construction

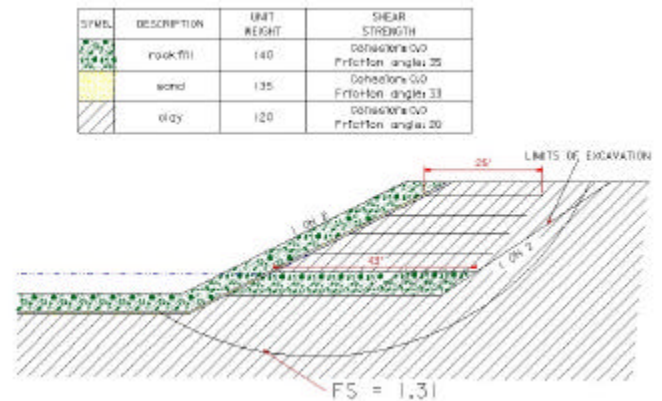
Alternative 1. The local stability required reinforcement tensile strength of minimum 2200 lb/ft (type TENSAR UX1500), the minimum bottom length of the reinforcement of 43 feet, and the minimum top length of 25 feet. Global stability analyses required the excavation slope to be 1(V) on 2(H) to assure the stability during the end of construction, considering the total soil strength of $c = 600$ psf as obtained by unconfined compression tests. Stability analysis performed for the river rapid drawdown,

between the top of riverbank and the normal elevation, resulted in a factor of safety of $F_s = 1.3$, as shown on Figure 9. The effective strength obtained by triaxial compression test on the existing clay material ($F' = 20^\circ$, $c=0$ psf) was used for the rapid drawdown stability. The stability was performed in two stages: the first stage considering the river elevation at the top of the riverbank and the embankment saturated; the second stage considered the river at normal elevation (4 feet above the river bottom) and the embankment saturated because the drainage possibility of the reinforced earth slope would be difficult and slow. Stability analysis results are illustrated in Figure 9.

Fig. 9 – Delaware River alternative 1 stability analysis for rapid drawdown conditions.

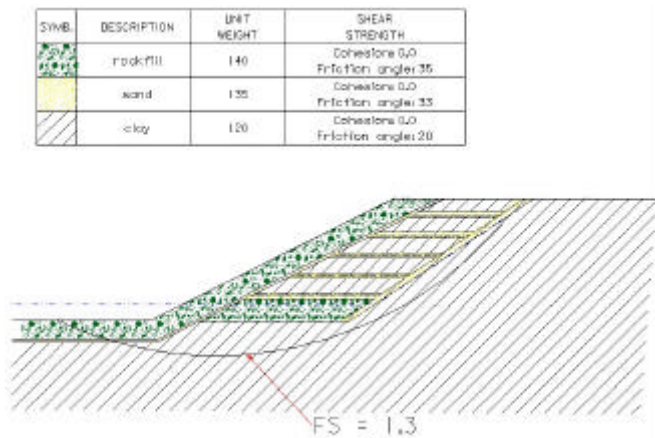
Alternative 2 consisted of a reinforced earth slope with the reinforcements placed within 1-foot thick granular material and the remaining of backfill using the local cohesive material obtained from slope excavation. The local stability will require geotextile with tensile strength of 1000 lb/ft, type TENSAR uniaxial geogrid UX900. The maximum length of the lower reinforced layer was reduced to 25 feet and the top layer to 17 feet. A 1-foot thick drainage layer was placed behind the reinforced earth mass to provide drainage during rapid drawdown of the river stages. Geotextile will be placed between the excavated slope and the drainage layer to prevent piping of the fine material into the drainage layer. The slope will be protected by a 4-foot thick layer of riprap. A 4-foot thick rockfill platform will be constructed at the base of the reinforced earth to assure dry working conditions. Global stability analysis for the rapid drawdown conditions was performed for two cases to determine the impact of the drainage of drainage: (1) disregarding the drainage effect of the sand layers and (2) considering the drainage of the reinforced earth mass during rapid drawdown. The stability analyses considered the effective strength obtained by triaxial compression tests for the cohesive soil material. The factor of safety was increased from $F_s = 1.02$ to $F_s = 1.3$ when the drainage effect of the granular material was considered.

Stability analysis considering the draining effect of the granular material is presented in Figure 10.

Fig. 10. Alternative 2 stability analysis for rapid drawdown

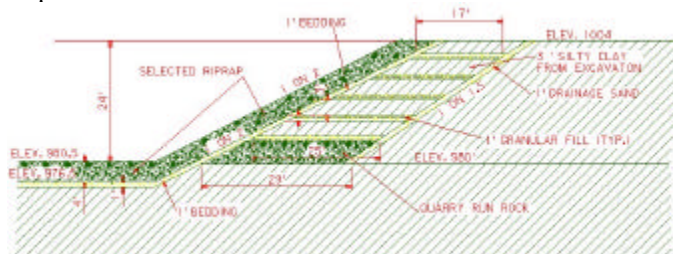
Fig. 11. Delaware River bank restoration typical cross section.

Alternative 2 was proposed for the Delaware riverbank restoration, based on technical and economical analyses. Figure 11 illustrate a typical cross section of the proposed reinforced slope.
