Research on the Permeability and Earthquake Damage of an Earth Dam Foundation

Research on the Permeability and Earthquake Damage of An Earth Dam Foundation

SYNOPSIS The experiences on geological investigation, permeability test, prediction of seepage failure patterns and the earthquake damage of an earth dam foundation are presented in this paper. Basing on the monitoring data and seismic records observed from the seismic station on the dam, the prediction of reservoir induced earthquake and possibility of liquefaction are analysed.

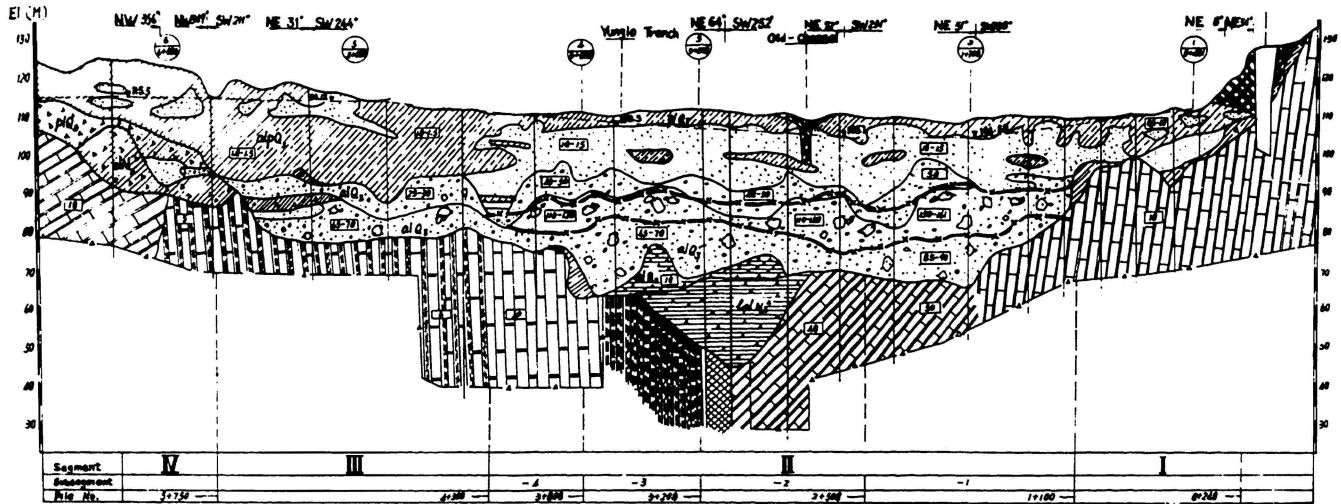
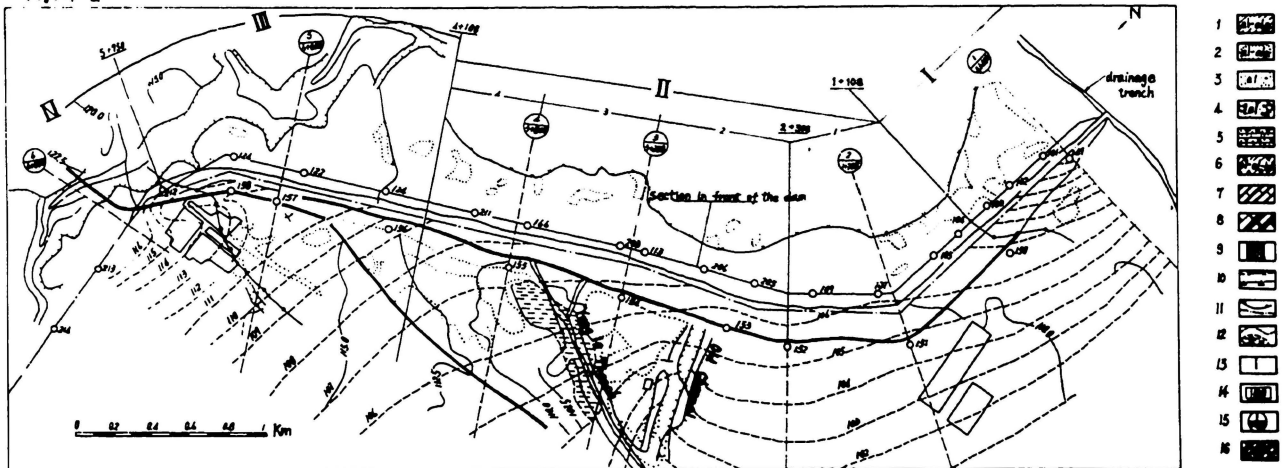
Fig.4-1 and 4-2

From Fig.4, the bed-rock in the dam area are hard crystallised marble and phyllite of Pre-Cambrian age, lake shale deposit of Tertiary rests unconformably upon it. The old river bed deeply cut into the bed rock and accepted a thick Quaternary deposits, consist of four main layers. They are from top to bottom cohesive soil, sand, sand-gravel, sand-gravel and boulder respectively. (Fig.4-1), the average values of coefficient of permeability of different layers at its definite location got from the bore-hole subsurface water drawdown test are figured at the respective layers on Fig.4-1. From these data, it can be found there is a strong seepage belt between the upper part of the sand-gravel boulder layer and the lower part of sand-gravel layer, with coefficient of permeability ranging from 110-160 M/24 hours at the elevation approximately 75-95 M, lying at the middle portion of the profile (Fig.4-1) from pile number 1+100 to 4+300.

Fig.4-2 is the plane of the dam site, during the first filling of the reservoir, with head 5-8 M (E1.115-118 M), the piping and boiling phenomena occurred predominantly at the downstream toe between the pile number 2+308 to 3+808, where the old channel and Yunglo trench are situated. In the profile, it is in consistent with the developing region of the concentrated seepage belt. While the water storage rose up to El. 118.0 M, water emerged in a certain area along the Yunglo Trench at the downstream side.

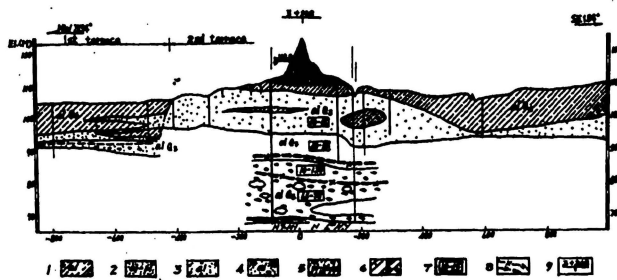
is shown in figure 5 (pile number 3+208). In front of the dam, sand layer outcrops widely reaching the boundary of 1st terrace, forming an open path for the seepage flow through the concentrated seepage belt to the downstream side. Behind the dam, unfortunately a rather thick impervious cohesive soil layer lies upon the sand layer, forming a bad condition for the drainage of seepage flow. So it is obvious that only a short blanket and a small number of shallow relief wells could do nothing for the prevention of seepage flow, damage occurred was a matter of course.

Fig.5 Geological cross section of the auxiliary dam at pile number 3+280
 1-Soil 2-Sand 3-Sand-gravel 4-Sand-gravel and boulder 5-Clay and breccia 6-bed rock 7-Coefficient of permeability 8-Concentrated seepage belt

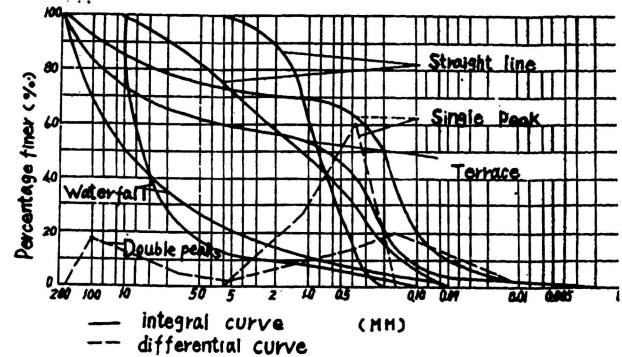
The integral distribution curves can be classified into three patterns, namely: straight line, terrace and water fall. "Straight line" represents an uniform gradation, with a small ununiformity and more fine grain ($d < 1$ mm) content, the seepage gradient of which is comparatively higher; "Terrace" pattern in general being discontinuous in size distribution and lacking the intermediate particles, containing less fine grains and higher uniformity coefficient; "Waterfall" pattern contains more coarse grains with high ununiformity and low dry unit weight, seepage failure gradient being rather small subjecting water head. The possibility of piping can also be distinguished by the fine grain contents (p). It would be soil flow when $p > 80\%$; soil flow or piping when $25\% < p < 80\%$; piping when $p < 25\%$.

Fig.6 Integral and differential grain size distribution curves of the sand and gravel materials showing the curve patterns

developing trend needs to be predicted by studying the differential grain size distribution curves as shown in Fig.6. Curve of single peak represents "safty type", while curve of double peaks belongs to "dangerous type".

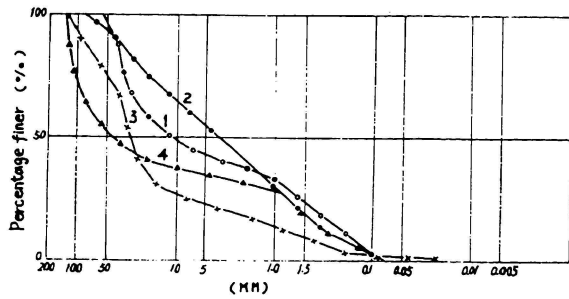
The concentrated seepage belt are located between the boundary of the sand-gravel layer and the sand-gravel and boulder layer. According to the seepage condition, from top to bottom it can be divided into four subbelts, their deformation condition are different, shown in Fig.7 and Table I.

Fig.7 Average gradation curves of the sand-gravel layer, sand-gravel and boulder layer inner and outer the concentrated seepage belt
 1-Outer concentrated seepage belt of sand-gravel layer
 2-Inner concentrated seepage belt of sand-gravel layer
 3-Inner concentrated seepage belt of sand-gravel and boulder layer
 4-Outer concentrated seepage belt of sand-gravel and boulder layer

It can be noticed from the results obtained from theoretical analysis as shown in Table I, the deformation patterns of sand-gravel and boulder layer inner the concentrated seepage belt are all "piping", with a rather small failure gradient 0.1-0.15; while for the

outer concentrated belt, the deformation patterns of the sand-gravel layer and the sand-gravel and boulder layer both are "soil flow". A part of sand-gravel layer inner the concentrated belt are "piping", while the others are "soil flow". The failure gradients for the above three subbelts being 0.63-1.08, all > 0.5. The size distribution curve shown in Fig.7 plotted according to the average values of the grain size analysis, which are in agreement with the results listed in Table I. By studying the geological condition, it can be found that the sand-gravel and boulder layer inner the concentrated seepage belt is situated in the central part of the main stream of the old river bed, with more coarse grains, higher permeability, forming relatively

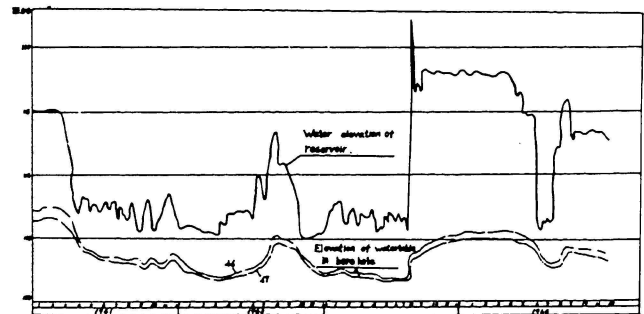
Fig.8 Process curves of the water level of reservoir and water table in the downstream observation bore-hole No.46 and No.47 during 1961-1964

From Fig.8 if we select the corresponding water level in reservoir and the water table in bore-hole 46 and 47 before and after the supplementary engineering works, it can be easily noticed that when the reservoir level at 118.0 M of February 1964 (post to supplementary engineering works) is taken to compare with the reservoir water level at 115.0 M of March 1961 (prior to supplementary engineering works), the water table in bore-hole 46 and 47 at that time had been lowered about 1-2 meters, revealed the supplementary engineering works had achieved good results.

After the supplementary construction engineering works were accomplished during 1961-1963, the blanket was elongated to 100-400 M in connecting with the impermeable soil cover layer of the 1st river terrace, and the deep relief wells had been increased more than 200 in number. The dam underwent a serious examination of the big flood of 1963 with water level up to 121.79 M in the reservoir. It proved that the supplementary design and construction works are successfully done. From the following analysis of the underground water dynamic condition, the question why the seepage treatment has been in good performance can be easily answered.

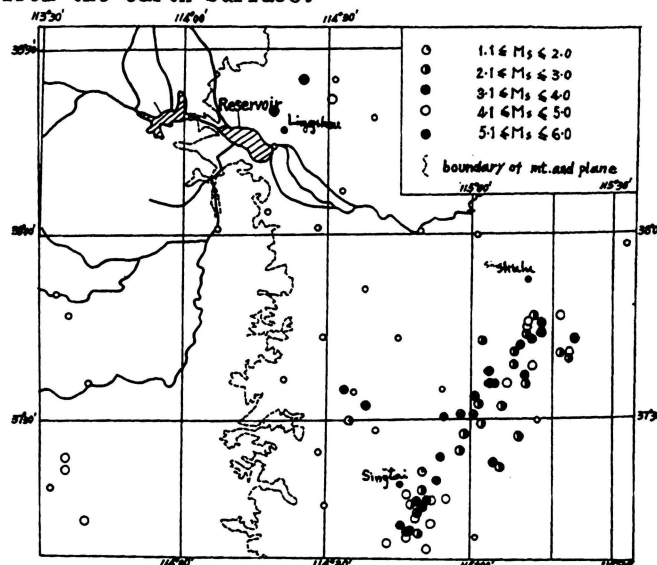
It can be seen from Fig.9, earthquake(M=3-6) predominantly occurred in the zone from Xingtai to Shulu, concentrated along the NE direction, which coincides with the strikes of the big

faults, at a distance about 100-120 Km beyond the boundary of mountain and plane, only a few smaller earthquakes distributed not far in the NE of the reservoir around Lingshou. This phenomena can be supposed that the big faults are dipping SE with a certain dip angle, as the shocks happened some tens Km under the earth surface along the deep seated fault zone, the epicenters must be located toward east from the earth surface.

Fig.9 Distribution of epicenters of historic earthquakes

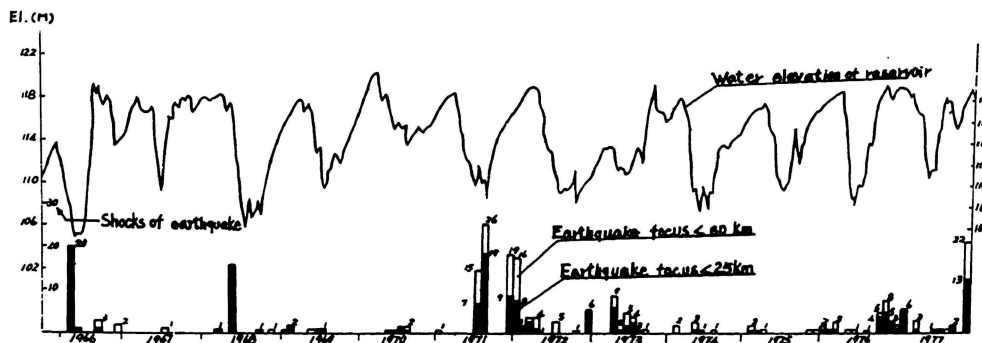
Fig.12 The relation between reservoir level and the number of shocks

From Fig.11 a and b we can find that about 50% of the "local earthquakes" are short focus distance and small magnitude shocks; Fig.11-c shows the number of shocks monthly, from which it can be seen in May (season of low water level) and December (season of high water level) the chances of shocks are higher. Fig.12 shows the process curve of the reservoir level and the shocks of "local earthquake" series with time. It is clear since May 1971 the frequency of small earthquakes increased and occurred during the period of large variation of reservoir level or at the longer duration of high water level. These are the evidences to illustrate that the "local earthquakes" are caused by the reservoir filling. The frequency of "local earthquake" appeared an increasing trend in recent years. It can be inferred that the "local earthquake" observed on the dam seismic station were caused by reservoir impounding on the base of favorable geological condition. Structures and fissures of the rocks surrounding and underlying the reservoir play a role for water seeping. As the water seeps into the deep seated fissures, it increases the pore water pressure and decreases the friction along the fissures, thus earthquake might be

occurred. The reservoir-induced earthquakes result from the dislocation of preexisting fault and fissures by the seeping water, which is a type of stick-slip mechanism. Though in this reservoir the induced "local earthquake" occurred after the filling of reservoir were all $M < 5$, predominantly $M=2-3$, they were all smaller than the design ones, but they occurred very frequently and increased with time, so beside the monitoring work of the induced earthquakes, the down stream water relief work must be guaranteed for the purpose to reduce the pore water pressure.

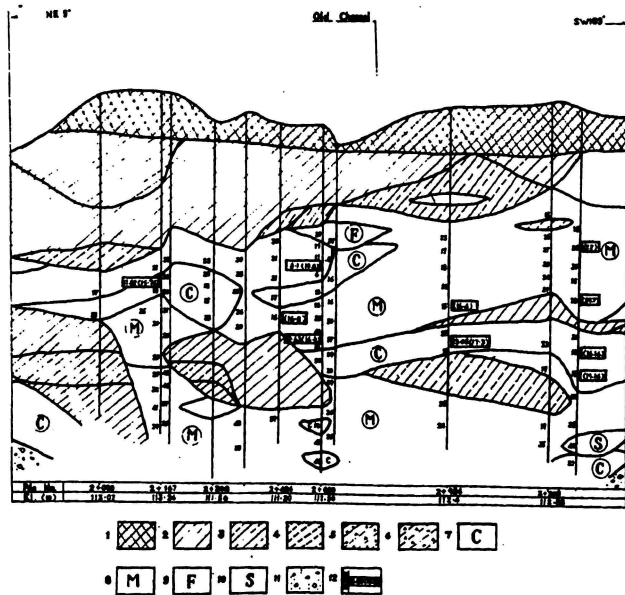
Fig.13 Geological section showing the results of penetration test

Fig.13 is a geological section in front of the dam, numerals on the left side of the bore-hole show the blows N get from in-situ penetration test and numerals written in the rectangular frame are the blows N' calculated by formula (1), numerals inside the small parenthesis represent blows of earthquake intensity 8° and

numerals outside the parenthesis represent earthquake intensity 7°. It is obvious that only a few parts of the sand layer with N less than N' which possess the possibility of liquefaction. These data demonstrates the problem of liquefaction will not be serious.

If we compare this information with our dam foundation, the weights of the soil layer in Fig.13 are calculated and shown in Table III. It can be found that only two data of section File number 3+280 and 3+288 (with + symbol) are evaluated to be liquefied. This result is in agreement with the analysis of the above paragraph, which demonstrates again the problem of liquefaction would not be serious.

From our preliminary study, although the problem of liquefaction would not be serious in our dam foundation, but for a definite conclusion, further investigation and research seem to be necessary. Beside the monitoring work of the earthquake activities, the determination of wave velocity of sand layer, dynamic triaxial test of the undisturbed sand samples etc. ought to be carried out if possible.
