(2013) - Seventh International Conference on
Case Histories in Geotechnical Engineering

Lessons from Revisiting Three Cases of Slope Failure

LESSONS FROM REVISITING THREE CASES OF SLOPE FAILURE

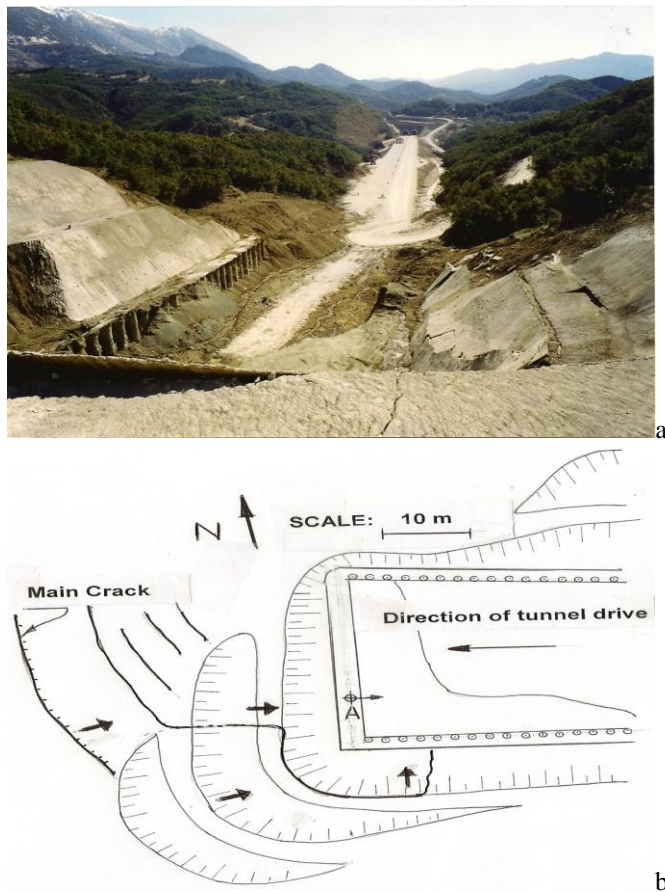
The west portal of one of the Egnatia Highway tunnels S2 (Epirus) was constructed with open excavation and partial refill. During the initial phases of excavation 2-3 benches were formed, each of which was 10m high and had inclination 1:1. From the floor of the lower bench one series of retaining bored piles was constructed at the two sides, so that a vertical cut 10 m high can be formed during final excavation up to the designed level. On the contrary, the final 11m high slope at the face would be vertical and unsupported. In the area of the face, the maximum height of excavation would be about 25m. For the avoidance of rockfalls from the faces of the slopes,

Fig.1a: General view of portal area looking towards the east (photograph taken from the point A).
 Fig.1b: Plan of the portal area (sketch).

- Slope was probably restricted to the upper mantle of colluvium and weathered flysh.
- It is possible that a failure surface or surfaces pre-existed as a result of previous landslide activity.
- Due to low permeability of the overall rockmass and the general topography of the surrounding area, high groundwater levels could be anticipated in the slope. This low permeability also means that additional recharge due to heavy rain will drain slowly, thereby contributing to excess water pressures in through the rockmass. Such high pressures, induced by the heavy rainfall in December 1997, triggered the movement that resulted in

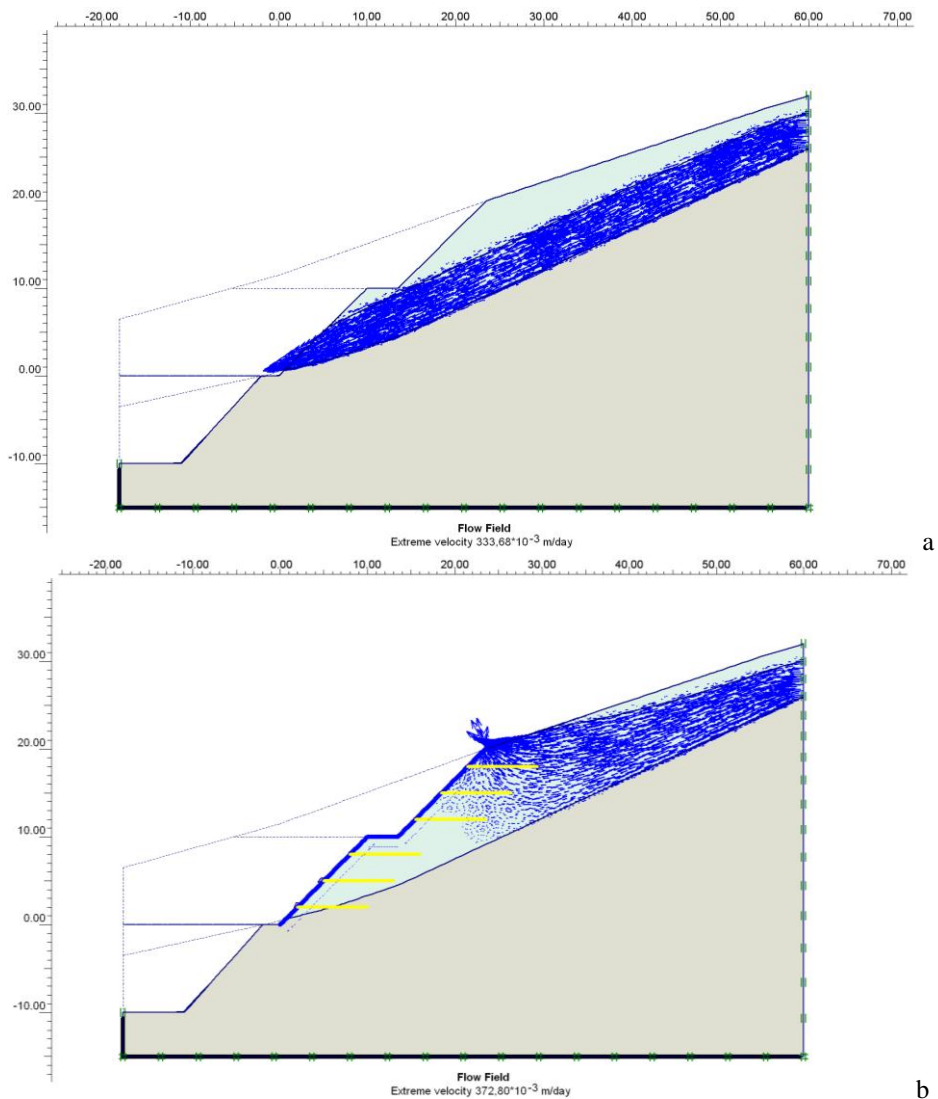
*Fig. 2a: Flow net in case of free slope face.
Fig. 2b: Flow net for anchored shotcrete on the slope face.*

It is obvious that the rise of the water level in the upper zone during rainfall was due to the negligible permeability of the underlain flysh, but also due to the restriction of the dissipation of excess pore pressures by the shotcrete. Of course, if all the drainage holes were operating well, no differentiation of the flow would exist, as presented in Fig. 2a and 2b.

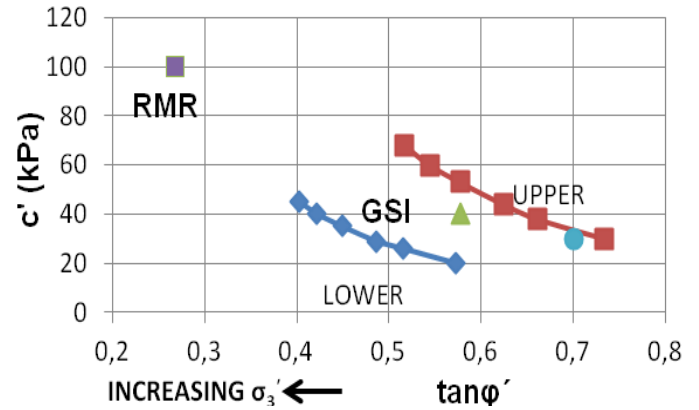
corresponding points are included in the range of variation of the combinations c' and $\tan\phi'$ and near the upper curve (GSI=17). In Fig. 4 the deformed finite element mesh is presented for a representative analysis. From the picture of the deformation of the anchored shotcrete its extensive damages could be justified. Finally, in Fig. 5 the plastic zones, and the shape of failure are presented, which seem compatible with the in situ observations.

Fig. 3: Shear strength parameters according to Hoek-Brown criterion.

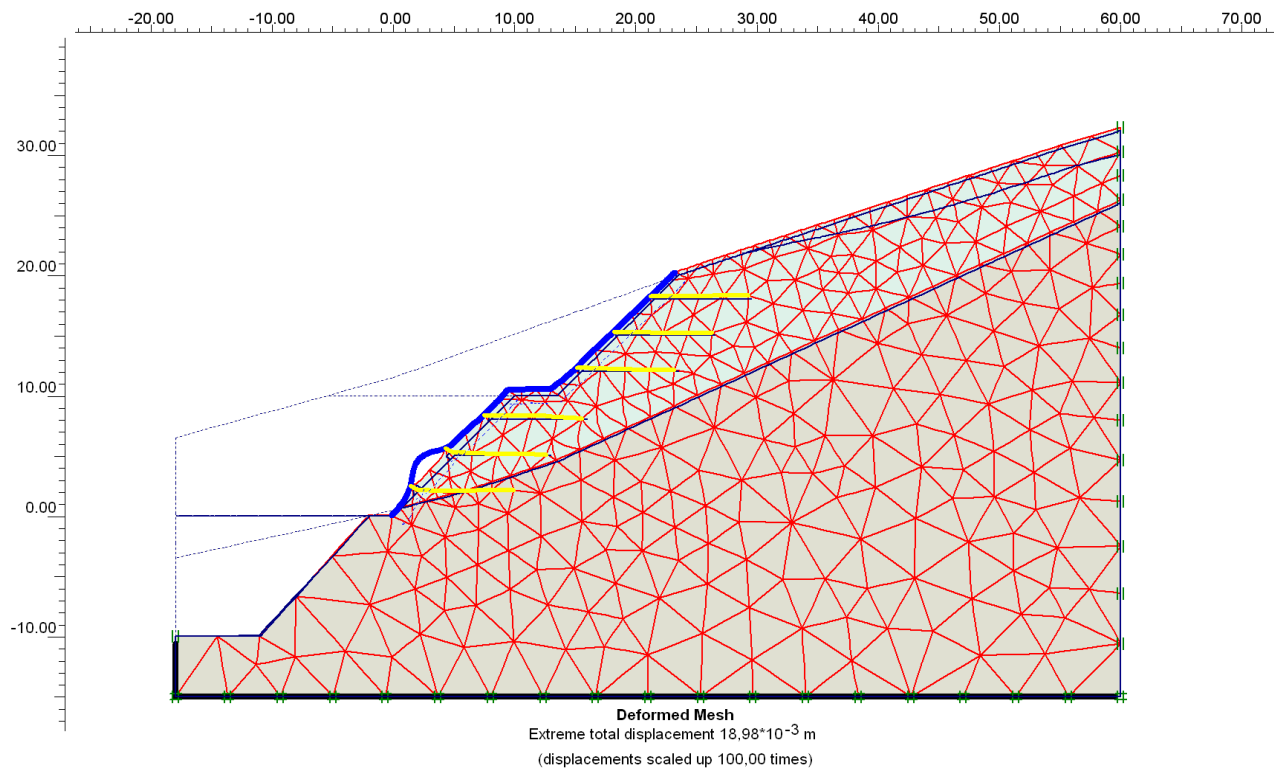
Fig.4: Deformed mesh and displacements of the anchored shotcrete.

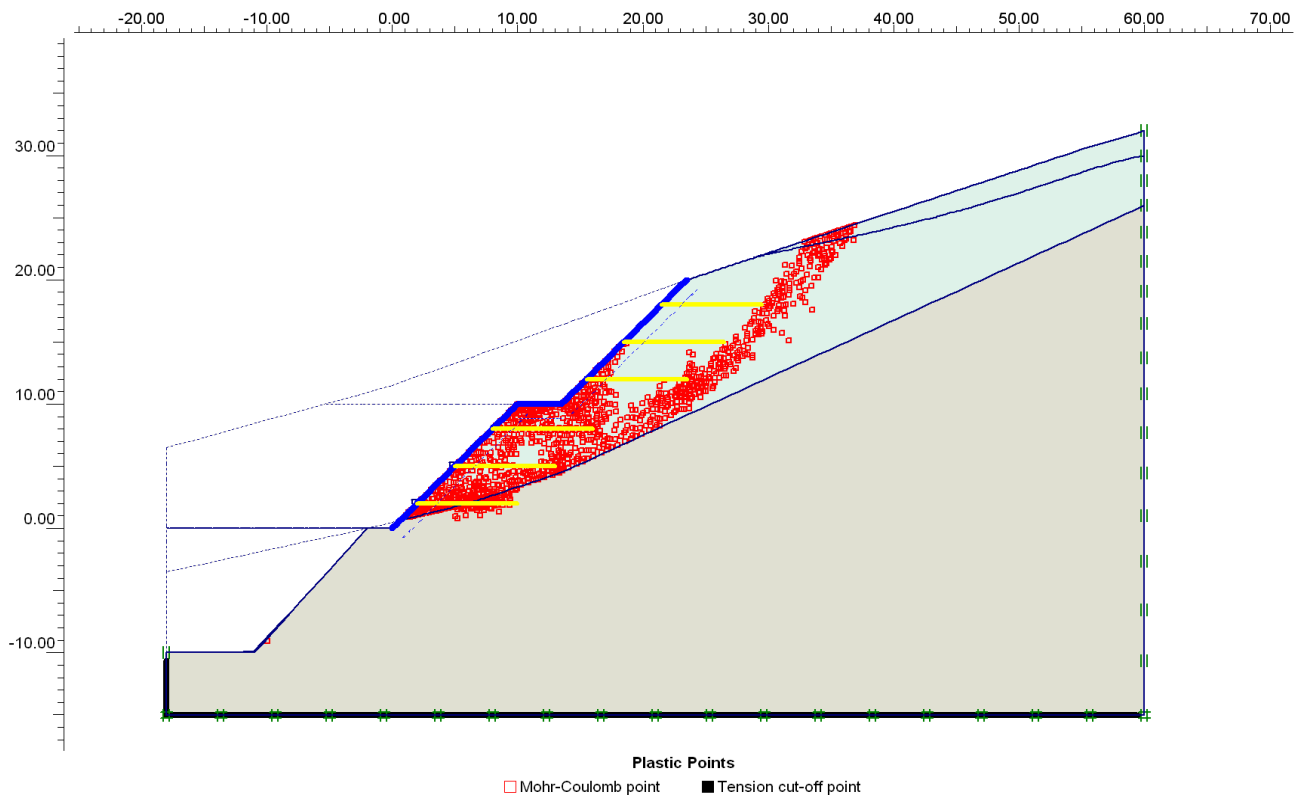
Fig.5: Mode of failure from a representative back analysis.

In conclusion, a suitable interpretation of the strength parameters, recognition of the inhibited water flow regime and numerical analysis offer a satisfactory explanation of the failure.

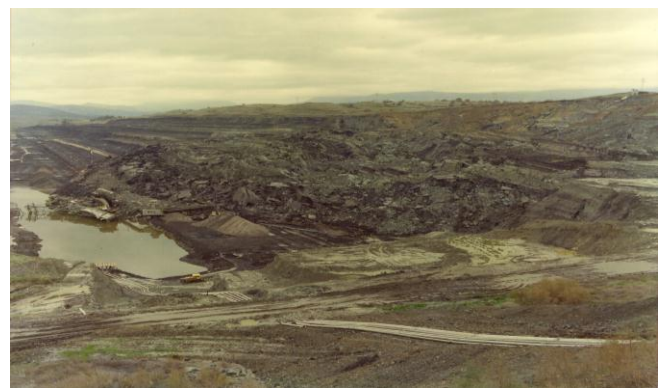
The slope had total height about 90 m, the failure occurred at a length of 400m, and the volume of the soil involved was about $2 \cdot 10^6 \text{ m}^3$ (Fig.6).

Fig.6: General view of the slope failure.

- The main factor is the creation of temporary water level, because of the intense rainfalls, which had preceded of the

slope failure. It is also important that the main group of joints followed the dip direction of the slope in the area of failure, so that these discontinuities opened up, because of the excavations, facilitating the inflow of the water.

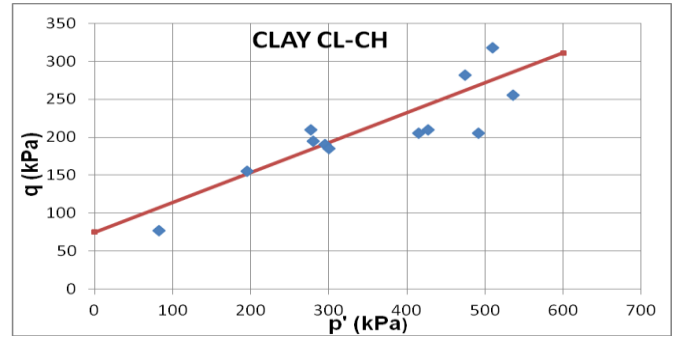
Fig.7: Representative diagram, p'-q from CIU tests.

The appreciable variation of results from only one sample is evident. The back analyses revealed important differences in the safety factor. Taking into account the mean design parameters mainly for the clay and the unfavorable possibility for the development of temporary groundwater level, the slope failure is successfully justified, as demonstrated in Fig. 8. Considering the low safety factors, which are applied at the open pit mines (MSF=1-1,3 in most cases), the importance of uncertainty in design parameters becomes obvious. Consequently, it seems that the experience of the staff and the capability of estimation of forerunner slope failure phenomena is a matter of particular interest.

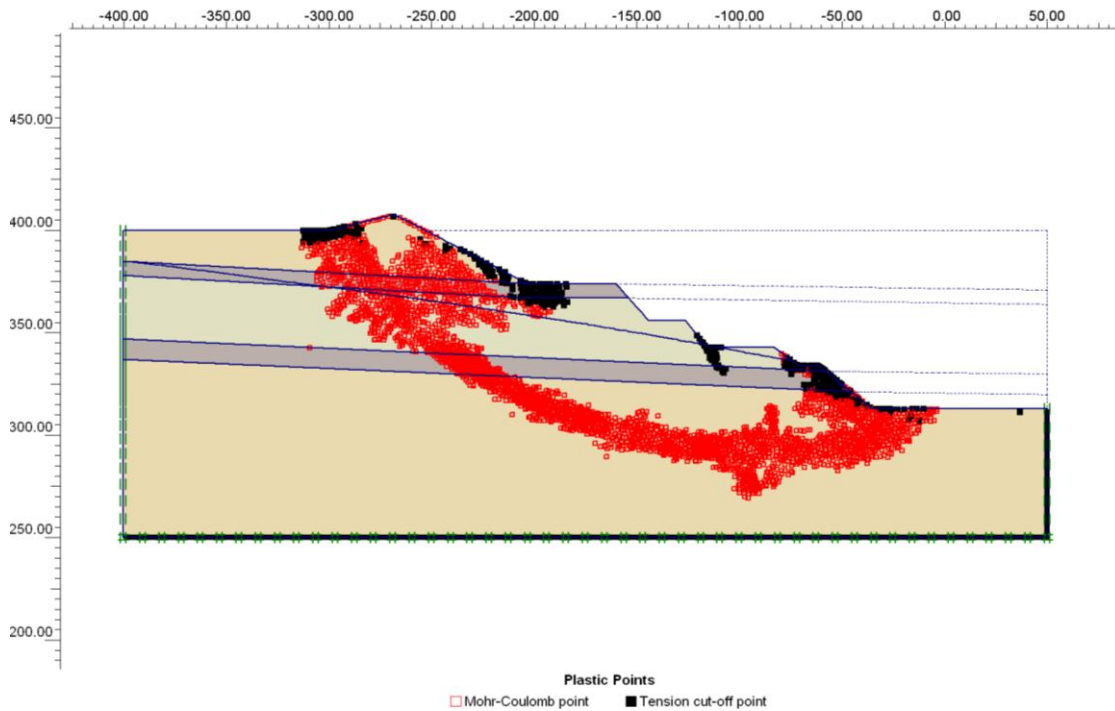
Fig.8: Plastic zones and failure mechanism.

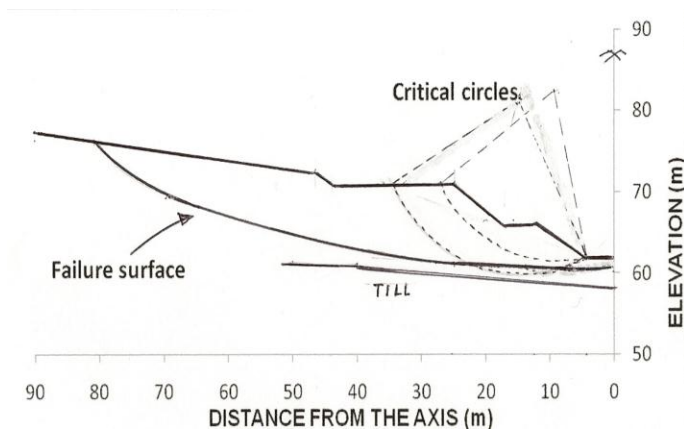
Fig.9: Cross-section of the failed slope (Sketch from a figure after Kankare, 1969).

- The cross section 52+70 of lower canal was analyzed (Fig.9), where the geometrical data were taken graphically from the article of Leonards (1982).

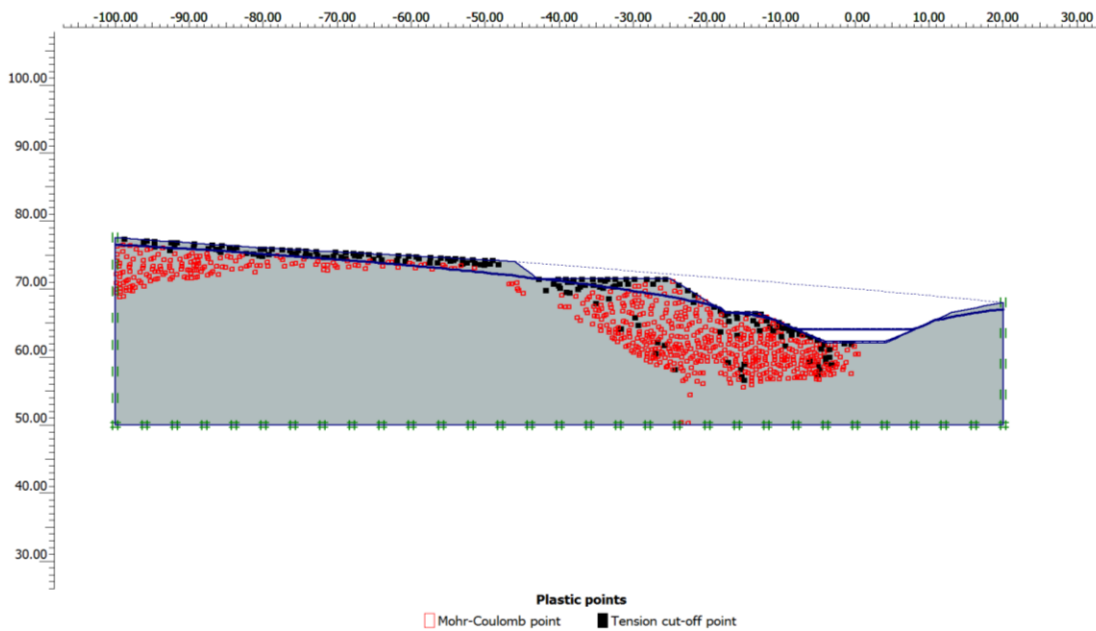
- In the analysis of the article, the flow net was calculated in the F.E. program of computer on the basis of the measurements. The safety factor, arised from the analysis, is $MSF = 0,992$ (practically equal to 1), very close to the minimum values of the Kankare analysis, which according to the position of the circular failure surfaces varied from 0,97 to 1,01. In Fig.10 the plastic zones are observed at the limit equilibrium.

Fig.10: Plastic zones of the cross –section 52+70 during the failure. Analysis with effective stresses for homogenous clay.

(ii) During the limit equilibrium the tension cracks at the crest are shown off, like it happens in practice. The failure seems to have variable curvature and extends more than in Kankare analyses, which were carried out with acceptance of circular surfaces.

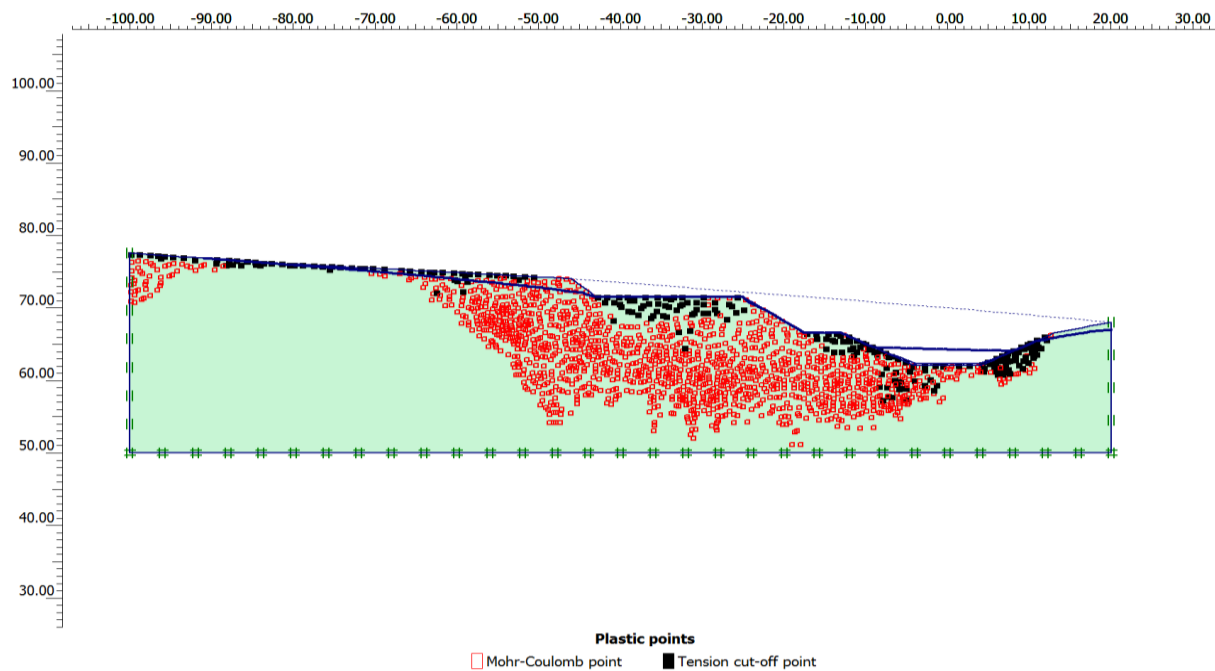
surface upwards zones have smaller strength than this at lower levels. Therefore, the development of shallow failure surface, which extends upwards, in comparison with the surface which corresponds to homogeneous soil, is possible. However, the rate of increase of shear strength in connection with the depth couldn't be directly and accurately developed, in order to be simulated the inhomogeneity of clay zone in terms of effective stresses. Yet, this procedure was attempted with constant angle of internal friction and linearly increasing cohesion c' with compatible way with the geotechnical data. The arised safety factor, from the analysis, which had indicative character with the acceptance of inhomogeneous soil, was $MSF=1,135$. The plastic zones are presented in Fig.11 and it is confirmed that the failure mechanism extends upwards enough and approaches a lot the really developed mechanism.

Fig.11: Plastic zones of the cross –section 52+70 during the failure. Analysis with effective for inhomogeneous clay.

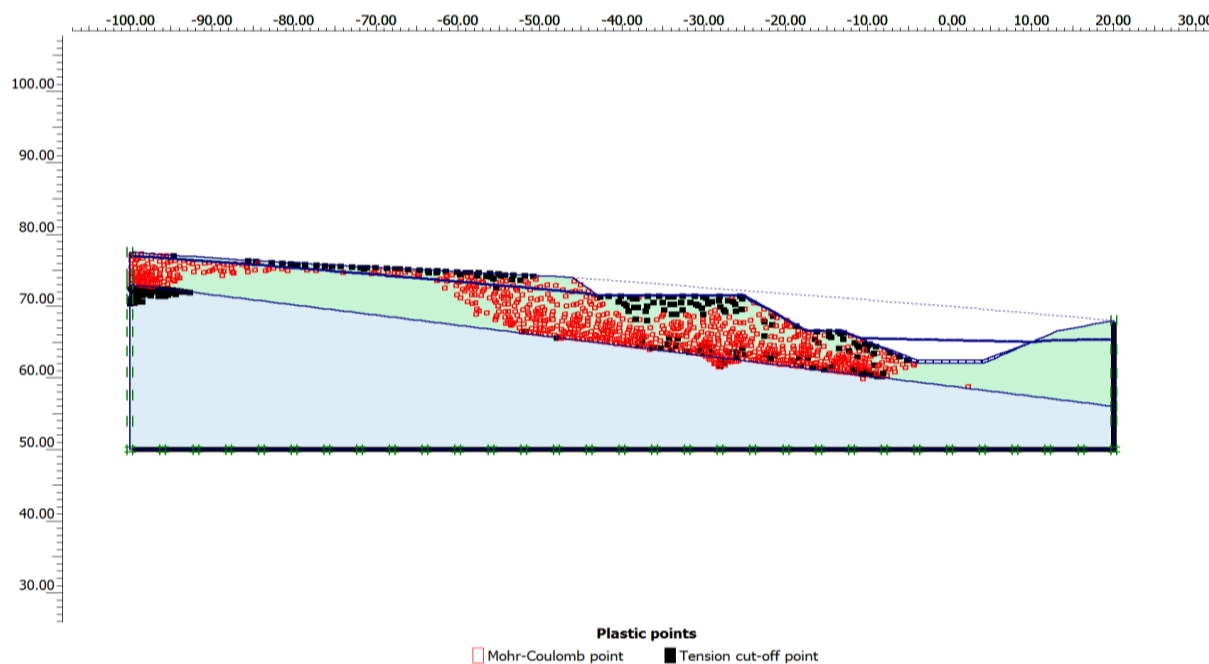
soil in 50%. It is clear that this solution gives with good approximation the real failure mechanism, which deviates a lot from a circular failure surface.

Fig.12: Plastic zones for inhomogeneous and anisotropic clay.
