## Vibration Response of Railway Bridge Piers to Nearby Pile Driving

**SYNOPSIS:** In the development of a new highway system approaching Tel Aviv, Israel, long piles had to be driven very close to an existing railway bridge. In view of the danger of structural damage to the bridge, as a result of ground vibrations excited by the pile-driving work, field measurements were ordered.

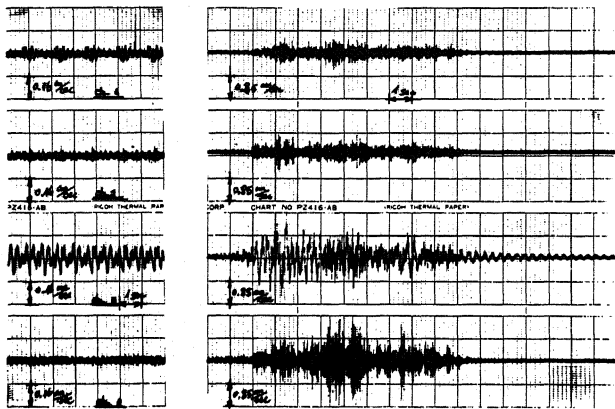
Fig. 3 - Vibration Measurements at pier 2: Test 1 (left); Test 2 (right).

It is interesting to note also, according to Tests 1 and 2, that the vibration at the pier head was amplified by a factor of two, as compared with the measurements at the foot of the same pier. This behaviour occurred during both hammer operation and train passage as well (Fig. 3). Vibrations at the pier heads 2 and 3 decreased with increasing depth of the driven pile, as can be seen in Fig. 4, mainly in the transverse direction. In the present case, the ground had a uniform composition in

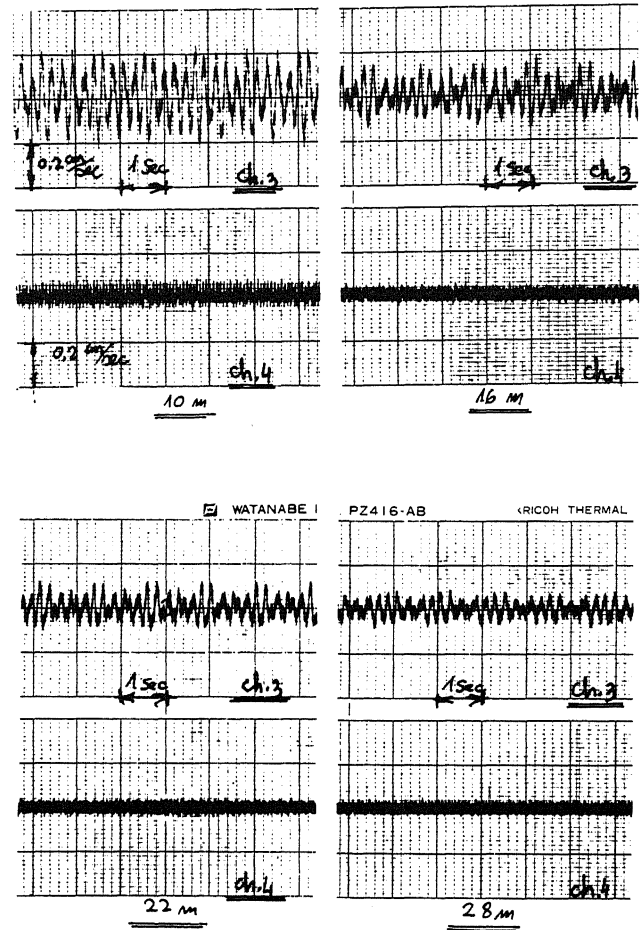
Fig. 4 - Vibration measurements at pier head 2, during driving of the special pile at various depths (Tests 6 to 9).

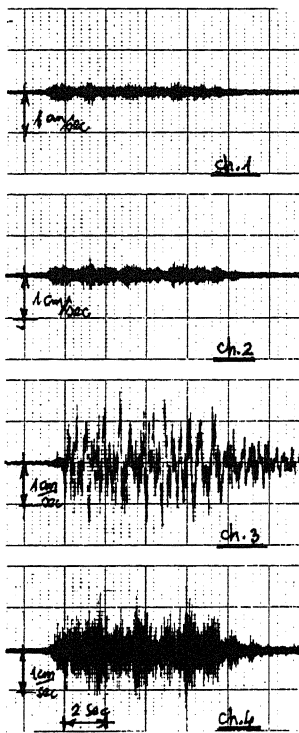
Fig. 5 - Measurements during passage of a rapid train (Test 10).

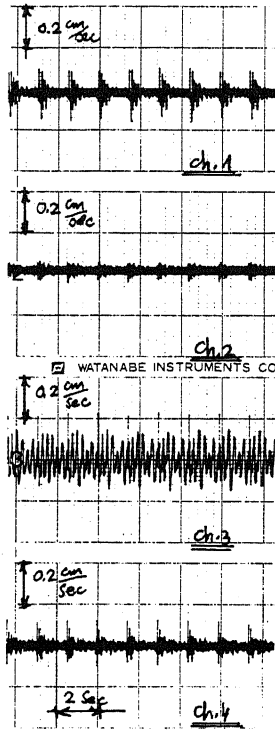
Fig. 6 - Measurements during driving of the closest pile (30m) (Test 14).

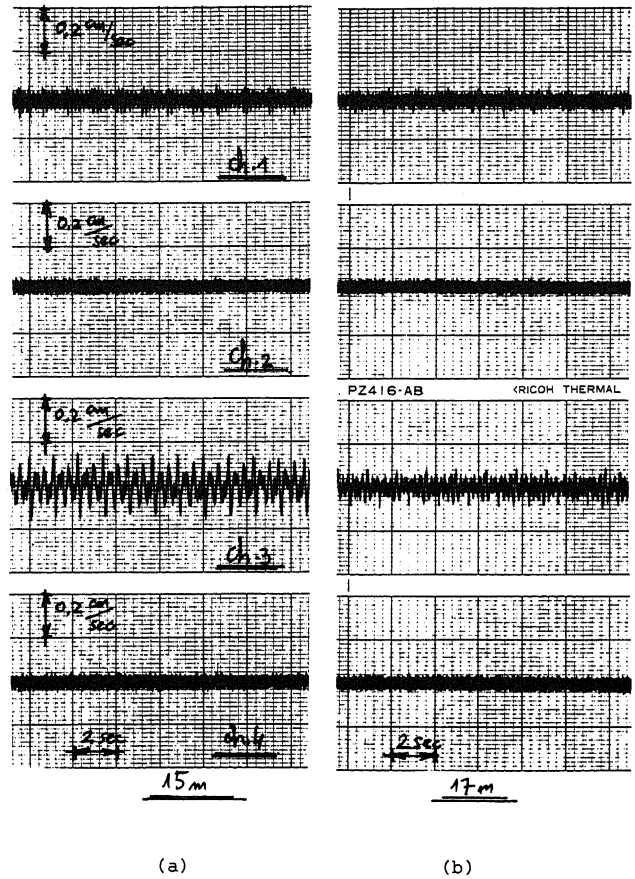
Fig. 7 - Vibration measurements during driving of pile NB-6: (a) Test 17 (15m); (b) Test 18 (17m).

the south bank of soft and medium strength clays, as mentioned earlier. On the north bank, where there was a compact sand layer between 16m and 22m, the same phenomenon was observed again, as the vibration at the pier head No. 7 was drastically reduced when pile NB-6 was driven from 15m to 17m deep (Fig. 7). This reduction in the amplitude is due to the high strength of the compact sand layer.

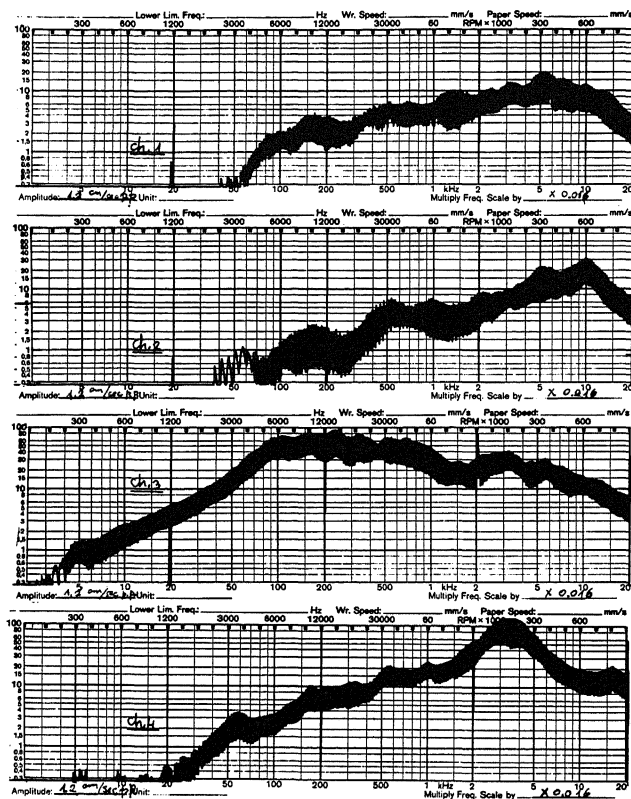
Fig. 9 - Velocity spectrum (third octave):  
 Test 10, channels 1 to 4: passage  
 of a rapid train.

Spectrum analysis (third octave) of the measured velocities yielded the frequencies of the vibrations and permitted the calculation of the pier head displacement amplitudes (Table 2). In most cases the spectrum had only one peak velocity. However, that of Test 10, Channel 3 (Fig. 9), was rather a type of "plateau", and could be interpreted to show a peak at 4 Hz. In this particular case, a lower velocity, at a lower frequency of 1.6 Hz, yielded displacement of +0.418mm instead of +0.215mm, as computed from the peak velocity.
