International Conference on Case Histories in
Geotechnical Engineering

Stability of Hill Slopes and Foundation Condition at Radio Astronomy Centre Ootacamand

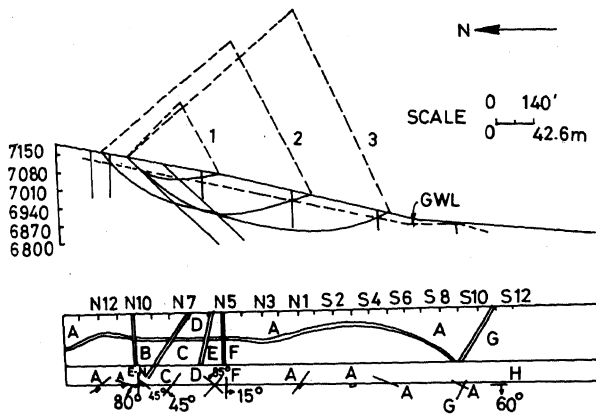
Fig.2. Prominent Joints and Critical Circles for Stability Analysis

less parallel to the strike and the other nearly perpendicular. Fig.2 shows prominent joints observed at the site.

The predominant joint in the area passes through centre of N-11 to S-9. The joint runs in NNE-SSW direction which confirms to the regional jointing pattern. The joint is nearly vertical.

Typical circles are shown in Fig.2 and the results of the analysis are given in Table III. The slopes are found to be stable for (a) and (b) conditions however condition (c) seems to be severe as the factor of safety indicates that it is necessary to take adequate precautions to ensure that water does not enter the joints leading to loss in shear strength. The preventive measures are discussed separately in section on remedial measures.

Cases	Slip circle 1		Slip circle 2		Slip Circle 3	
	c, ϕ kg/cm ²	0.49 0.24	0.49 0.24	0.49 0.24	0.49 0.24	0.49 0.24
		18.0 31.0	18.0 31.0	18.0 31.0	18.0 31.0	18.0 31.0
(a)	1.8	1.9	1.62	2.16	1.5	2.16
(b)	1.75	1.85	1.3	1.68	1.1	1.3
(c)	1.0	0.85	-	-	-	-

- i) The entire area was covered with 0.3 m thick compacted fill so that the water does not enter the joints and soften the material.
- ii) Net work of drains was provided to intercept and drain out surface water. The drains were lined properly with polythylene and asphalt to safe guard against the percolation.

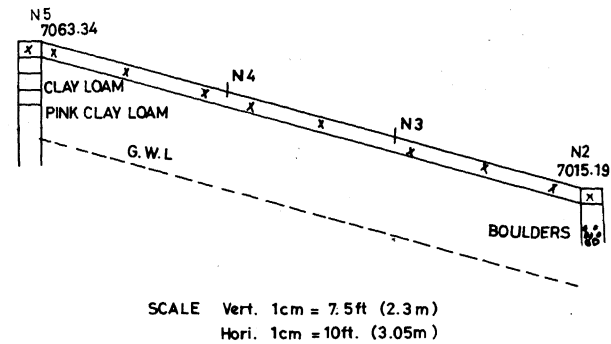
Fig. 3. Typical Soil Profile

To conduct the stability analysis, it was necessary to evaluate the properties of soil at the site. Typical soil profile given in Fig.3 along N-S Direction show clays or clay loam occurring upto considerable depths, however in N-1, N-2 and S-6 regions boulders are encountered at shallow depths.

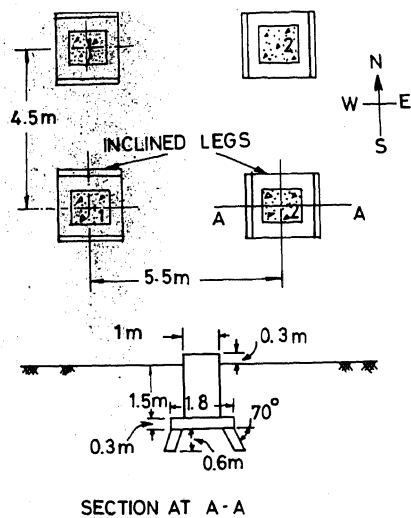
Fig.4. Typical Tower Footings

The load coming on foundation is due to dead load and wind action. As the towers are very high, one can expect high influence of wind loads which may cause reversal of stresses. In view of this it was necessary to design foundation taking into consideration the worst combination of forces. The loading conditions on N and S group towers are given in Table IV and V for typical tower footings shown in Fig.4.

For loading corresponding to case (ii) a net upward pull of 3.84 Tons was found to be acting. Besides this net upward pull, no base friction could be mobilized to resist horizontal forces. The foundation required to be modified for adequate resistance against pull and sliding. In the light of this, legs 0.6 m deep and 0.3 m thick inclined at 70° to horizontal in east-west direction on two sides of footing were considered. Fig.4 shows typical tower footings with inclined legs. With the provision of inclined legs a passive resistance of the order of 27.0 Tons could be mobilized. The safe pull that could be resisted worked out to be 30.5 Tons. Foundation as per this design were adopted.

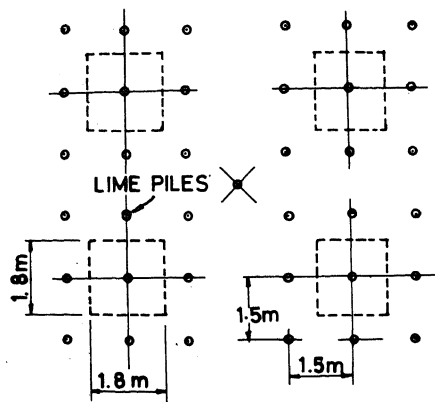
Fig.5. Layout of Lime Piles

As mentioned earlier at S-8 location soft soil was encountered between 6.7 to 11.6 m depths. For proposed fill height of 6 m the settlement worked out to be in the range of 30 cm which is very high. Also an analysis of stress transfer showed that it is necessary to improve the strength characteristics of S-8 location.

The strength characteristics of S-8 location was improved by providing lime pile grid penetrating 1 to 2 m below soft material. Some limited studies had indicated that within around 3 months to a year 10.2 cm hole filled with calcium oxide would produce a lime pile of around 0.6 m in diameter having strength around 1.0 to 2.0 kg/cm^2 . The following procedure for construction of lime piles was adopted.

- i) Boreholes were drilled to a depth of 12.2 m using 10.2 cm auger.
- ii) The layout of boreholes adopted is shown in Fig.5.
- iii) Calcium oxide shell type having 98 percent purity mixed with 10 percent sand was poured into the borehole and the borehole was closed.
