Structural and Functional Distress Due to Slag Expansion

E. M. Morales

Principal, E. M. Morales & Associates, Quezon City, Phillippines

SYNOPSIS Cracking and heaving of a Single Storey R.C. Building was initially perceived as settlement. This error led to unnecessary and costly remedial measures such as Piling for the Phase II Building which further aggravated the problem. The heaving was caused by a seemingly innocent decision during the construction stage to use Slag from a steel mill as the base course material. This Slag reacted with the highly corrosive groundwater which caused heaving of the Building and discomfort and morale problems to the Building occupants. Careful engineering study and investigation resulted in a very simple solution which saved the Building from abandonment and demolition.

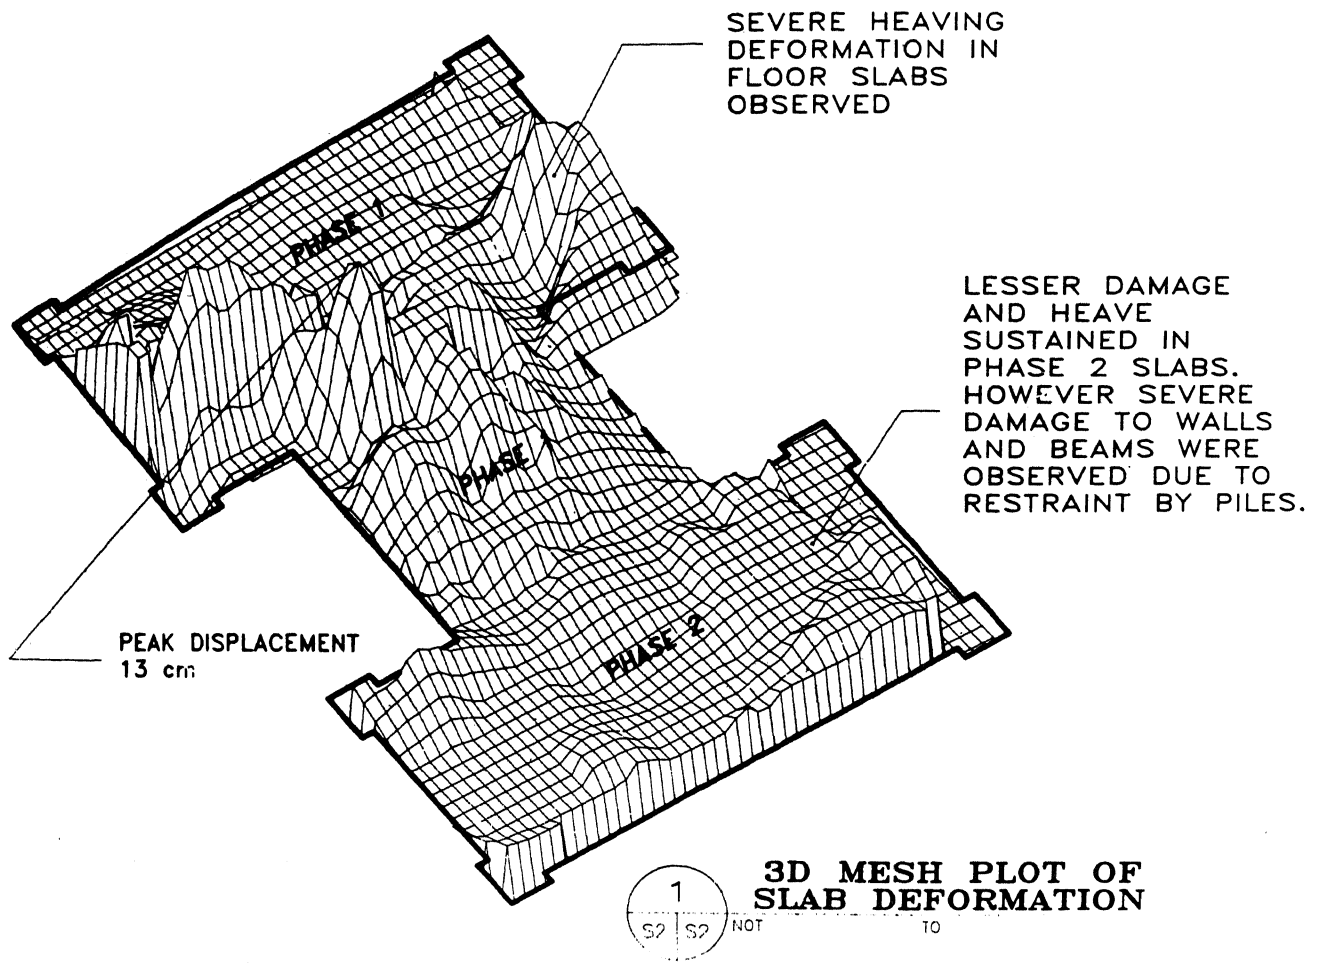
Fig. 1: Slab Deformation 3D Mesh Plot

Severe cracking and extreme waviness were observed in the slabs. Maximum slab displacement is 130mm (5.21 inches) at the analytical laboratory. The 3D mesh plot of the slab deformations is shown in Fig. 1. The 2D Contour Plot is also presented in Fig. 2.

With reference to the slab displacement contour map (Fig. 1 and Fig. 2), it can be shown that Phase I has heaved or displaced more than the Phase II. Although the two are supported by different foundation elements (continuous footing vs. pile foundation for Phase I and Phase II respectively), this would not really explain why there is less heaving and cracks in Phase II because if heaving of the same magnitude have occurred, more damage would have resulted because of the rigid restraint offered by the piles.

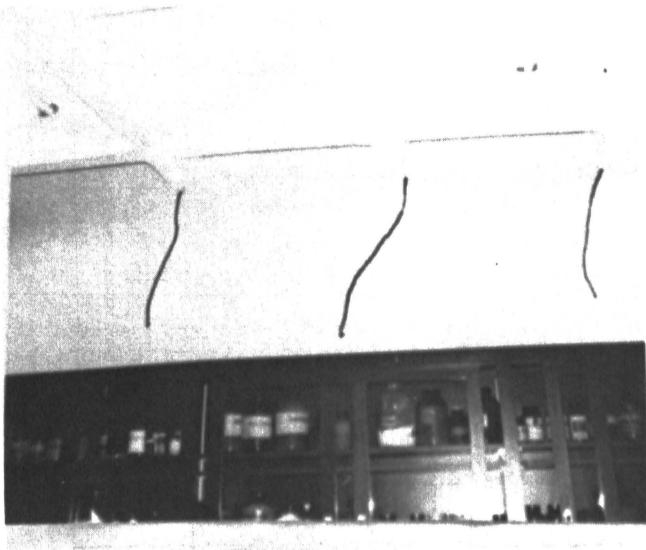
Figure 3:

Soon after completion, the walls of the Phase II addition experienced more severe cracking than the corresponding walls of the Phase II portion. Waviness was detected in the slabs but somehow these were lesser in magnitude as can be seen in Figs. 1 and 2. The main indication that something was still wrong was in the extent and magnitude of cracking in the walls and constant adjustments on the doors and windows (See Fig. 3).

Shows cracks at wall to Waffle Slab Intersections at Phase II portion of the Building.

The floor slabs which were originally dowelled into the perimeter walls and interior walls were recommended to be saw cut using a diamond saw. This has the effect of releasing the walls from any uplift pressures acting on the slab. This will in turn reduce the cracking on the walls and other structural elements.

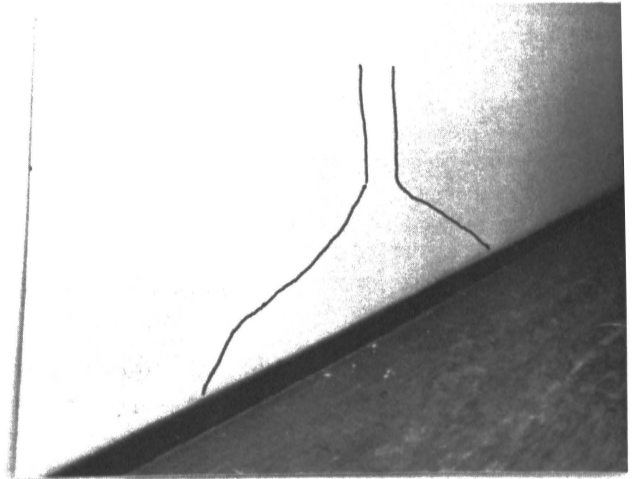
Figure 4:

Fig. 4 which was taken along the corridor near the interface between Phase I and Phase II showed a unique but typical crack pattern in Phase II that is not manifested in Phase I.

The crack pattern shows propagation from the floor intersecting the column line diagonally on both sides. This shows that the wall is flexing but because of the rigid restraint of the walls, has failed the wall in shear instead, because of the upward pressure on the wall footings.

Shows unusual cracking pattern at Wall-Column Interface. The Wall is being restrained from upward movement by the column which is in turn restrained by the Pile Foundations (Cracks highlighted for clarity).

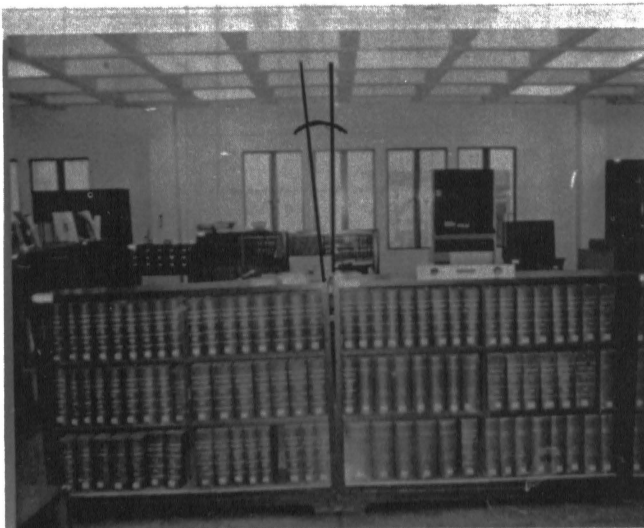
Figure 5:

The magnitude of heaving in some Slabs is illustrated by Rotation of two (2) adjacent bookshelves.

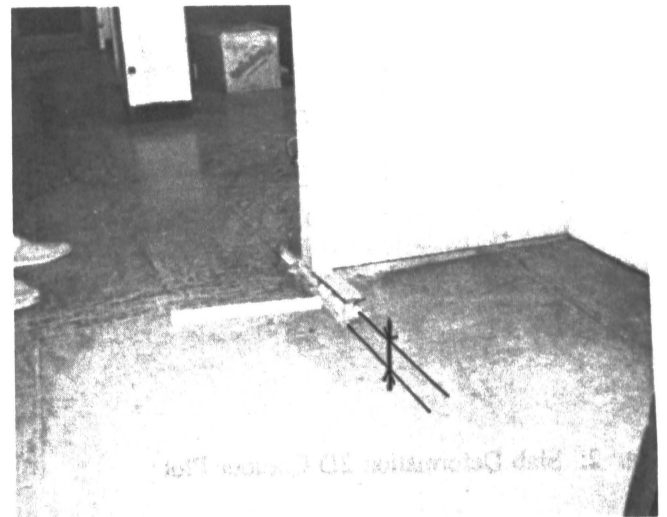
Figure 6:

Light partitions heaved at some locations lifted-off from their bracket connections from the Floor Slab.

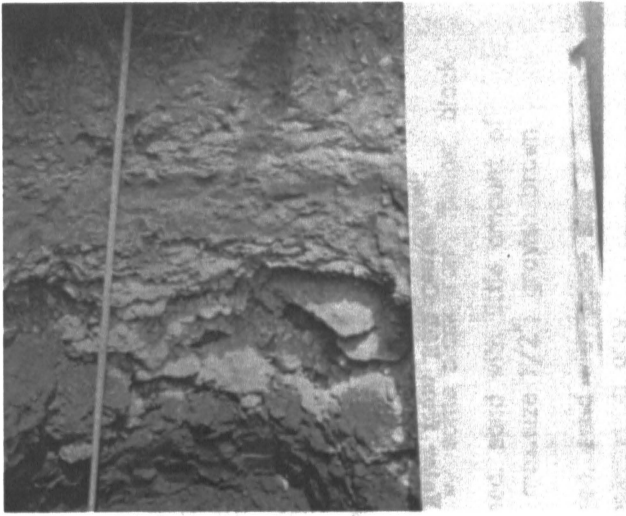
Figure 7:

The Test Pit shows expanded Slag (whitish material) and imported Fill. Scale is approximately one meter.

As soon as facility work load permits, the slabs that were released by diamond saw cutting shall be removed and the slab excavated and replaced by compacted clean granular Fill.

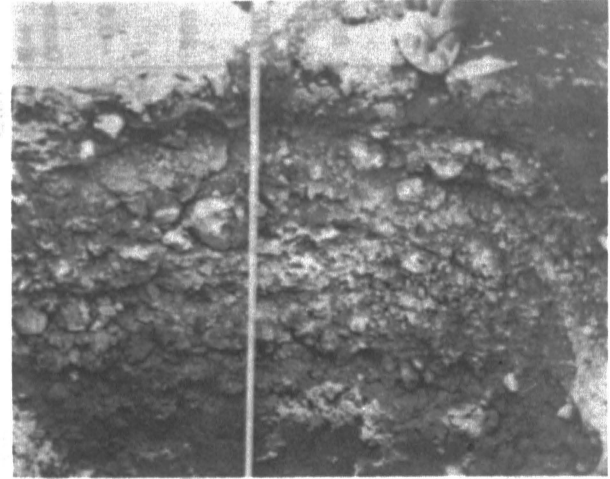
Figure 8:

Expansion in the Slag is clearly evident in this picture at the top portion. Note some cavities formed in the process.

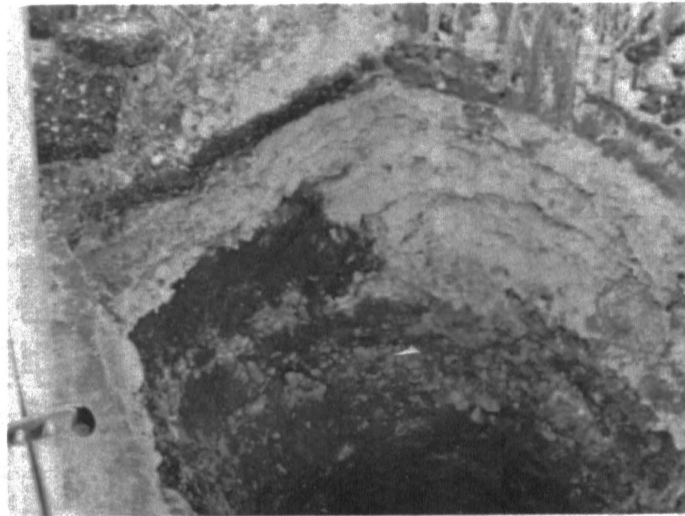
Figure 9:

Expanded and Unexpanded Slag (White Portion) is clearly shown. Note the magnitude of expansion shown in the lower portion of the Slag layer.

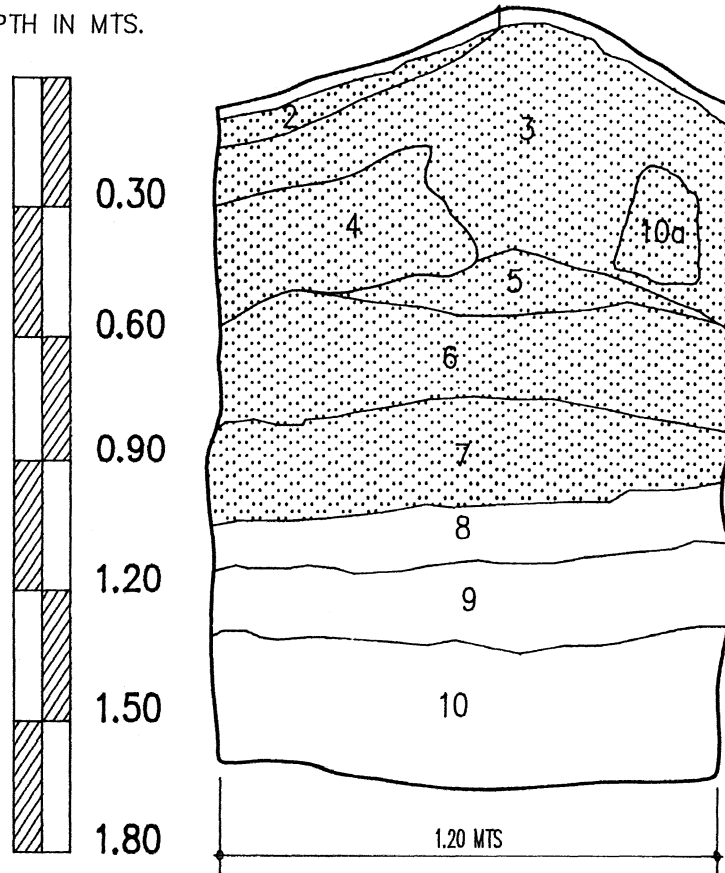
Fig. 11: Log of Test Pit No. 1

- 1 – 2.0cm Asphalt pavement
- 2 – Silty fine to med. sand with slag and traces of gravel; max.size 1/2" ; grayish brown
- 3 – Slag with traces of gravel and coarse sand
- 4 – Coarse to med. sand with slag & gravel; max.size 1/2" w/ some black iron fillings; black
- 5 – Silty fine to med. sand with little amount of slag & gravel; max.size 1/2"; grayish brown
- 6 – Silty fine to med. sand with some slag & gravel; max.size 1/2"; brownish gray
- 7 – Silty fine to med. sand with some slag & gravel; max.size 1/2"; grayish
- 8 – Clayey silt with traces of fine gravel and little amount of sand; med. plastic; gray
- 9 – Clayey silt with traces of fine sand; medium plastic; brownish gray
- 10 – Clayey silt with some fine sand; medium plastic; brownish
- 10a– Highly oxidized slag (spongy)
