Tailing Dam Zelazny Most Environmental Hazard

Proceedings: Third International Conference on Case Histories in Geotechnical Engineering, St. Louis, Missouri, June 1-4, 1993, Paper No. 2.36

SYNOPSIS The factors governing the geotechnical stability of copper tailing dam Żelazny Most, the largest in Europe, have been discussed. The efficiency of pumping wells barrier against outflow of contaminated ground water has been predicted for a period of next 15 years.

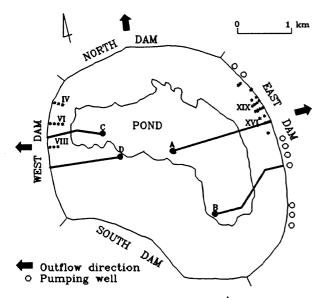
The tailing disposal reservoir, Zelazny Most (Fig. 1), is placed near the town Lubin in West Poland, approximately 100 km from the German border. The reservoir is the most important link of the Polish copper production chain. Since 1977 the reservoir has been storing the flotation wastes from the mechanical processing plants of all four Polish copper mines. It is known that more than 90% of the all material becomes waste as a result of the flotation process. The daily production of waste is about 80 000 tons. The waste is continuously transported hydraulically and deposited in the reservoir with subaerial method. After the sedimentation process is completed, the water used for hydraulic transport is clarified, impounded in the central part of the reservoir and is returned in the flotation system. The reservoir provides also retention of mine waters. The excess of water is periodically discharged to the Odra river.

Fig.1 Copper tailing disposal reservoir Żelazny Most

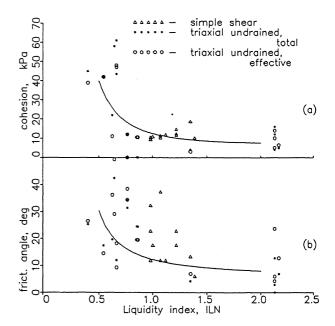
Geotechnical properties of the groups IV and V are presented in Fig. 3, as a function of normalized liquidity index (from fall cone test).

Fig.3 Strength properties of IV and V tailings groups
