Baldwin Hills Reservoir Failure

G. A. Leonards

Purdue University, West Lafayette, Indiana

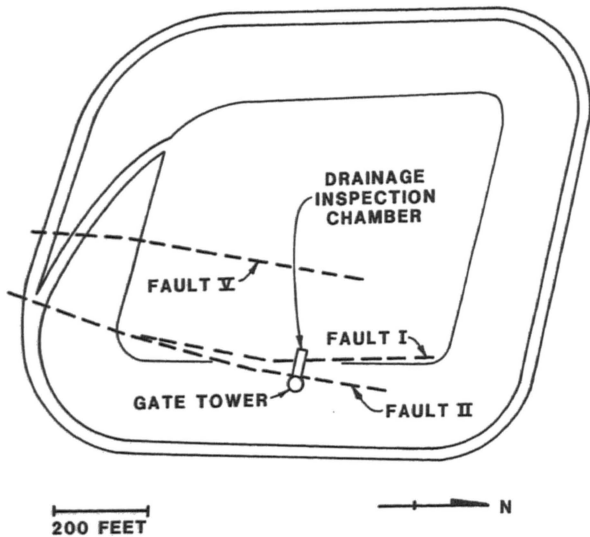
FIG. 4. Location of Auxiliary Faults

Oil fields adjoin the reservoir on the south and west, and the existence of an associated subsidence bowl was known. The Inglewood fault, an active fault that is a branch of the San Andreas system, lies within 600 feet of the west rim of the reservoir. Tectonic and seismic activity associated with the Inglewood fault was well recognized. Auxiliary faults crossed the reservoir in a

general N-S direction, as shown in FIG. 4. The gate tower was moved eastward from its original location to avoid positioning it directly over a fault. A photograph of fault I, exposed by excavation near the gate tower in April, 1948, is shown in FIG. 5. Note the fragile nature

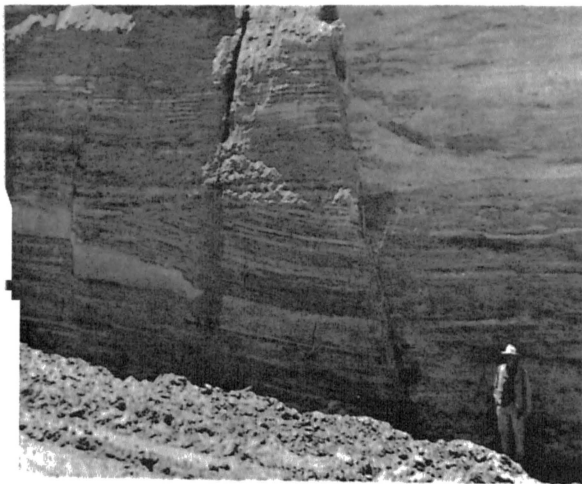
FIG. 5. Photograph of Auxiliary Fault I

of the soil along the planes of weakness. The consensus of opinion was that the auxiliary faults were not active, although the Department's geologist reported apparently fresh slickensides along the structural weakness planes (Wilson, 1949). Because the reservoir was in an active seismic zone, the embankments were designed to resist a

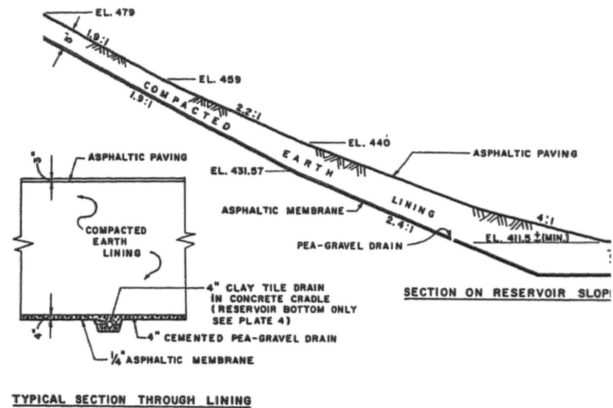
FIG. 6. Main Features of Reservoir Lining

the security of the reservoir was critically dependent preventing water from seeping into the foundation soil. The main line of defense was a 10 ft. thick clay liner (tapering to 5 ft. at the top of the embankment slopes). To maintain flexibility, the clay was compacted to 92 percent of the standard Proctor maximum density at a water content 5.5 percent wet of optimum. As a second line of defense, a 1/4 in. asphalt membrane was sprayed on the subgrade soils in two coats. An open weave cotton fabric was placed between the asphalt coatings at points of stress concentration. No effort was spared to construct a membrane as free of defects as possible and all operations were inspected with special thoroughness.

The main design concept was to control leakage with the clay liner. Normal seepage through the lining would be collected and monitored. In the unlikely event that a crack would develop in the lining, it was expected that the reinforced, flexible asphaltic membrane would remain intact. Increased seepage through the lining would be observed in the inspection chamber and its location noted. Ample time would be available to drain the reservoir and effect repairs.

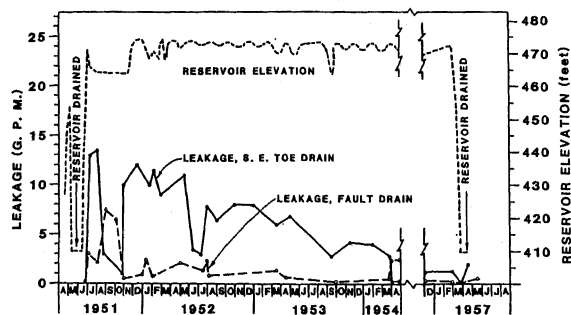
FIG. 10. Seepage Into Reservoir Underdrains

During June 1951, the reservoir was refilled. Again, the southeast toe and fault drains immediately responded with large flows. Subsequent attenuation of the flow rate was interpreted to mean that the leaks were "self-sealing" (FIG. 10). Instead, it appears that the asphalt

membrane was ruptured and seepage entered into the foundation to begin a long-term process of progressive movements -- aided and abetted by regional subsidence. This view is supported by the settlement record of the gate tower, crack initiation and growth in the inspection chamber, and by the early pattern of subsidence that developed across the reservoir floor (FIG. 11). In ad

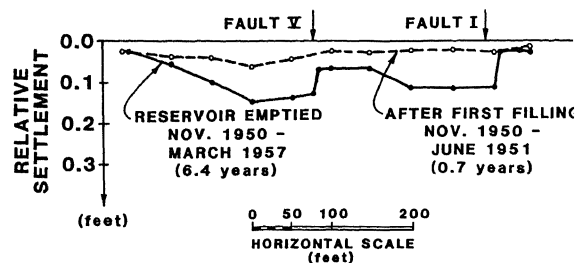
FIG. 11. Relative Settlement Across Reservoir Floor in E-W Direction (total movement minus regional subsidence, after Casagrande, et al., 1972)

tion, post failure investigations disclosed cavities in the locale of fault I nearly 50 feet below the reservoir floor -- evidence of long-term seepage erosion -- which is supported by calcification detected on the surfaces of some of the cavities. It may be that some cavities predated construction of the reservoir. In any case, collapse of cavities due to progressive seepage erosion a subsidence would occur suddenly; the effect on the already weakened clay liner would be to rupture it sufficiently so that water could enter the foundation under pressure. I believe that this is the most likely mechanism that triggered the rapid demise of the reservoir December 14, 1963.

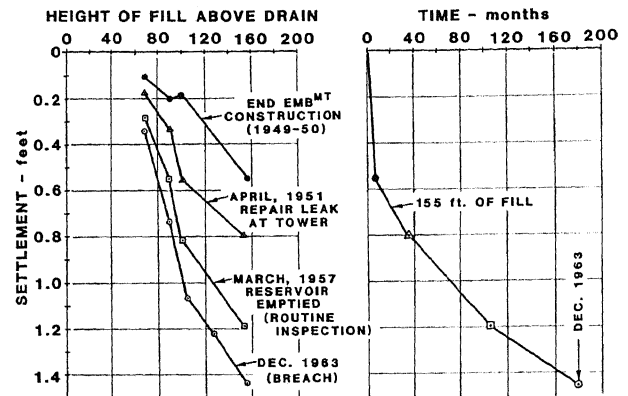
FIG. 12. Settlement Along 12-inch Foundation Underdrain

Settlement vs. fill height at any given time are reasonably regular. The settlement vs. time under 155 ft. of fill shows that the time dependent settlements are nearly double the immediate settlement. One might ask whether this should be expected if no water was seeping into the foundation, but this is easy to do in hindsight. At the time, the regular settlement pattern, and their monotonic attenuation with time, was apparently taken to be normal.

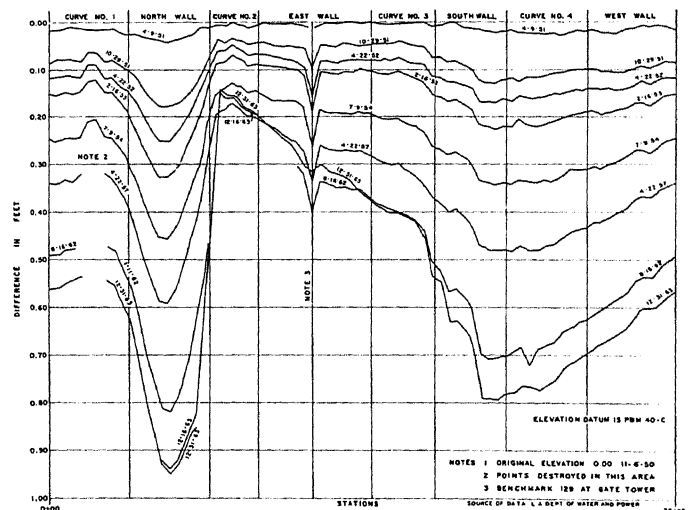
FIG. 13. Settlement Records of Perimeter Parapet Wall

I was unable to obtain tabulations of the monthly crest settlement measurements. However, the crest settlement patterns published in the State of California Report (1964) are shown in FIG. 13. The sharp curvatures displayed are due to the distorted scales that were adopted; the patterns themselves reveal, positively, only the

locations of maximum subsidence, which correspond to the location of fault I. A plot of the maximum crest settlement vs. time is shown in FIG. 14. It appears that

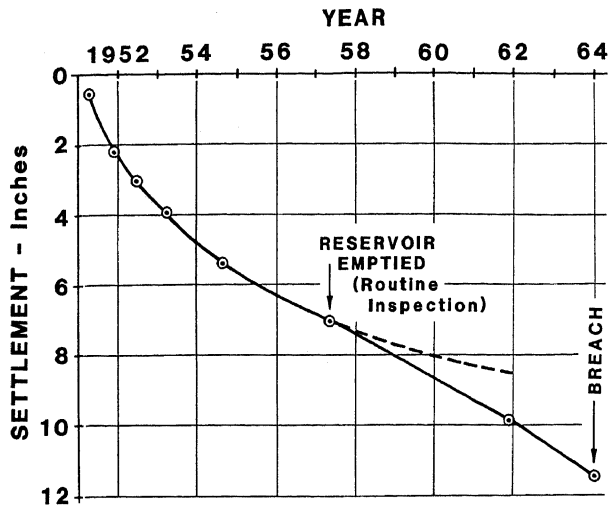
FIG. 14. Maximum Crest Settlement vs. Time

around 1957 (when fluid injection in the adjacent oil field was underway), the rate of settlement began to depart from the extrapolated path but, again, this is easy to recognize in hindsight. In the absence of an expected settlement-time relationship, and a stated criterion of unacceptable departures from the norm, the plot - in itself - is not decisive.

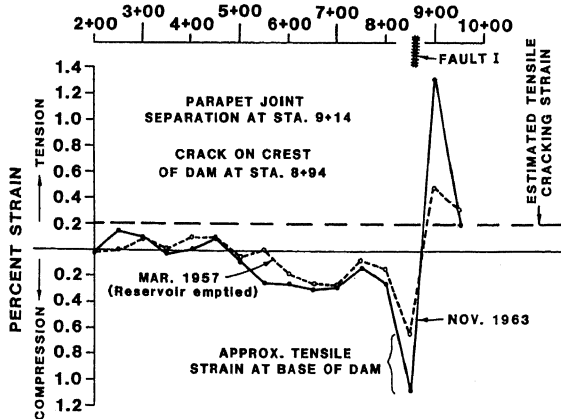
FIG. 15. Strain Distribution Along the Crest of the Main Dam

The simplified procedure proposed by Leonards and Narain (1963) was used to calculate the strain distribution along the crest and base of the dam using the measured settlement patterns (FIG. 15)**. The results,

although approximate, are revealing. As it was not possible to obtain samples to measure the tensile strain at cracking, it was estimated to be approximately 0.2% strain (Leonards and Narain, 1963). The locations at which the calculated tensile strains exceeded the estimated cracking strain agreed with the locations at which cracking was observed to occur at the crest of the dam. What is of crucial importance, however, is the observation that at the base of the dam the critical tensile cracking strain had already been exceeded in 1957. Had it been possible to make such calculations prior to 1963, they may have led to more frequent lowering of the reservoir and inspection of the lining. In that event, the catastrophe most likely would have been avoided.
