Integrated Approach for Stabilisation of Varunavat Parvat Landslide – A Case Study

INTEGRATED APPROACH FOR STABILISATION OF VARUNAVAT PARVAT LANDSLIDE – A CASE STUDY

Tehri Hydro Development Corporation Ltd
Rishikesh, INDIA – 249 201

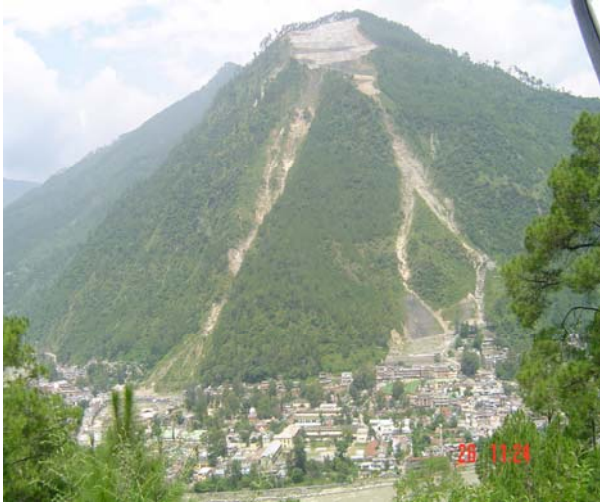
Fig.1 view of Varunavat Parvat post- landslide

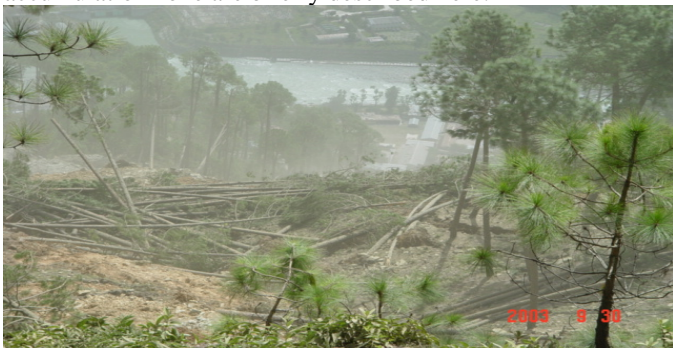
incorporates the old slided materials and fragments of quartzite and phyllites. Though distress was noted in June 2003 and the mass was mobilized by continuous increase in pore water pressure over months due to heavy rainfall during monsoon. The rock debris from the hilltop of Varunavat Parvat started falling during the night of 23 September 2003 and continued for the next 15 days. The crown of the landslide is located about 750 m above the Rishikesh-Gangotri National Highway. It is sparsely vegetated with pine (about 30% cover). Pine trees (having very less root to shoot ratio) were planted by Forest Department around 24 years ago and were observed to be tilted (see fig-3) indicating manifestation of the creep movement of the area. In the crown region, many pine trees upslope tilted trees were noticed, which indicate the rotational movement of the slide mass. Based on the geometry of the exposed scarp, the depth of the slip surface was estimated to be 20-25 m. The zone of displaced mass is about 200 m long, 250 m wide and 20 m deep. A number of cracks trending NE-SW and E-W were observed in this zone. Some of the cracks were about 3 m deep. The slide zone was monitored to visualize the extent of the slide zone and cracks. Though no extension of slide was observed in the upslope direction, but new cracks were noticed on the left flank of the slide and the loose material resting on the slope hovered the fear of moving down in the near future. Based on the ellipsoidal geometry of the landslide mass, about 80,000-1,00,000 m³ volume of material was displaced at the time of disaster, which has rolled down the slope of Varunavat hill along three transportation chute tracts and accumulated in three different accumulation zones respectively. These zones are locally named as Tambakhani zone, Ram Lila ground zone and Masjid Mohalla zone (Horticultural and Jal Nigam). Out of these three chutes the Ram Lila ground zone is the most prominent one because of the presence of the large scale habitation around it. The Characteristic features of each accumulation zone are briefly described here.

Fig.3 View of tilted and fallen pine trees in the slided Area.

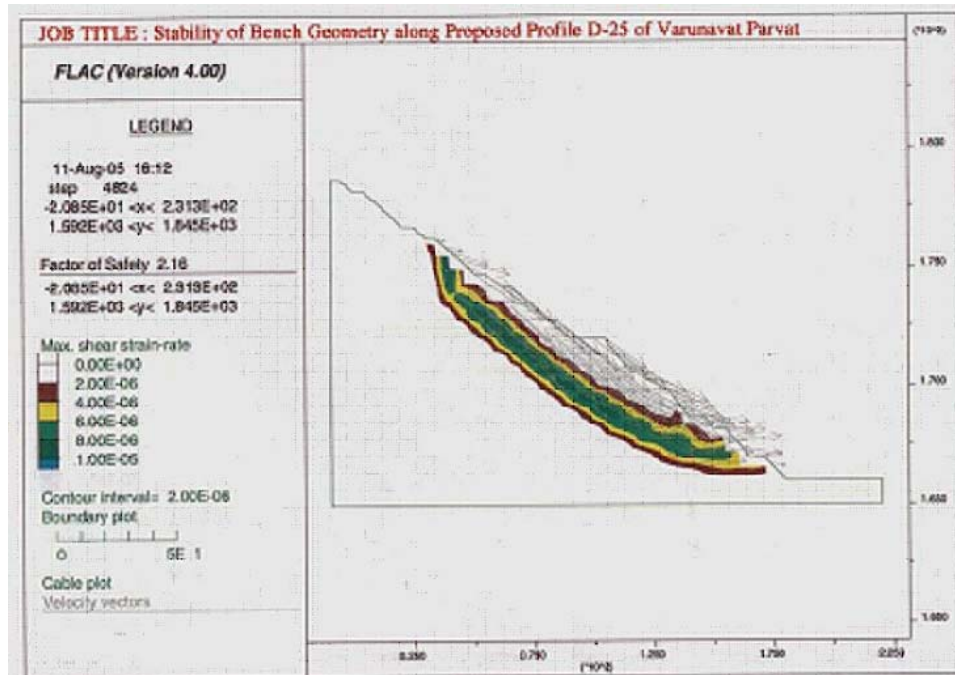
The results of analysis in terms of factor of safety of the overall slope along the proposed profiles for different cases showed the failure envelope and factor of safety value for the slope with bench width of 4m / 5.5 m with 10m thick weathered rock layer(beyond 50m from the crown). The simulation was also carried out with 5m long rock bolts of 32mm diameter at 3m spacing. The factor of safety did not change significantly as the failure envelope passed below the rock bolts. The factor of safety reduced by about 20 percent when the thickness of the weathered rock beyond 50m from the crown was increased to 20m. The results of analysis shown in figure.4 revealed that factor of safety is always more than 2.

Fig.4- Results of 2D Analysis showing shear strain & Factor of safety

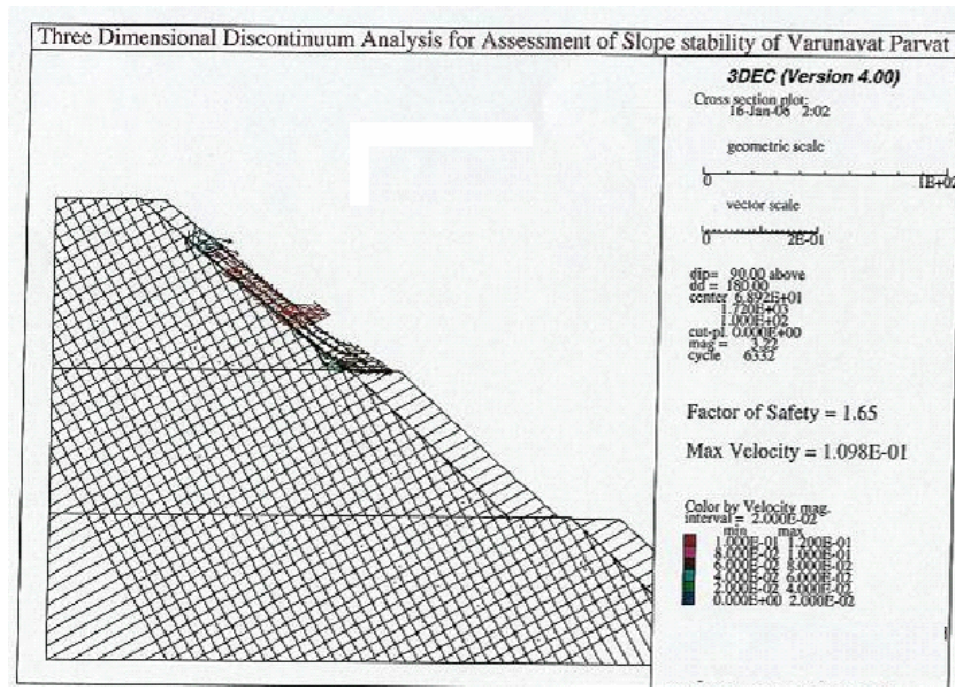
failure is identified by the software, by identifying the abrupt rise of the velocity vectors of the blocks along a failure surface. The failure surface, along which the shear strain rates are maximum, is identified by the software automatically. The shear strength reduction techniques applied to three dimensional stress analyses, yielded a factor of safety of 1.65. The velocity vectors along the profile D50 are shown in figure- 5. It can be seen that the large velocity are observed at EL. 1720 and at EL.1740, indicating unstable mechanism, if the shear strength is reduced by 1.65.

Fig.5- Results of 3D Analysis showing velocity vectors & Factor of safety

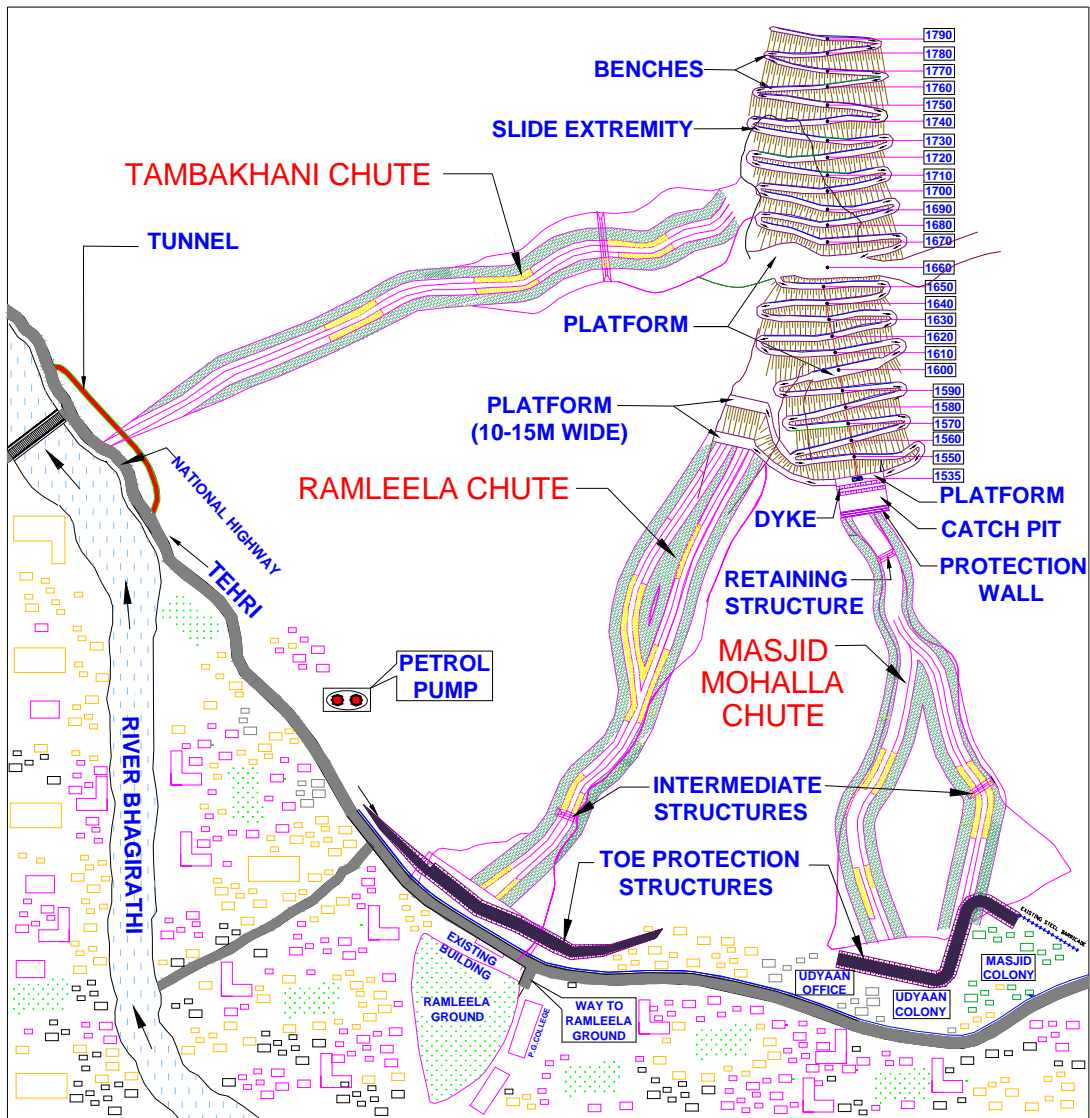
Fig 6- Conceptual scheme for stabilisation measures of Varunavat Hill

The slopes of about 10 m to 25 m height with 5.5m berm width were excavated. All the berms were connected fig-6 The excavated muck was then disposed off to the identified dump yards. The slopes and berms so created by modification of the profile were covered with shotcreting/geo-grid/geo-jute to protect against the erosion and weathering actions. Shotcreting was used for the berms and slopes on the weathered rock. The gentle slopes and berms on soil were protected by soil reinforcement with Geo-grid whereas the flatter soil slopes were covered with bio-degradable geo-textiles which can support the growth of the vegetation. The toe of the soil slopes were also stabilized with Gabions wall. The slopes were reinforced with rock bolts to reduce the possibility of local failure of the slopes if any. Prestressed cable anchors are being installed on the toe of the steeper rock slopes of greater height or at any other locations where there is wedge formation due to intersection of joints as advised by the geologists of GSI.

(iii) A tunnel of about 350 metre length (see fig. 6) is being constructed on the national highway at Tambakhani to avert the Rock fall hazards (The alternative of Tunnel alternative was preferred to Rock- shed structure due to space constraint on techno-economical considerations. Although, rock sheds structures are widely used on steep slopes above narrow railways or roadways. An effective shelter requires a steeply sloping roof covering a relatively narrow span but in our case because of of a wide multi-lane national highway, it was not possible to design a rock shed structure with sufficient strength to withstand large rockfalls even by considering placing a fill of gravel or soil on top of the rock shed in order to act as both a retarder and a deflector for rockfalls directly into the river.

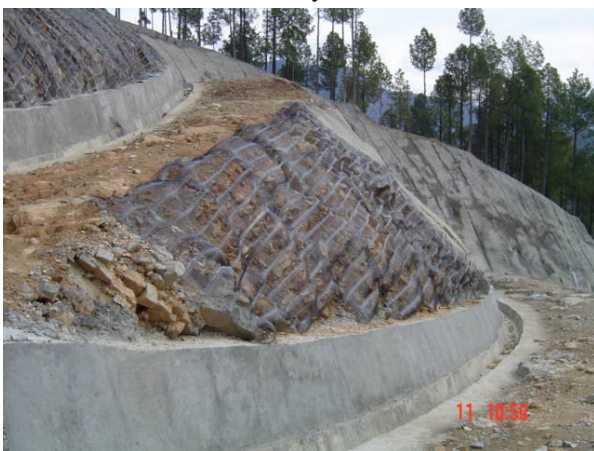
Fig.7-Slope stabilisation measures & construction of side drain on the benches in Crown Area

undertaken through the network of side drains on the benches, intercepting catch drains, contour drains and its disposal through the available natural water courses namely the Tambakhani, Ramlila and Masjid Mohalla chutes. This is being done by constructing cement concrete open drain on each of the interconnected benches as well as the network of contour drains on the slopes between El.1650 m and toe of the hill slope. Similarly the Subsurface drainage is being managed by providing 6m to 9m long perforated pipes of 75mm diameter on each of the treated slope for releasing the pore water pressure. The drainage pipes are being installed in the predrilled holes into the hill at a negative gradient of about 10 degree to the horizontal to ease the release ground water

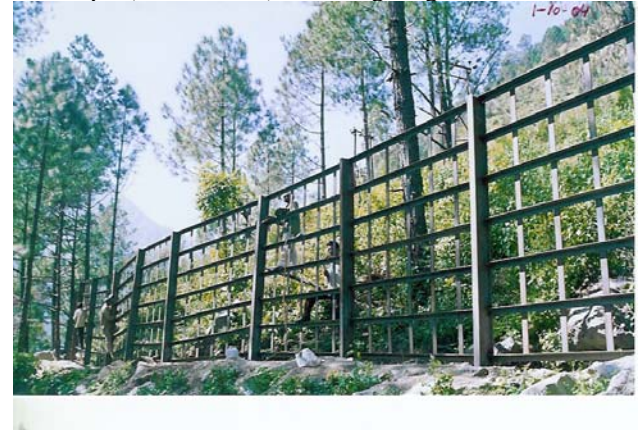
Fig.8 Restraint measures by construction of Steel barricading structure

(i) Retaining Wall of Cement Concrete Blocks placed in two tiers was constructed at the toe of the chute on Ram Lila ground before taking up the treatment work for creating the catch pit to arrest falling of any debris/stone during the construction Stage keeping the safety of the public into consideration. This wall served the purpose satisfactorily during the Crown treatment. However during the treatment of the Ram Lila chute, Cement Concrete Retaining Wall of about 6 Metre height is planned to be constructed. The alternative of Geogrid Wall initially envisaged was changed to Cement Concrete wall due the large space requirement for the Geogrid Wall. Probably the most effective permanent rock fall protective system for most highways or in the vicinity of township is the construction of a catch ditch at the toe of the slope. The base of this ditch should be covered by a layer of gravel to absorb the energy of falling rocks and a sturdy barrier fence should be placed between the ditch and the roadway. The location of the Retaining wall /barrier fence can be estimated by means of rockfall analysis by calculating the trajectories based on the available literature. The criterion for the minimum distance between the toe of the slope and the rock fence should be such that no rocks can be allowed to strike the fence before their kinetic energy has been diminished by the first impact on the gravel layer in the rock trap.

(ii) Geogrid Wall of about 6 metre height has been constructed to create the catch pit for arresting any debris/boulders for the safety of the public residing in the vicinity. The option of preferring the Geogrid wall (with Gabions facings) to other option was due to its flexibility and high energy absorbing capabilities and having techno-economically a viable alternative at this location
