(1984) - First International Conference on Case
Histories in Geotechnical Engineering

Design and Construction of a Railway Yard, Embankment and Foundations under Difficult Groundwater Conditions

Design and Construction of a Railway Yard, Embankment and Foundations Under Difficult Groundwater Conditions

Hari D. Sharma, S. Sengupta
Fluor Canada Ltd.

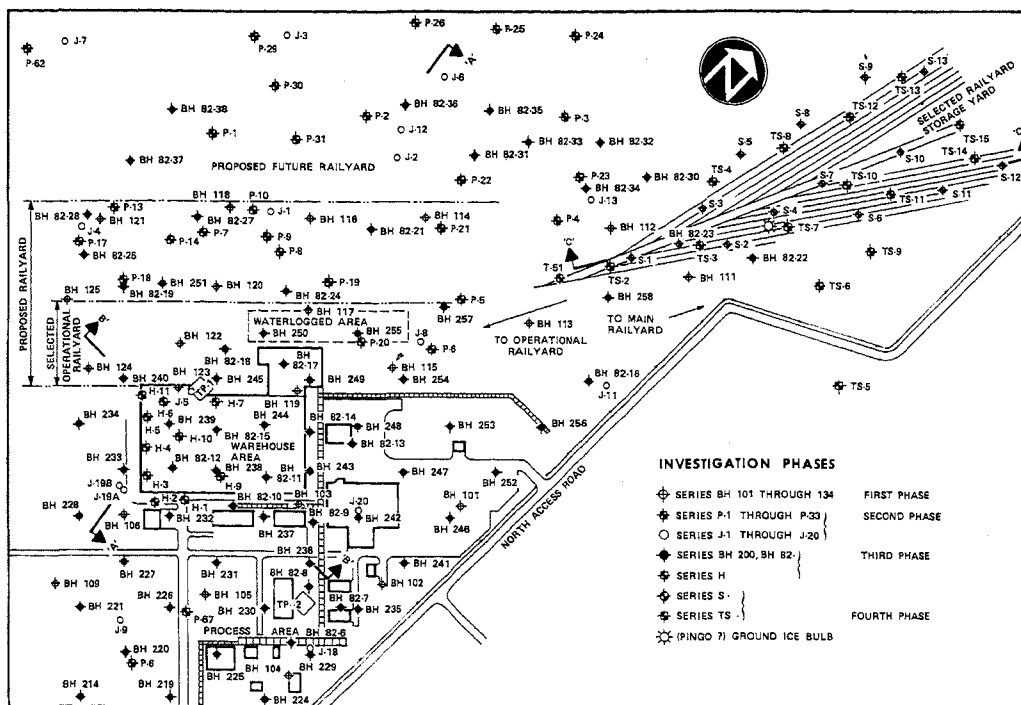
Fig. 1. Borehole Location Plan

The purpose of this work was to define basic soil conditions, their suitability for sub-grade support and the use as fill material. A total of 34 boreholes, 10 within the confines of the plant site and 24 in the railway yard area, were drilled and have been shown in Figure 1 as indicated by BH 101 thru 134. Field sampling included standard penetration tests, split-spoon samples, undisturbed Shelby tube samples and bulk samples. Laboratory test included the determination of moisture contents, Atterberg limits, grain size analyses, moisture-density relationships, unconfined compressive strengths and soluble sulphate concentrations. A total of sixteen sealed standpipes were also installed in the area.

In January - March 1982 further site specific geotechnical investigation work was carried out for both the railway yard and the plant site. This work consisted of drilling and digging a total of about 100 boreholes and test pits as shown in Figure 1 by borehole series (BH 200) and (BH 82) and test pit series (H). Results of this work confirmed earlier interpreted soil stratigraphy including the results obtained from hydrogeologic work. Figure 2 exhibits typical sections across the site.

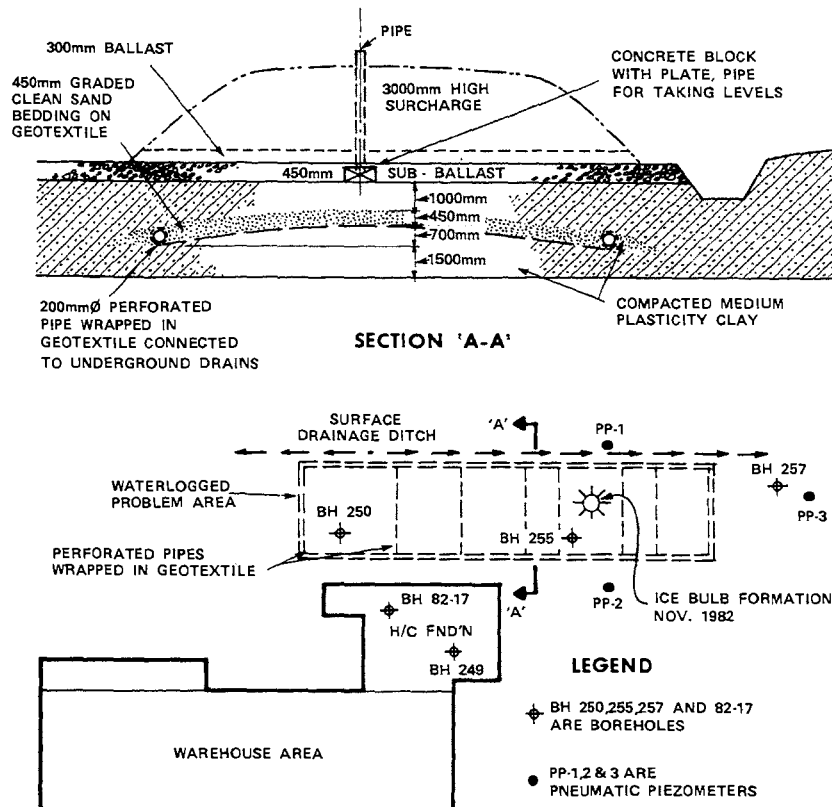
Fig. 3. Water Problem Area and Solution

across the railway yard area. With this background the cut and fill operation in the railway yard area was commenced in Fall 1981 which was scheduled to be completed before the freezing weather. During excavation operations extensive groundwater was encountered in the area that could not be stopped. The reasons for this continuous groundwater flow were not obvious from the sub-surface information available then. Hydrogeological investigations for the area were therefore undertaken, results of which have been summarized earlier. These investigations revealed that the bedrock was under high artesian pressures and, in certain locations of railway yard area, the bedrock was at shallow depths below ground surface. Figure 2a shows the soil, bedrock and water profiles. This indicated that if excavation, as planned to elevation 101.6m, was carried out in railway yard area then it would cut the bedrock which had artesian pressures. This would result in uncontrollable water flow. In order to proceed with the construction of the railway yard site preparation work some form of mitigative action was therefore required to deal with this hydrogeological condition. The following six design alternatives were studied before a final solution was selected.

Finally Alternative 2 was adopted. This utilized the lower elevation (102.5m) terrace of Alternative 6 as an operational yard area and extended the railway yard northwards for this purpose. Selected operational yard and storage yard areas are shown in Figure 1.

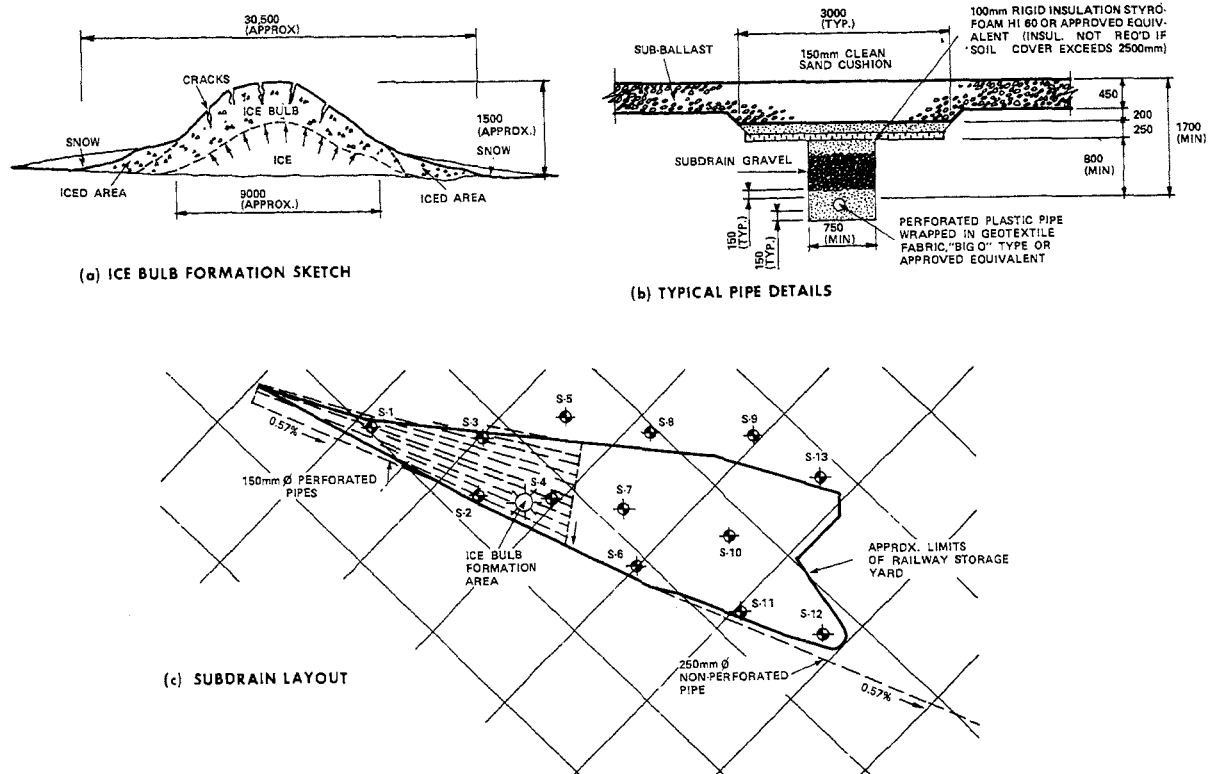
Fig. 4. Ice Bulb Problem-Solution :Railway Storage Yard

Growth of an ice bulb, during the Winter 1981 - 82, was noticed near the N-W corner of the railway yard area as shown in Figures 1 and 4. This ice bulb (Pingo-shaped) was kept under observation for a few weeks and its growth in size was regularly reported. The total area encompassed by this bulb was about 30m in diameter as shown in Figure 4. The convex part of this bulb exhibited extensive cracks indicating upward fluid pressure. When this ice bulb was cut by a bulldozer it discharged a significant amount of water flow even though the air temperature was near -30°C. Formation of this ice bulb became a matter of concern since the area lay below the proposed rail line approach track. No information on soil and ground water conditions was available for this area at the time of this observation. The fourth phase of geotechnical investigations, as detailed earlier, was therefore carried out for this area. In general the soil in the area is clay till above bedrock. Local sand layers were observed within the till. Results of these investigations also indicated that groundwater was high in standpipes placed in holes S1 and S3. Also the bedrock piezometric pressures in S1 were about 0.3m above grade level. The overall area was a groundwater discharge area. The existence

of ponded water in a low area surrounding boreholes S2, S3 and S4 was recorded. It is possible that a sand layer or a pocket or more pervious zones in till was being fed by upward flow due to its continuity with bedrock which probably was feeding the surface water. Whatever the source of water, the high groundwater obstruction to this flow due to surface freezing of the area appeared to be the reason for the growth of this ice bulb. The obvious solution would be to provide a year around drainage for this water. A few alternative solutions to achieve this goal were proposed.

The adopted solution consisted of a series of trenches located about 10m apart. In these trenches were placed perforated plastic pipes wrapped with geotextile, which were surrounded by clean sand for effective drainage. Where these pipes were at depths shallower than 2.5m, rigid Styrofoam HI-60 insulation was placed above them to inhibit freezing. This method has been effectively used on many projects as a frost protection technique (Dow Chem. 1980, and Sharma 1981). These drains were then connected to a collector drain which finally discharged into an existing drain. In order to have free flow these pipes were placed at a minimum slope of 0.5 percent. At the outlet end of the discharge pipe, provisions were made to keep it open throughout the year. Arrangements such as a heated and insulated sump pump system near the outlet, heat tracing of the last 20m metal section of pipe at discharge point, and blowing hot air at outlet, if required, were also provided. Construction of this system was finished about one year prior to completing the final levels of the railway storage yard. This ensured that the groundwater table had effectively been lowered and would be kept low year round.
