Effects of Collapse Settlement of Fill on Reinforced Earth Walls

G.E. Blight

SYNOPSIS

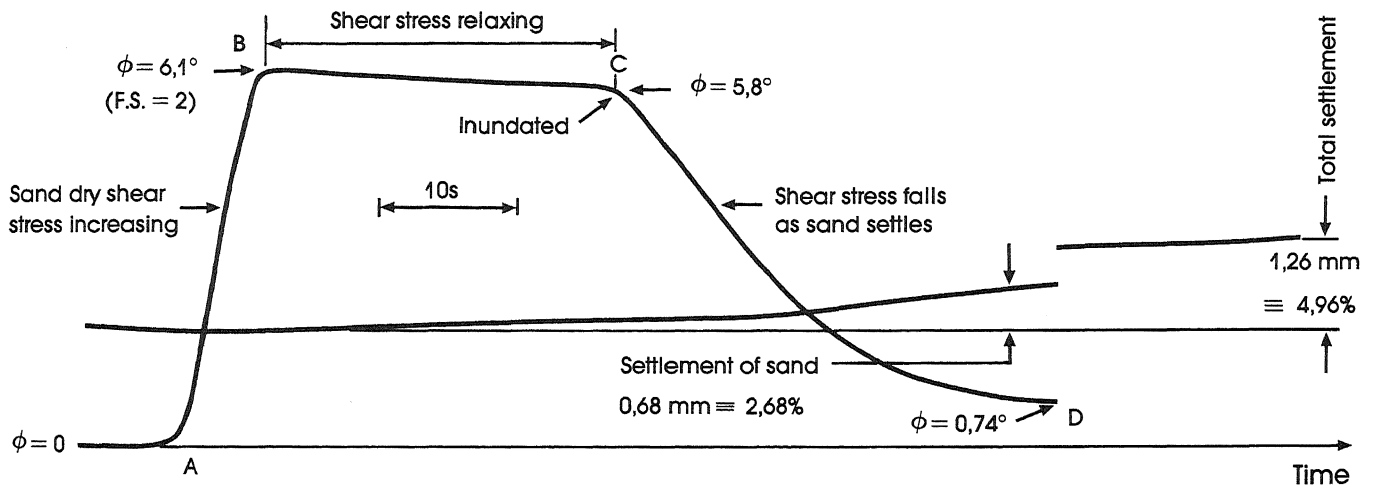
AB in the figure represents the stage during which the dry sand was loaded to a factor of safety of about 2 (actual $\delta = 6.1^\circ$). At B the loading was stopped and the sand inundated. At C it appears that the water reached the sand-galvanized steel interface and the shear stress reduced (C to D) to an angle of friction of less than 1° . Simultaneously the sand settled, although most

Figure 1: Variation of shear load at sand-steel interface when dry sand is inundated.

It can be inferred from Figure 1 that as the wetting front moved downwards through the fill, successive layers of reinforcing strips temporarily lost their shear resistance and allowed the pressure in the fill to move the wall facing forward. As the wetting front passed, shear resistance was re-established, possibly at a greater angle of friction, and the wall facing re-stabilized.

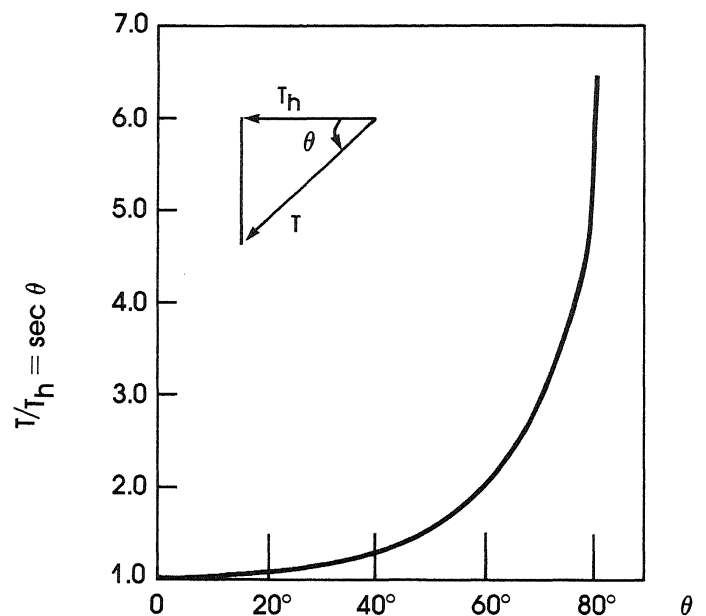
Figure 2: Strip tension T required to exert horizontal component T_h for various inclinations θ .

As a result of the relative settlement, the strips become inclined adjacent to the wall. For an inclined strip to exert a horizontal tension component T_h , the tension in the strip has to be (see Figure 2)

As shown by Figure 2, T increases rapidly with increasing θ . If the design factor of safety against yield of a reinforcing strip is 1.6, a strip inclination of 51° will cause yield. If the factor of safety against tensile fracture is 2, an inclination of 60° will result in fracture.

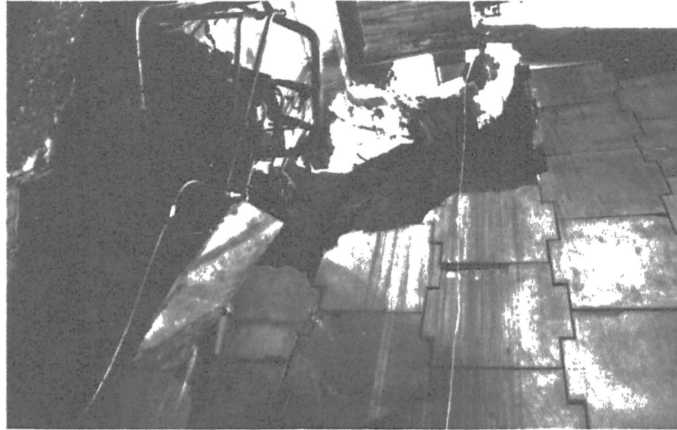
Figure 3: Frontal view of the failure at Grootgeluk Mine

The walls support the earth ramps that provide access for 250T haul trucks to tip their loads from the base of the U into a primary crusher. Eight years after construction one of the side walls (the south wall) of the U failed, a wedge of fill sliding out together with a section of the concrete panel facing. The height of the section that failed was 16m. A view of the failure is shown in Figure 3.

- (i) A water pipe in the failed area had been leaking for an unknown period, discharging water into the fill.
- (ii) The fill consisted of a sandy gravel which contains a considerable proportion of clay. It was certainly not free-draining but had an estimated permeability of only 1m/year. Penetration of water into the fill by infiltration of rainwater would have been slow. Equally, water fed into the fill by the leaking pipe would not readily have dispersed.

- (iii) Several reinforcing strips had never been placed in the wall. For example, one facing panel was attached to four instead of the required six strips. In other cases 60mm x 3mm strips had been used instead of 80mm x 3mm strips.

- (v) A deep rut in the surface of the fill showed that a heavy wheel load had been applied to the surface of the failed area shortly before the failure occurred.
- (vi) Several of the strips supporting the failed section had clearly broken some time previously, as the fracture surfaces had rusted.

Because of progressive collapse settlement and construction errors, the factor of safety of the section of wall that failed may have been close to unity before the water pipe started to leak. The penetration of the fill by water from the leak would have resulted in further collapse settlement and an increasing inclination of the reinforcing strips in this zone. Simultaneously, the accumulation of water would have reduced the shear strength of the fill. The last straw may have been the straying of a heavy vehicle onto the surface of the fill above this zone, now in a critical state. As often happens in engineering failures, there was no coherent eye-witness account of the failure.

Observations at Grootgeluk indicated that reinforcing strips were dragged down over a distance of 500mm to 750mm back from the wall facing. If one sets the acceptable angle of inclination at 37° (a 25 per cent increase in strip tension), then the maximum permissible settlement of the backfill relative to the wall facings is 375mm. Hence the limitation on settlement or misplacement of strips in elevation is not severe. Relative displacements of less than 375mm over a fill height of 16m should be easily possible with good supervision and careful compaction.

The case histories described above, illustrate the importance of applying the usual control norms during the construction of Reinforced Earth structures, as well as the necessity for adequate compaction of the fill. As shown by measurements on Reinforced Earth structures, the tensions in reinforcing strips at a particular level can vary widely (Blight, Dane and Smith (1)). Circumstances that result in increasing strip tensions may cause certain strips to break, thus reducing the overall factor of safety of the structure. Recognition of these facts will lead to the building of safe, durable structures.

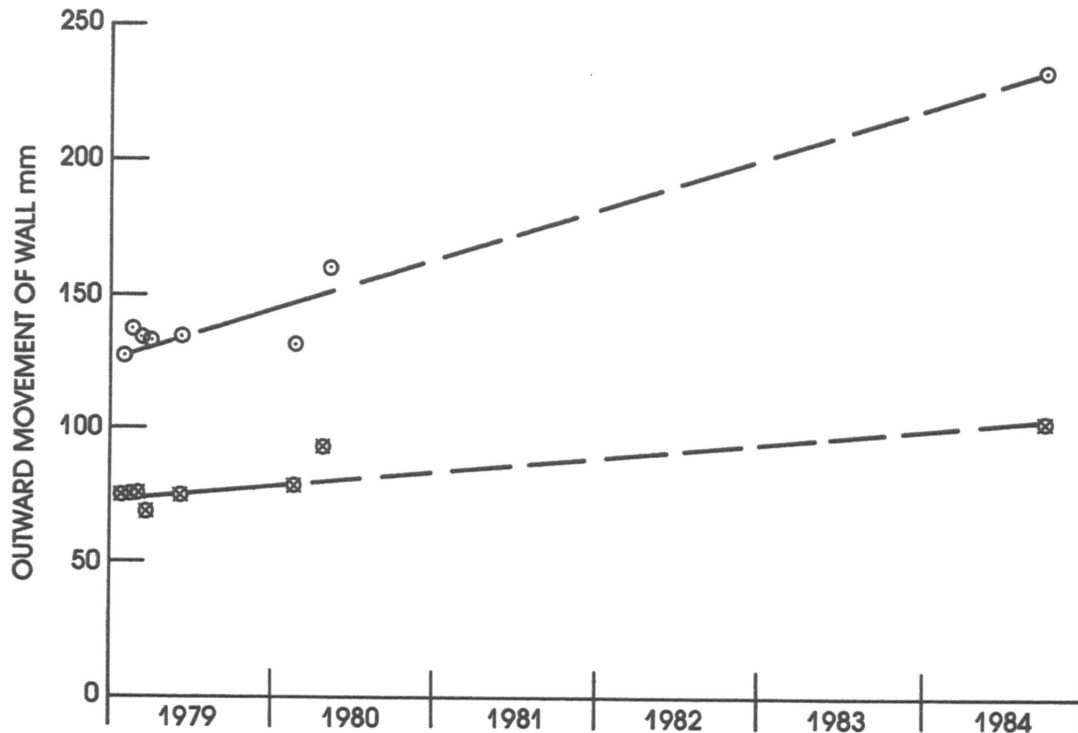
monitored over a period of five months. The observed movement was only 1mm and hence measurements were stopped. The observed movements of the north wall over the period 1979 to 1984 are illustrated in Figure 4. The 1984 measurements seem to show that the rate of movement of the wall had been almost constant with time.

Early in the life of the wall complex there had been concern because the facing of the north arm of the U had been found to be moving outwards. The movement of the wall was monitored for fifteen months, but when the rate of movement was seen to be moderate (between 10 and 20mm per year), measurements were stopped. At the same time, the wall that ultimately failed was

Figure 4: Observed movements of north wall at Grootgeluk Primary Crushing Plant.

The inclination of the strips may have resulted from setting the facing slabs too far ahead of the fill with the result that the unsupported reinforcing strips drooped down to rest on the fill surface. On the other hand, the observed progressive movements of the north wall were probably caused by a similar mechanism, involving collapse settlement, to the movement of the

Koningnaas wall. Because of the relatively low permeability of the fill, the process of progressive release of friction would have taken place slowly over the years as each seasonal wetting front progressed through the fill. The same process was probably taking place on the south wall, but was unobserved.

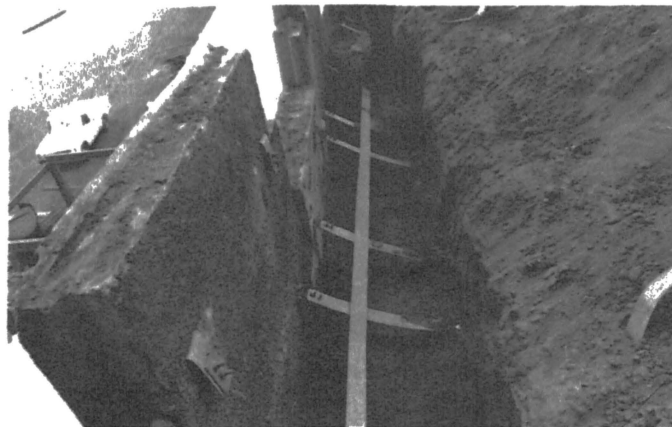
- (iv) Strips in the wall adjacent to the failed section were found to be inclined at steep angles to the horizontal. Inclinations as steep as 80° were found. It is surmised that a similar situation applied to the section of wall that failed. Figure 5 shows a row of inclined strips uncovered in the post-failure examination.

Figure 5: Inclined reinforcing strips uncovered during post-failure examination
