Geotechnical Investigation into Causes of Failure of a Gabion Retaining Wall

SYNOPSIS: This paper describes the post-failure analysis of a 26m long x 4m high gabion retaining wall located in a suburb of Johannesburg, South Africa. The wall had been built just beyond the toe of a natural slope with most of the gabion units resting on the bed of a small river. The river bed soils consisted of approximately 2.5m of soft, dark-grey, silty clay underlain by massive granite bedrock. The water table at the toe of the wall was within 0.1m of the river bed surface. Failure of the wall occurred over the weekend after backfilling to grade behind the wall had been completed.

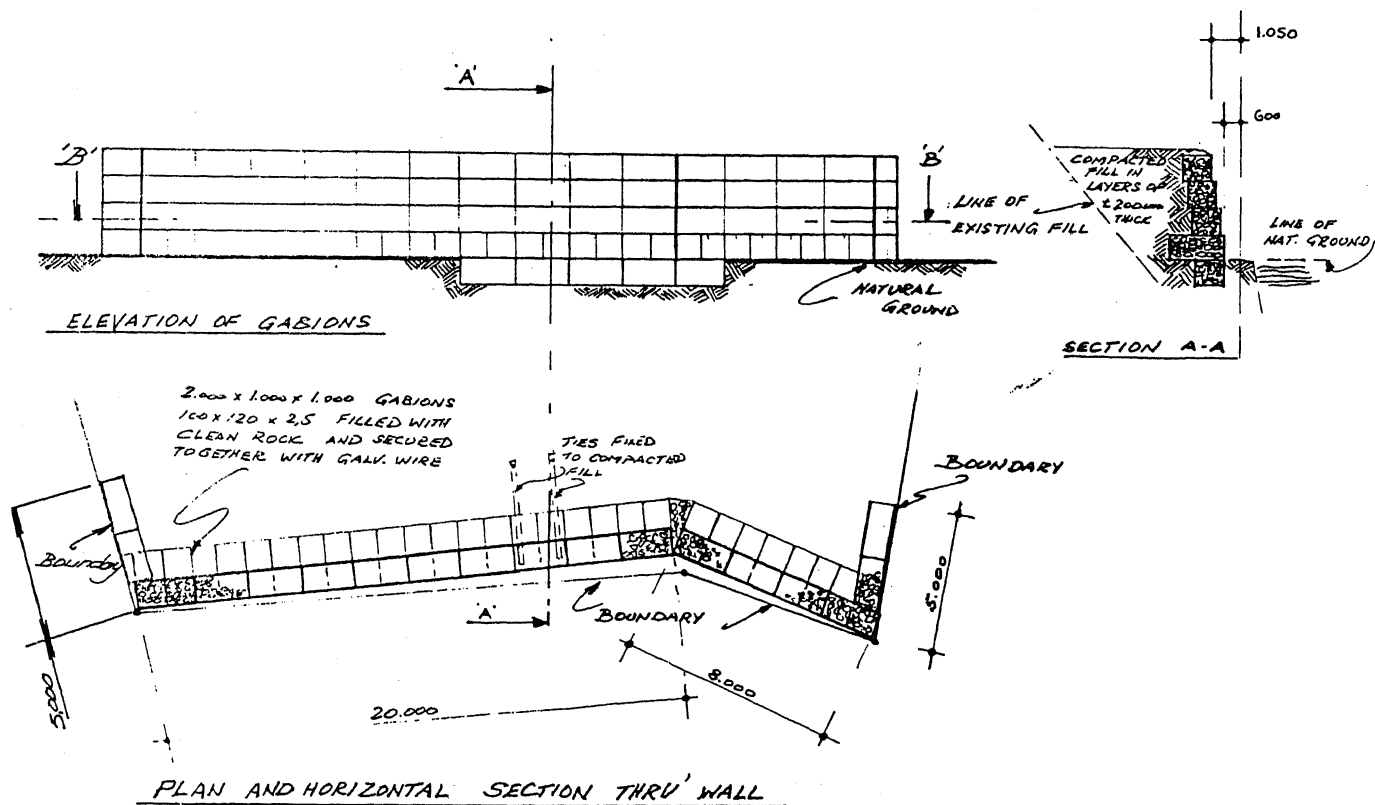
FIG. 1

The retaining wall itself consisted of 2m x 1m x 1m gabion cages containing angular rock fill. The front face of the wall was constructed of two rows of gabion units for a length of approximately 26m. The height of the wall along this length was 4m above the river bed. The north and south wing walls of the structure were 9m and 6.5m long, respectively. Figure 1 shows a sketch of the structure prepared by the contractor.

Sketch of Gabion Wall Showing Configuration and Dimensions

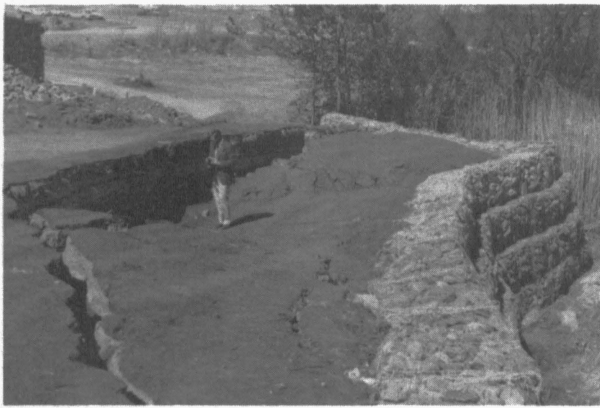
failure and to make recommendations for the redesign and/or repair of the wall. A preliminary field investigation revealed that a classic rotational type of failure had occurred along the central portion of the wall. A maximum downward displacement of approximately 1.4m was evident along the intersection of the semi-circular failure surface with the backfill surface. Bulging of the river bed at the toe of the wall was clearly visible. These characteristic features of the failure are shown in Figures 2a and 2b. Reconnaissance of the site revealed the presence of a concrete wall, approximately 3m in height, located just downstream of the retaining structure as shown in Figure 2c. This concrete wall acted as a dam before development in the area took place. Although it was breached at the time of the failure, the wall could back up water under flood conditions. The size of the spans between piers of the bridge located just upstream of the gabion wall, as shown in Figure 2d, suggested that flow in Klein Jukskei River could be substantial. The reconnaissance also revealed the presence of rock outcrops on the opposite river bank and to the north and south of the site. These outcrops formed a natural channel that directed the flow of the river toward the wall. The site conditions described above had a significant impact on the recommendations made by SRK.

- (a) surface displacement of backfill
- (b) bulge at toe
- (c) view downstream with concrete wall visible
- (d) view upstream with bridge span visible

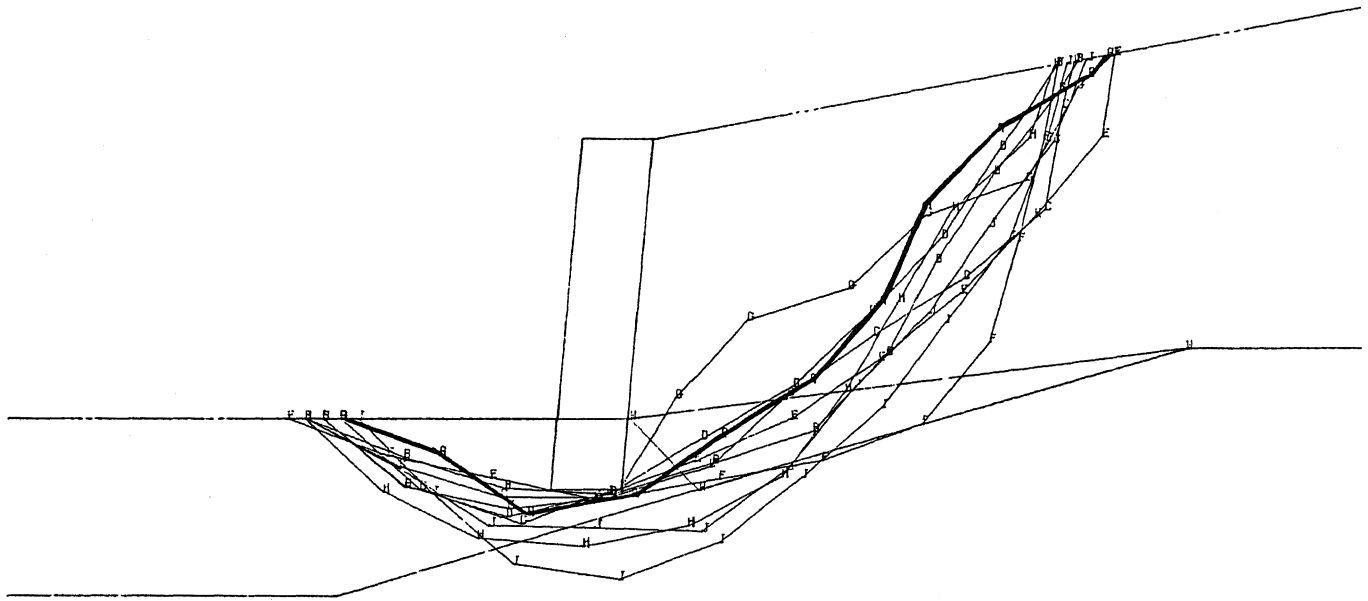
FIG. 3

Failure Surfaces for Short-Term Stability
 ($s_u = 12 \text{ kPa}$; FS = 1.0)

The results of the short-term stability analysis using $s_u = 12$ kPa are shown in Figure 3. The highlighted failure surface evident in the figure results in a factor of safety of 1.0. The analysis confirms that failure of the wall occurred because of overstressing of the underlying soft clays. As a matter of

interest, analyses were also performed for $s_u = 3$ kPa and 20 kPa. Factors of safety of 0.7 and 1.2 were obtained, respectively. This suggests that even with the maximum measured value of the undrained strength, the wall and backfill would be only marginally stable.

On the basis of these two threats to the future stability of the wall, SRK concluded that flood conditions at the site must be established before any remedial measures for the foundation stability of the gabion wall could be evaluated. They recommended that, in the absence of such information, the gabion wall should be removed.

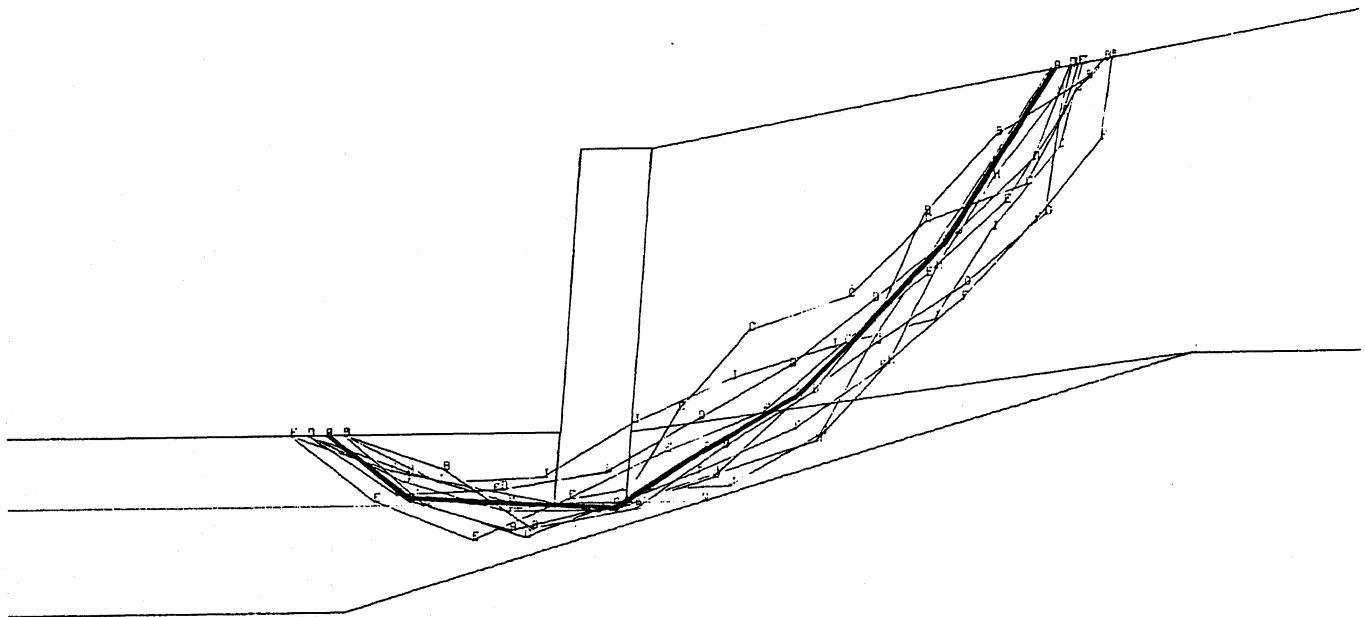
FIG. 4

Failure Surfaces for Long-Term Stability
 ($\bar{c} = 0$; $\bar{\phi} = 30^\circ$; FS=1.2)

Analyses were also performed using the effective stress parameters. The results of these analyses are shown in Figure 4. The factor of safety of 1.2 suggests that even if the clay were to drain under the loads existing at the time of failure, the long-term stability of the wall would still be questionable, especially if any of the conditions existing at the time of failure should change. Such changes could occur if, for example, the ground water table should rise, or erosion of the foundation materials should take place, or should additional loads be imposed on the backfill from normal activities of the site user.
