CASE HISTORIES OF FAILURE OF DEEP EXCAVATION EXAMINATION OF WHERE THINGS WENT WRONG: NICOLL HIGHWAY COLLAPSE, SINGAPORE

Professor John Endicott

Fellow, AECOM

During the construction of Contract C824 of the Circle Line in Singapore, on 20th April 2004 an 80 m long section of excavation, 30 m deep, totally collapsed. The resulting crater was as deep as 15 metres and was more than 100 m in diameter. Six lanes of the adjacent Nicoll Highway subsided by as much as 13 m. Four construction workers were killed. Fortunately no vehicle was involved.

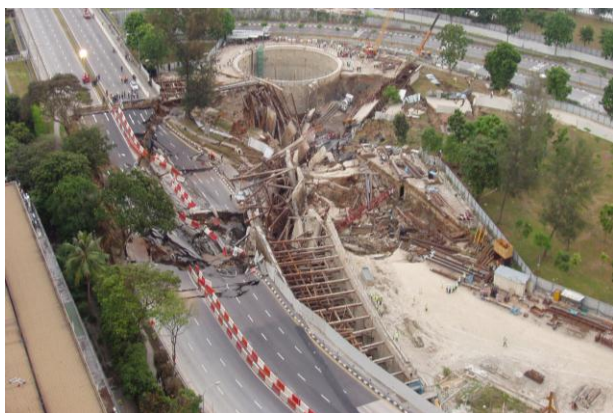
Plate 1. Photograph of the Collapse

Prior to the collapse, a cut and cover section of tunnels was under construction for the underground railway system of the Mass Rapid Transit System (MRT) on behalf of the Land Transportation Authority (LTA). The site was located within an open recreational area alongside the Nicoll Highway which is a dual three lane urban road, see Plate 1.

About 80 metres length of the diaphragm walls converged to meet each other. The steel struts were destroyed. Adjacent to the walls the subsidence was about 13 m and the visible settlement extended to a radius of about 50 m, see Plate 1.

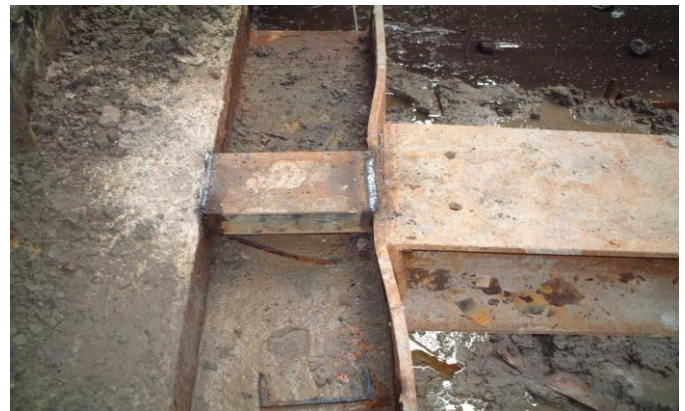
Plate 2. Photograph of Revised Stiffener

In February 2004, two months before the collapse, walers between struts and wall panels at a nearby location were found to have buckled. As a consequence the design of the connection between the struts and the walers was changed. Pieces of steel channel section were added to strengthen the connection, see Plate 2. Unfortunately the strengthening did not provide adequate capacity. Subsequent laboratory tests on perfectly constructed samples showed about half the capacity, see Figure 1. Moreover whereas steel normally strain hardens and has marginally increased capacity after initial yielding, the connection exhibited brittle failure with massive reduction in capacity after first yielding.

Neither the original design nor the revised design for the connection was properly carried out.

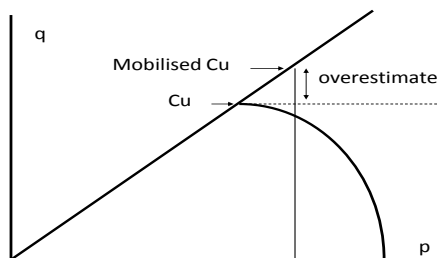
Fig. 2. Overestimate of strength when using Method A

The majority of the soil supported by the diaphragm wall was soft marine clay which would not drain significantly during the works. Therefore it was rightly assumed that the soft clay would be undrained. PLAXIS allows input of undrained shear strengths directly, Method B, or input of effective stress strength parameters c' and ϕ' , whereby the shear strength is calculated using the Mohr Coulomb model with an undrained setting, Method A. The undrained setting, with no change of volume of the soil, results in no change in the isotropic stress, p' , and an over-estimate in the strength of a normally consolidated clay. The manual recommended the use of Method A. The error is about 18% over-estimate of the strength of one-dimensionally consolidated clay Figure 2. The effect is an underestimate by only about 4% underestimate of the force applied to the wall for any one stage but for multi-stages the cumulative effect is greater and, for example, using Method A for this project the computed displacement of the wall is about half of the value obtained by using Method B. The bending moment in the wall is similarly under-estimated.

As a consequence of using Method A, the diaphragm walls were weaker than they should have been. However, during the day of the collapse, inclinometers showed that the walls only developed one plastic hinge and not two hinges that would be required for failure of the wall.

The lesson learned is to understand what the program does and which method to use. One should not follow the manual without making sure that the recommendation applies to the particular application.

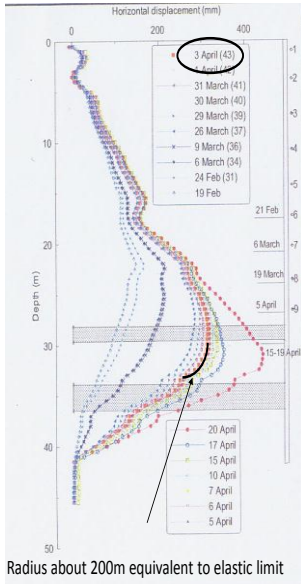
Fig.3. Inclinometer readings

Inclinometers located inside walls or in soil adjacent to wall panels are used to monitor displacements of the walls. From the inclinometer profiles one can determine the radius of curvature at any given time from which it is possible to determine the bending moment in the wall panel. Inclinometer results showed that a plastic hinge developed in the wall panel at the location of the failure some three weeks months before the collapse, see Figure 3. The Alarm Level for the displacement was exceeded and it was relaxed twice, without recognizing the distress of the wall panel at the time. On each occasion a back analysis was carried out which matched the maximum displacement but did not match the deflected radius of curvature. In the back analyses, the soil strengths were reduced to develop more pressure on the walls and induce more displacement. This also resulted in increasing the calculated forces in the struts which did not represent the observed reduced forces in the struts. A correct back analysis would have identified that there was a problem with the struts.

protecting the surrounding ground and adjacent property. Such limits do not relate to the performance of the wall in bending for which a limit on the radius of curvature would be appropriate.

Lesson learned is to understand the monitoring and to set appropriate the AAA limits for the capacity of the structural members as well as for protection of property.

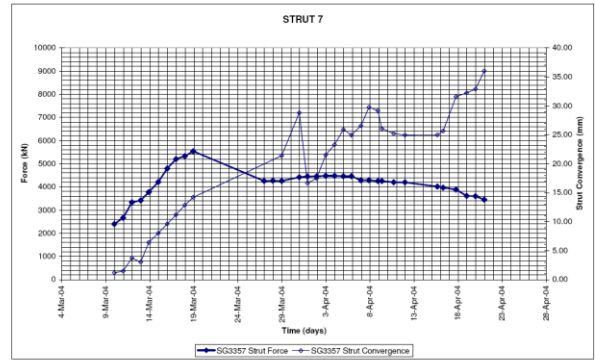
Fig.4. Force v Convergence for Strut at Level 7

More insight can be obtained from the inclinometer readings. The two inclinometers were located in wall panels on opposite side of the excavation and the sum of displacements for the two inclinometers is the convergence between the two wall panels. Under normal operations strutting should work within the elastic range and therefore the convergence between opposite wall panels and the forces on the intervening struts should be proportional to the stiffness of the strutting system. By comparing the two sets of data, for struts at level 7 as shown in Figure 4, although there is scatter in the convergence data, there is an overall trend of increasing convergence whereas the force in the strut does not change appreciably during late March 2004 and reduces during the three weeks in April 2004. Although the data is not precise, the trend is evident that the forces in the struts were not increasing as they should have done. The assumption in the back analyses that the strutting was behaving elastically was wrong and had the measured forces in struts been used as input data to the back analyses a proper back analysis of the wall could have been achieved.

Lesson learned is to conduct back analyses which properly match all of the relevant monitoring results and not just one result.

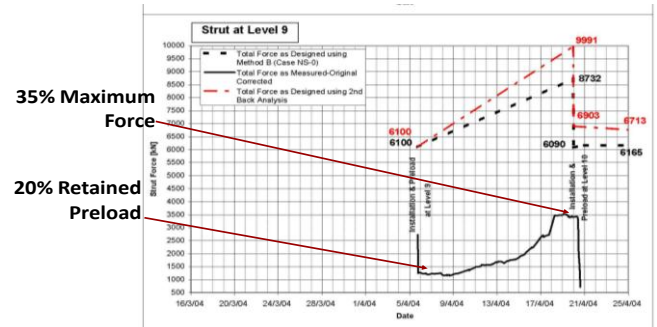
Fig.5. Force v Time for Strut at Level 9

The design required the struts to be pre-loaded to 75% of the design maximum force and locked off. Forces in struts were measured and reported automatically every hour. The record of forces in the strut at level 9 is shown in Figure 5. Within one hour after lock-off the load had dropped to only 20% of the required pre-load. A similar result was recorded for struts at level 7 some two months before the collapse and again at level 8. One month before the collapse.

The AAA limits were based on not over loading the struts. Because the AAA limits were set with a maximum force commencing at 50% of the design load no warning was issued. Just before the collapse the readings had not exceeded 35% of the design value. Moreover, it was not observed at the time that the force in the strut was only 35% of what it should have been and therefore the strut was not providing the support to

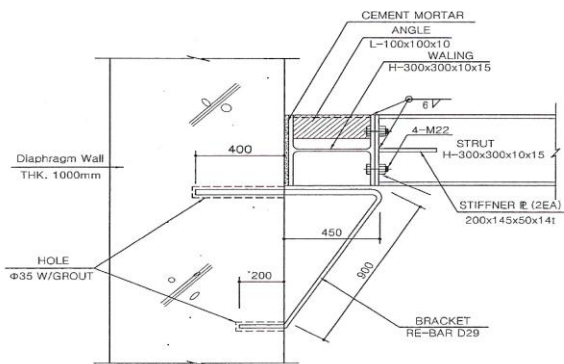
Fig.7. Connection Strut to Waler

In September 2007, only three years after the collapse of the Nicoll Highway, there was a collapse of a deep excavation in another city. The excavation had several similarities. It was 30 m deep in recent alluvial deposits with diaphragm walls, in this case terminating on rock just above and below the final excavation level. Ten levels of steel strutting, with king posts, with splays and steel walers were adopted in a similar arrangement. The connection between the struts and the walers were provided, with stiffeners made from steel angle section, see Figure 7. Channel sections were not used but the detail resulted in the same fundamental lack of shear stiffness. Conclusions about the cause of failure are incomplete because of lack of evidence.
