Nipigon River Landslide

SYNOPSIS A massive landslide occurred on the Nipigon River, north of the Town of Nipigon, Ontario, Canada in the early morning hours of April 23, 1990 and involved an estimated 300,000 cu m of soil. Although there was no loss of life, there were significant environmental and economic impacts.

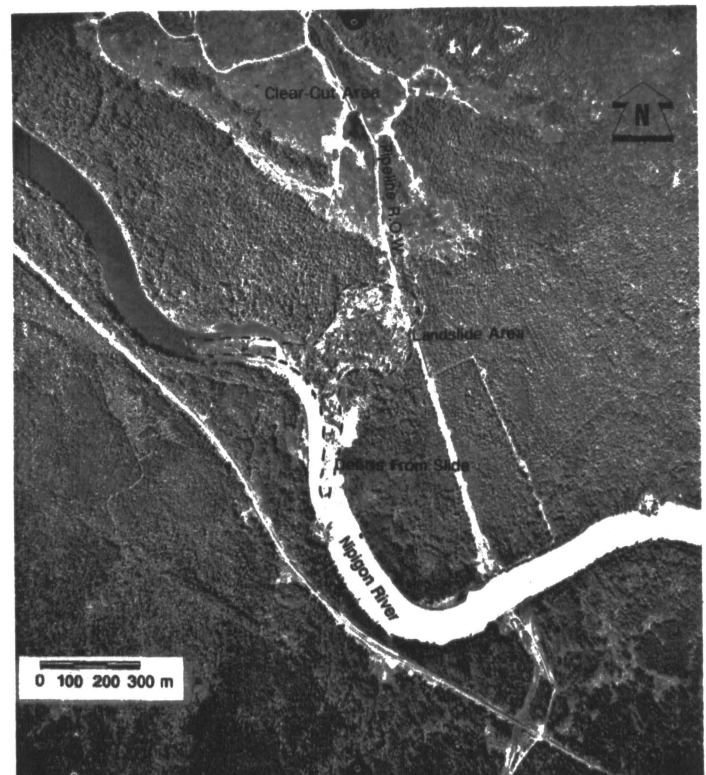
Figure 2 Aerial photograph of landslide.

Figure 2 is a reproduction of an aerial photograph taken shortly after the occurrence of the landslide and shows the Nipigon River and the areas where failures have occurred. Some of the slumps are most likely due to the deflected current from this landslide under study here. It can be seen, as a common factor, that the slides are located on the outside sections of the river meanders - where bank erosion is at its greatest.

Air photo analyses showed that this area of the river has experienced bank failures in the past - even prior to the construction of the upstream hydro dam in 1931. This section of land is very wet with poor surface drainage, possibly adding to the relative instability of the banks in this area.

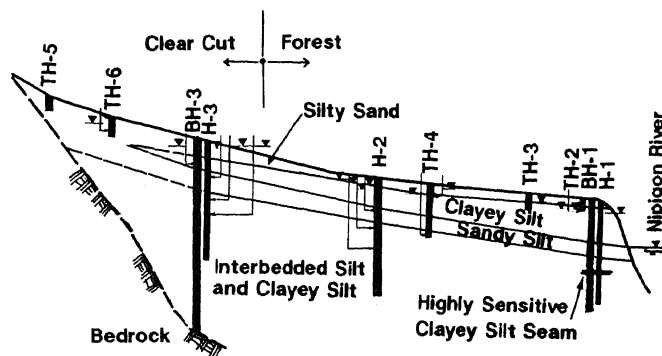
Figure 4 Stratigraphic Section

Generally, a silty SAND stratum is overlying a clayey SILT, beneath which there is another silty SAND/sandy SILT layer. Beneath the lower SILT/SAND, interbedded, very soft, SILT and more plastic CLAY/SILT layers are found. The subsurface conditions can be seen on the geological section shown on Figure 4 and the river bank section shown on Figure 5.

It should be noted that the clear-cut area uphill of the landslide is a shallow south and southwest facing bowl-shaped slope which absorbs sun radiation in the early spring. Surface water from snow melt and precipitation is collected in this area, readily recharging the groundwater in the lower lying slope portions. The surficial soils in the clear-cut slope area are fine sands, which taper out towards the rock outcrops further uphill and most likely connect with the two sand horizons further downhill (see geological section on Figure 4).

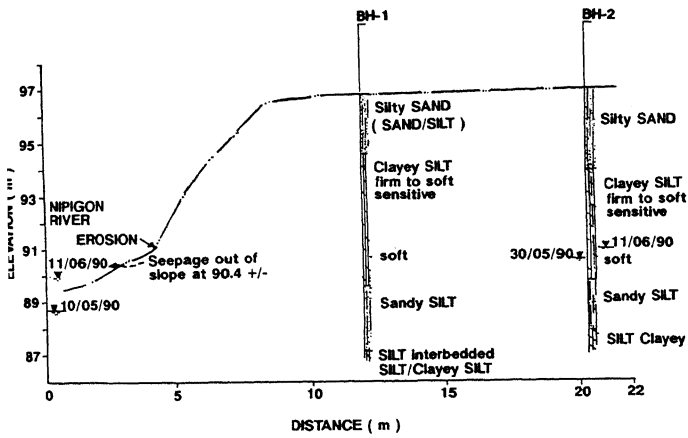
Figure 5 River Bank Configuration

A stability analysis was performed by Trow on the river bank configuration as drawn in Figure 5. The analysis was performed using the commercial program SLIDE, developed at the University of Toronto. This program is based on Bishop's Simplified Method of Slices with circular slip surfaces.

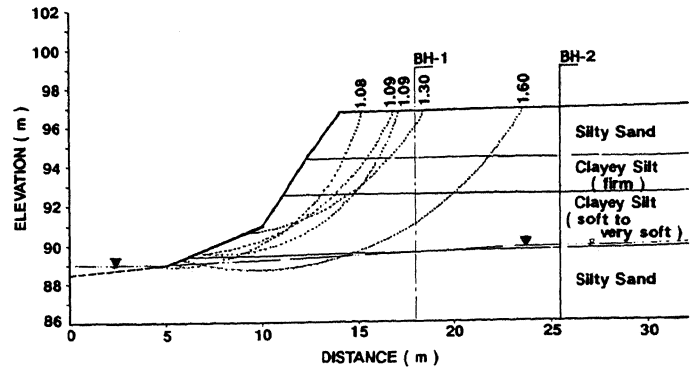
Figure 6 Slope stability analysis - Case 1

In Case No. 1 the conditions of the slope at the time of the soils investigation were investigated with a low river water level (prior to increase of flow) and the lowest measured groundwater elevations in the standpipe and piezometer. The results are shown on Figure 6.

Case No.	Groundwater	River Level	Minimum Factor of Safety
1	low	low	1.08
2	same as river	high	1.01
3	high	high	0.93
4	high	low	0.86

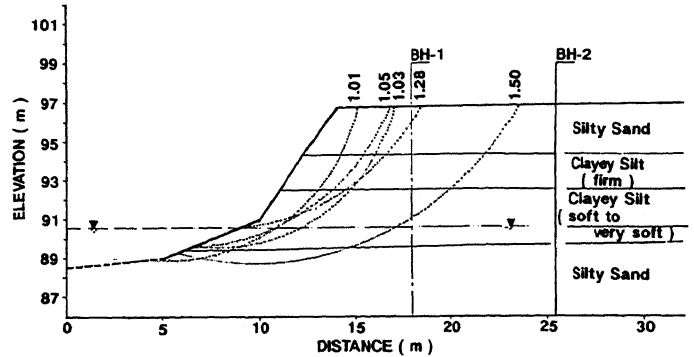
Figure 7 Slope stability analysis - Case 2

In Case No. 2 the condition of a high river level with the groundwater level at the same level as the river elevation was analyzed. The results are shown on Figure 7.

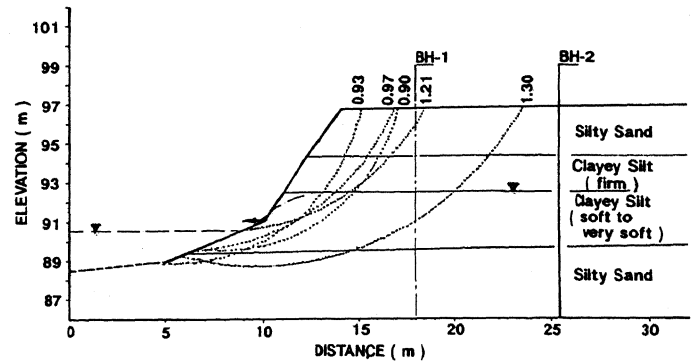
Figure 8 Slope stability analysis - Case 3

In Case No. 3 spring conditions were simulated with high river levels and a high groundwater level with seepage at the toe, as was observed during the field program. These results are shown on Figure 8.

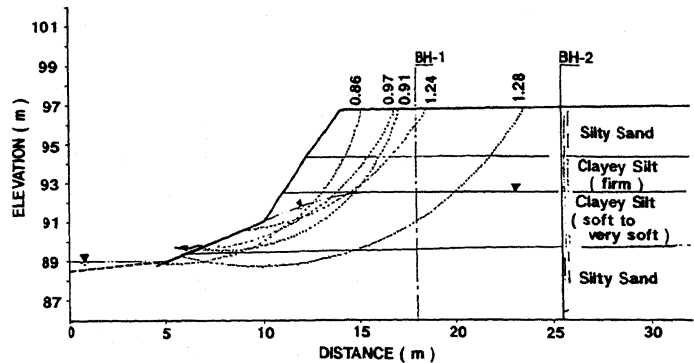
Figure 9 Slope stability analysis - Case 4

In Case No. 4 spring conditions were simulated with a high groundwater level, including seepage at the toe of the slope, and low river levels or minimum flows. This situation is similar to drawdown condition. The results for this case are shown on Figure 9.

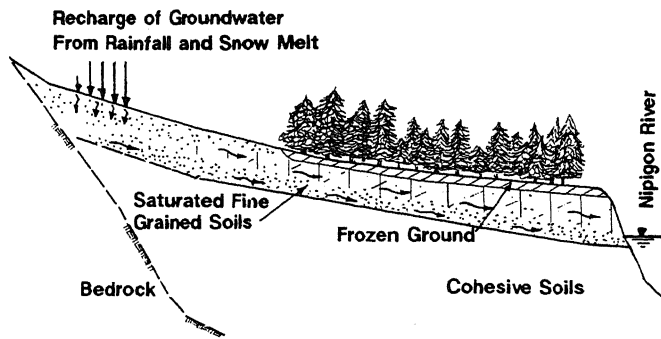
Figure 10 Model for soil saturation.

The higher than normal groundwater pressure existed at the time of the landslide due to warm weather and heavy rainfall immediately prior to the slide and the recent timber harvesting operations uphill of the slide area. During a site visit on April 24, 1990, the day after the slide occurred, it was apparent that the frost was out of the ground in the cut-over area with water ponding on the surface, whereas in the tree covered areas and in the landslide zone, the ground was still frozen. Thus, in the cut-over areas, surface water could penetrate into the ground, recharging the groundwater in the soils of the failure area, which were still capped and confined by the overlying frozen ground. Similarly, some recharging could also have taken place in the cleared pipeline right-of-way. Figure 10 illustrates these points.

The qualitative observations in April 1990 were confirmed by ground temperature measurements on May 12, 1992 at various locations within the forested area and within the clear-cut area uphill from the landslide. While the ground surface within the forested area was at, or below, 0°C down to a depth of about 0.5 to 1.0 metres, the ground within the clear-cut area was completely thawed, ranging between +10°C near the ground surface to a low of +3°C at 1.0 m depth.

- 1) Tree harvesting uphill from the river within the glaciolacustrine deposits should not take place unless an engineering study is undertaken to develop strategies that would ensure that tree cutting would not contribute to increased groundwater recharge into these deposits.

- 3) Areas in which surface water was ponding along the pipeline right-of-way should be identified and drainage should be provided as needed.
