Performance of an Earthdam and Cut-off Through Deep Alluvium

SYNOPSIS: The main dam at the Bighorn development consists of a zoned earthfill embankment with a concrete cut-off wall constructed through the river alluvium by the slurry trench technique. Upon first filling of the reservoir in 1972, erratic drops in piezometric heads in the alluvium upstream of the cut-off and significant downstream leakage prompted the construction of a weight berm at the downstream toe and implementation of a program of regular monitoring of all piezometers and seepage measuring facilities. Concern for the integrity of the structure was not allayed until completion of a dam safety evaluation in 1984. The paper summarizes the design and construction aspects of the main dam and concrete cut-off, documents the results of monitoring records of seepage and piezometric heads since reservoir filling and assesses the extent of reservoir siltation. Records and inspections demonstrate satisfactory performance of the structure.

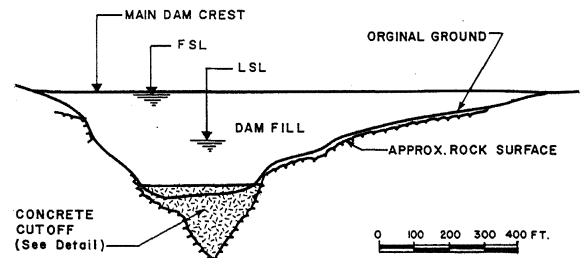
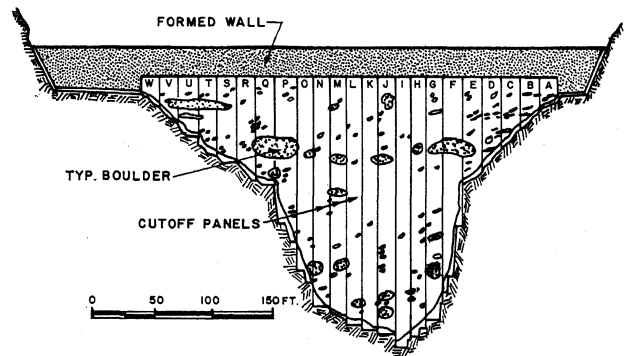
Fig. 4 Concrete cut-off construction

During the initial placement of core fill against the wall, a flow of water emerged on the riverbed downstream at the juncture of panels R and Q (Figure 4). The flow, originating as seepage through the upstream cofferdam, was attributed to an imperfect interface between the panels or possibly a window in the vicinity of the large boulder overlying bedrock in that area. The joint was thoroughly grouted from holes extending to the boulder. The grouting was apparently successful, because later it proved necessary to provide temporary drainage for water ponding at the same location on the upstream side of the wall.

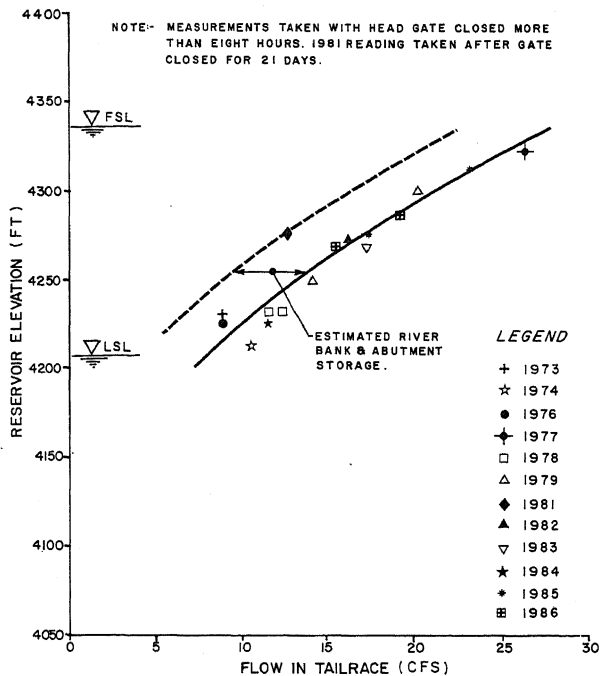
Fig. 6 Variation in seepage with reservoir level

Seepage - As indicated by flow measurements from Weir 1, located between the downstream toe of the dam and the tailrace (Figure 1), the variation of seepage flows with reservoir elevation since first filling of the reservoir is reasonably consistent indicating no major increase in seepage with time. However, since a significant portion of the total dam and foundation seepage is flowing through the river bed alluvium under the weir, it is possible that reasonably large variations in total seepage may occur before a change in Weir 1 flows is observed. Maximum seepage flows as determined from stream gauge measurements taken in the river channel downstream of the powerhouse when the tunnel headgate is closed have reached 28 cfs (Figure 6) whereas the peak flows recorded at Weir 1 have been about 3.5 cfs. The flow values for different reservoir levels given on Figure 6 represent stream gauge readings taken at least 8 hr after headgate closure to minimize the effect of riverbed and abutment storage outflow at lower river levels. However, outflow from riverbed and abutment storage is a significant component of the measured flows as indicated by the 1981 reading taken 21 days after gate closure.

Since the stream gauging station is approximately 0.5 mi downstream of the powerhouse, it was recognized that the measured seepage flows at this location included not only seepage through the dam and foundation but also headgate leakage as well as seepage through the abutments. To increase confidence in the measured values an estimate of seepage through the cut-off wall, i.e. through construction joints, cracks, etc., was made utilizing measured piezometric levels in the alluvium downstream of the wall, permeability values from pump tests and, since the bedrock channel below the riverbed narrows in the tailrace to about 1/2 the width of that at the cut-off, an average area of flow equal to 75% of the cut-off wall area below the river bed. The calculated seepage flow through the wall was thus estimated to be between 8 cfs and 13 cfs when the reservoir is at full supply level (FSL). To this was added leakage past the headgate, estimated at 7 cfs based on depth of water in the tunnel and the velocity of a floating wood chip observed during a tunnel inspection in 1984. An assessment of abutment leakage was more difficult to perform in view of the conflicting evidence available. The steep faces of the canyon walls downstream of the dam are visibly jointed and faulted but exhibit insignificant seepage above the

river bed. Leakage from the diversion tunnel outlet in the north abutment rarely exceeds 0.5 cfs and piezometric heads within the left abutment rock remain well below FSL and are not significantly affected by changing reservoir levels. However, water losses were reported in a number of abutment drill holes and one hole required about 29 ft³ of grout, bran, plaster of paris, calcium chloride and bentonite to seal the hole over a 100 ft interval. Allowing for random jointing, the total seepage through both abutments could be 2 to 3 times the quantity determined for intact strata and may be in the order of 6 cfs. Likewise an estimate of the leakage through bedrock below the cut-off contact was difficult to assess but, based on insitu pump tests, should be no greater than 1 cfs. It was concluded that the total calculated seepage from all sources when the generating units are not operating, the headgates are closed and the reservoir is at FSL was within the range of 18 to 27 cfs, which is comparable to measured flows in the tailrace after deducting the riverbed and abutment storage component.

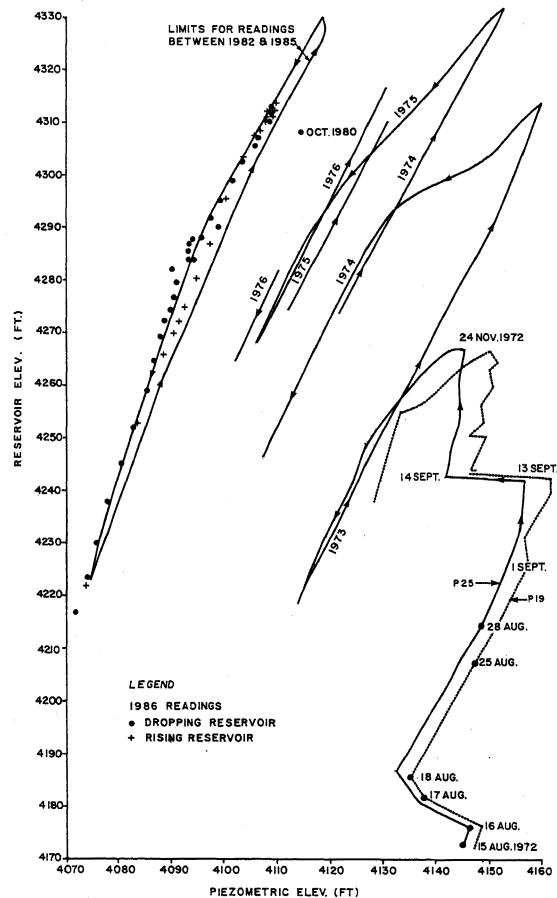
Fig. 8 Piezometric heads in P19 and P25

Over the years the piezometric levels in the alluvium immediately upstream of the cut-off gradually decreased until about 1982 when steady-state conditions were reached (Figure 8). Readings from piezometer P19,

located about 30 ft upstream of the cut-off near the top of the river sediments about 100 ft south of P25, showed an almost identical variation in piezometric elevation as P25 until it became unserviceable in 1976. The records of these piezometers in the first few years of reservoir operation appear to confirm an abrupt and not insignificant reduction in the effectiveness of the concrete cut-off, resulting from either leaky construction joints in the panel wall, inadequate sealing of the wall at the bedrock contact or other imperfections in the concrete of unknown character.

Since about 1982, however, P25 readings have varied monotonously with reservoir level. This phenomenon is considered to be the result of either stabilized seepage conditions in the alluvium adjacent to wall apertures, or an increase in reservoir sedimentation or a combination of both effects. Records from piezometers P45, P46, P47 and P48, 100 ft farther upstream, are not particularly useful in explaining the current steady-state conditions across the wall. P46 readings indicate an hydraulic connection exists between this piezometer and P25, whereas piezometric levels in P45, P47 and P48 have remained relatively constant over the years (Figure 9). The linear relationship between P25 and P46 is not surprising as these piezometers appear from preconstruction river valley contours to lie in the main river channel. P45, P47 and P48, on the other hand, are located in the flood plain on either side of the main channel where less pervious sediments could be expected as a result of lensing and beaching effects.

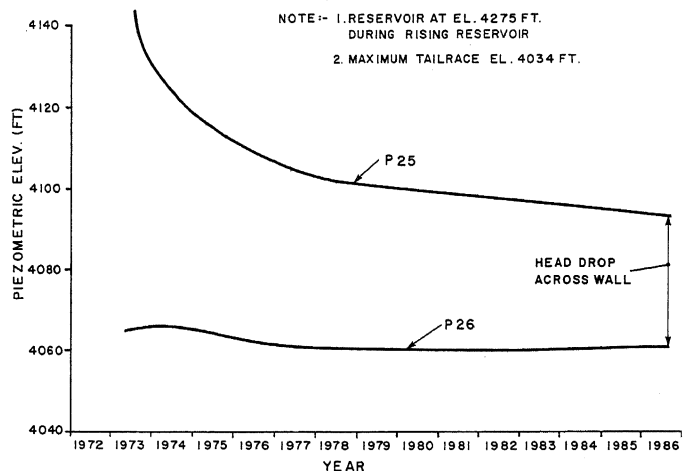
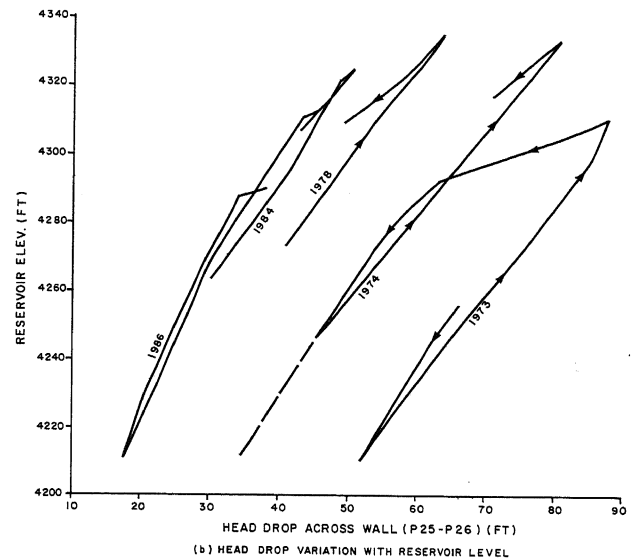
Fig. 10 Head drop across the cut-off

An indication of the performance of the cut-off wall is illustrated on Figure 10. Except for erratic variations during the first few months following reservoir filling, the head drop across the wall has declined at a decreasing rate over the years until the early 1980's when conditions more or less stabilized (Figure 10a), varying only with reservoir elevation (Figure 10b). Downstream of the cut-off wall, the piezometric profile through the bottom of the chimney drain and underlying alluvium (Figure 11) indicates that hydrostatic conditions with heads 25 to 30 ft. higher than the tailrace level have prevailed in the alluvium since 1973. However, pneumatic piezometer G32, located in the chimney drain, denotes pressures in excess of hydrostatic suggesting the native sands and gravels are more pervious and acting as an

underdrain. Piezometers downstream of P26 exhibit an average gradient over a distance of approximately 1300 feet between the cut-off and the tailrace channel of about 0.02, a value which has decreased only marginally since reservoir filling.

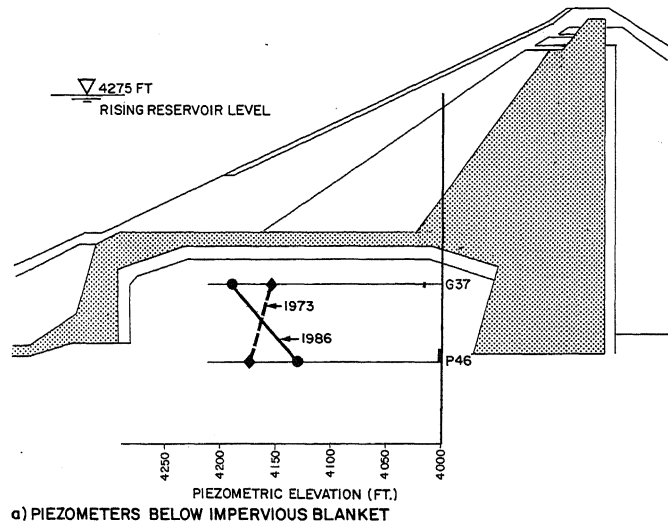
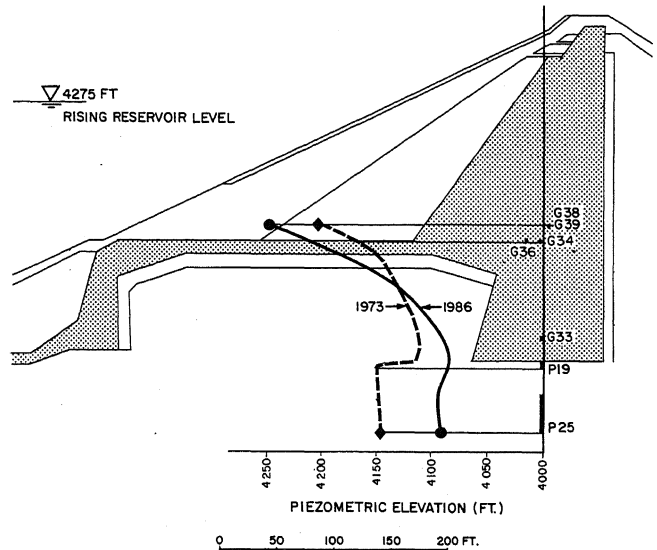
Fig. 12 Piezometric profile in embankment upstream of cut-off

During initial reservoir filling, the impervious core of the main dam was not fully saturated and water from the pervious upstream shell and the foundation gradually seeped into the core as well as the common fill below the impervious blanket establishing a steady-state phreatic surface. Subsequent pressure reductions in the river gravel has allowed the foundation alluvium to act as an underdrain for the blanket and the impervious core (Figure 12). The hysteresis effects exhibited by pneumatic piezometer G37 also indicate the common fill under the upstream blanket is relatively impervious and the blanket is working satisfactorily (Figure 13).
