A Geological Appraisal of Slope Instability and Proposed Remedial Measures at Kaliasaur Slide on National Highway, Garhwal Himalaya

G.S. Mehrotra
Central Building Research Institute, Roorkee, India

R.K. Bhandari
Central Building Research Institute, Roorkee, India

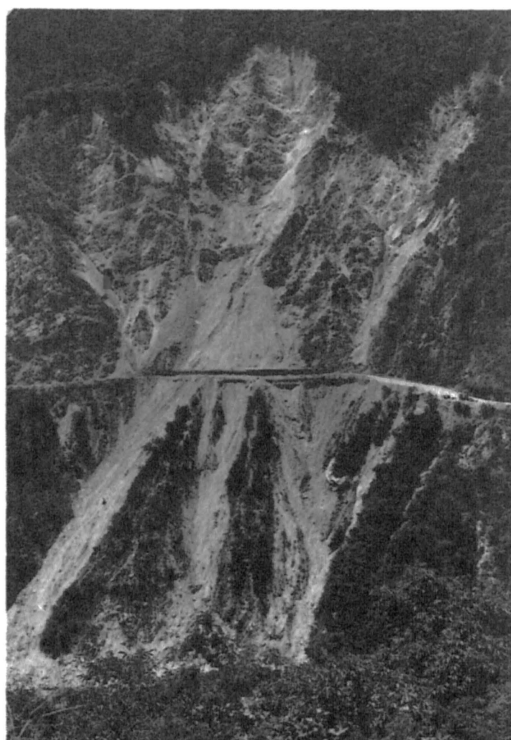
FIG.1 - KALIASAUR LANDSLIDE ON HARDWAR-BADRINATH ROAD

The Kaliasaur landslide located at km 147 in the Garhwal Himalaya has been a major problem to the communication and safety of road users for over six decades (Fig.1).

The slope forming material consists of weathered, loose, crushed and pulverised rockmass mainly of quartzites and shales. The slide is constantly on the move particularly during the monsoon season (June-September) when the debris flow and rock fall are quite severe. These mass-movements are caused mainly by heavy precipitation and consequent development of hydrostatic pressure build up in the colluvium in highly fractured and jointed rock mass. In addition, extensive toe erosion by meandering Alaknanda river also cause progressive failure of the overlying materials (Fig. 2).

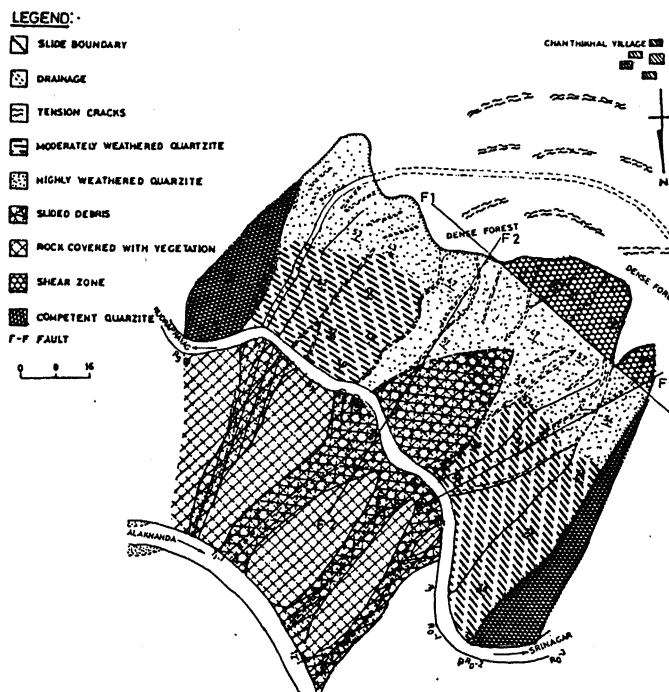
FIG. 3 - GEOLOGICAL MAP OF KALIASAUR LANDSLIDE ON HARDWAR-BADRINATH ROAD

Observations along the road and along the river suggest the presence of two types of quartzites. One is of light green colour with thin beds of maroon shales, and the other is massive and well jointed yellowish white quartzite. On the western side of the slide zone the quartzite are light green with shale bands having a general southward dip with amounts ranging from 25° to 60° . These quartzites end up abruptly along a scree zone beyond which massive yellowish quartzites dipping southeast with amounts 30° to 40° , are exposed. It appears that the scree zone conceals a fault zone trending NE-SW and extending across the river. The massive quartzites continue upto the western flank of the slide zone where they end up against the slide debris. On the eastern side of the slide zone the quartzites exposed have maroon shales with a south eastern dip and amounts varying from 30° to 60° . These quartzites continue along the river bed. It appears that another fault zone trending NW-SE may be present somewhere within the slide zone.

The rocks appear to have been folded into a plunging overturned anticline on the western side of the slide zone with a plunge towards north-east. Another anticline appears to be on the eastern side of the slide zone with plunge towards south. There appears to be a number of fault zones in this area. A major fault appears to be along roughly East-West trend. This fault zone passes through the crest of the slide zone and separate the metabasics from the quartzites. Two other faults with trends roughly NE-SW exist in this area. They all appear to be high angled and one of these passes through the main slide zone. All these faults merge into Chhantikhal fault.

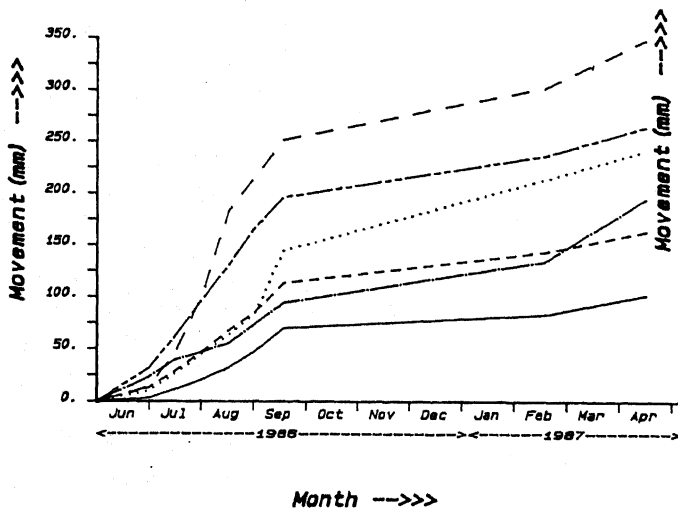
FIG. 5 - LATERAL MOVEMENT OF PEDESTALS BY TAPE EXTENSOMETER

Monitoring of surface movements were started before the onset of the monsoon in 1986. During rainy season fortnightly observations were taken. About 1000 observations have been taken so far. Some of the typical time displacement observations are shown in Fig. 5. The analysis of the data clearly indicated two directional movements - north eastern and north western - in the eastern and western sides of the slide zone (Fig. 6). The extent of the lateral movement of pedestals towards the eastern side varied from 0 - 117.8 cm whereas the pedestals on western side showed movement 0 - 76.1 cms indicating thereby that the eastern part of the slide area is more unstable.

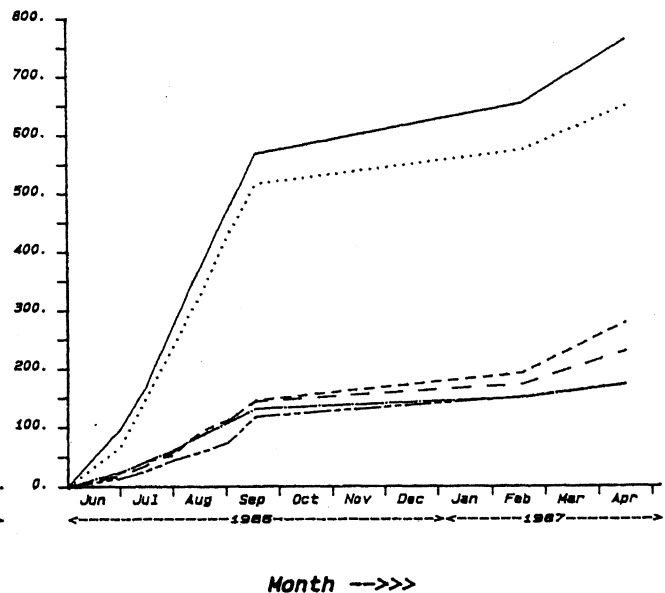
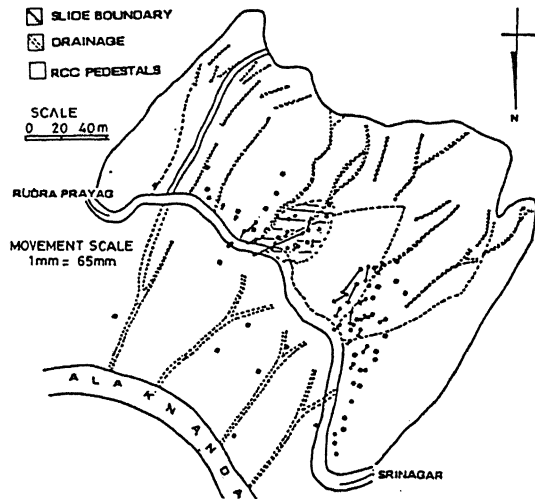
FIG. 6 - SURFACE MOVEMENT PATTERN OF KALIASAUR LAND SLIDE

The study has thus clearly indicated that the eastern side of the slide area is a zone of intensive landslide movements involving both deep seated and surface movements. In the central and western sides of the slide area, the movement is conferred predominantly to surface debris.

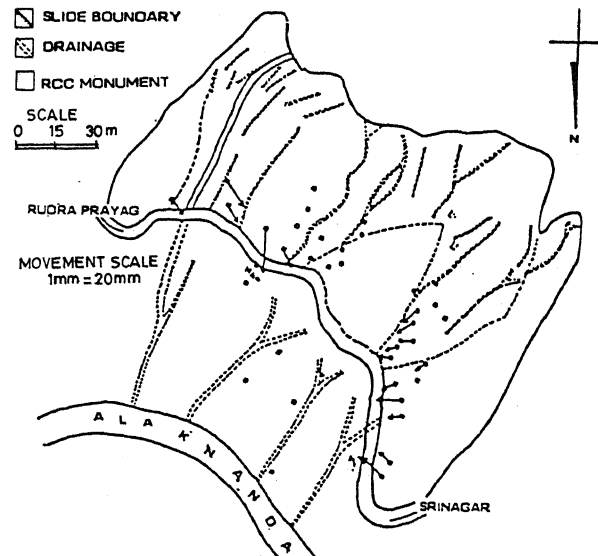
FIG. 7 - CRUSTAL MOVEMENT PATTERN OF KALIASAUR LAND SLIDE

The crustal movement studies pertaining to movement of the underlying slope material were carried out with the help of Electronic Distance Meter (EDM). The observations were taken before monsoon, during rainy season and thereafter till April 1987. The analysis of the data have shown significant lateral movement towards north east direction ranging from 0-22.5cm. The lateral movement towards north-west direction varied

from 0-17.6 cm.(Fig. 7). The results further indicated movement in vertical direction ranging from 0-6.9 cm.

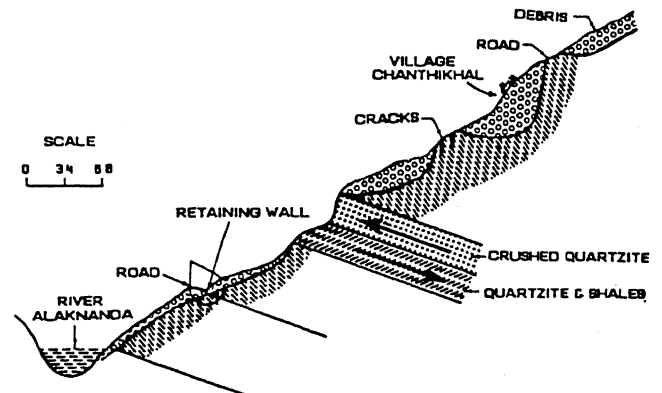
FIG. 8 - CROSS SECTION OF KALIASAUR LANDSLIDE

Kaliasaur landslide is essentially a multi-tier, retrogressive landslide in a complex rock formation with clear evidences of fault planes revealing intense tectonic activity in the geological past. Evidences of sliding at the interface of quartzites and maroon shales must presumably have been the starting point. Road construction activity in general and repeated back cutting required for restoring the road width, year after year, poor drainage, recurring debris slides in the colluvium cover on the slope robbing it of the vegetative cover and river action at the slope toe have all been responsible to develop the landslide to it's formidable size obtaining today. A typical slide cross-section is shown in Fig. 8.

1. Grading of the slope uphill of the road.
2. All tension cracks and fissures in the rocks to be sealed.
3. Timber piling for stitching of the slope.
4. Construction of anchored drum diaphragm retaining wall along the road to control the slide mass overlooking the road.
5. Construction of anchored stone masonry wall towards other side of road to check the under cutting of road due to palaeo channels.

6. Vegetating the slope.

7. A toe wall in masonry at the junction of the slope down hill of the road with the river. This wall is to be designed to withstand the scour of the river.
