04 May 2013, 10:30 am - 11:30 am

Ground Deformations Observed After 23.10.2011 M_w 7.2 VAN Earthquake (Turkey)

GROUND DEFORMATIONS OBSERVED AFTER 23.10.2011 M_w 7.2 VAN EARTHQUAKE (TURKEY)

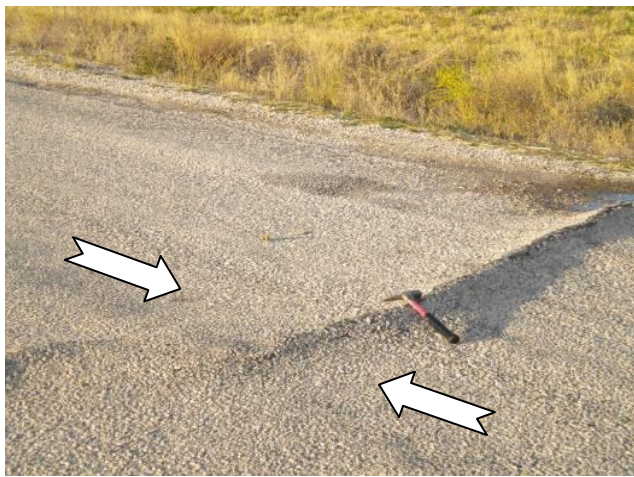
The causative fault that ruptured during the M_w 7.2 Van earthquake is located about 10 km to the north of the city center (Figure 2). No significant surface rupture was observed during the field studies carried out by the authors or other investigators just after the earthquake. However, small scale traces of compressional deformations up to 5-10 cm were measured at several locations along the fault line especially in brittle structures (Figure 3). The signs of compressional deformations point out a thrust fault with the upper plate thrusting southward. The city center of Van is placed on the footwall side of the thrust fault whilst heavily damaged Ercis district is on the hanging wall side. The fault ruptured during the Van earthquake is classified as a blind fault since no obvious sign of surface rupture presents (Alan et al., 2011, Ozkaymak et al., 2011). A fault is identified as a blind fault when the rupture does not reach all the way up to the ground surface and so no clear evidence of fault rupture can be observed (Groshong, 1999; Gates and Ritchie, 2007).

Fig. 3. Trace of compressional deformation on secondary asphalt road

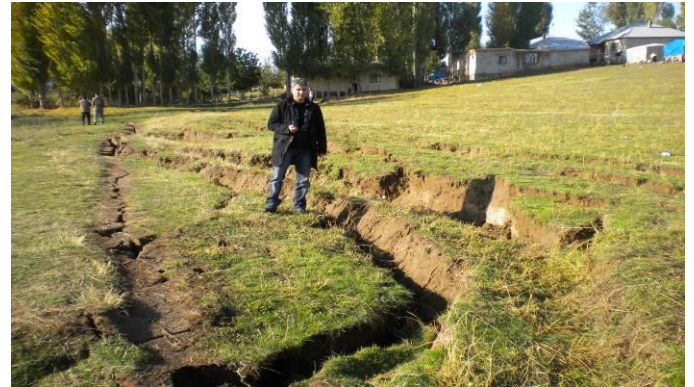
Earthquake-induced ground deformations were extensive in many regions around the eastern and northeastern shores of the Lake Van after the M_w 7.2 Van earthquake. Fortunately, no serious ground deformation-related building damages and collapses were officially reported around the earthquake affected zone except small scale damages in one-story masonry buildings and infrastructural transition lines. Liquefaction and lateral spreading were apparent at many locations, particularly in the floodplains of rivers and streams as well as in the recent deposits nearby the Lake Van. Celebibagi and Kasimbagi villages in Ercis district and the Karasu River floodplain severely suffered from ground deformations associated with liquefaction and lateral spreading. Numerous sand boils and lateral spread cracks with varying dimensions were observed around these settlements and along the embankments of the Karasu River (Figure 4). Furthermore, a large scale seismically-induced landslide near Citoren village was initiated after the earthquake blocking the Karasu river bed (Figure 5). No liquefaction or lateral spread-related features occurred in older deposits than recent alluvium during the Van earthquake.

Fig. 4. Lateral spreading cracks in Celebibagi village (Ercis) affecting one-story masonry buildings at the background

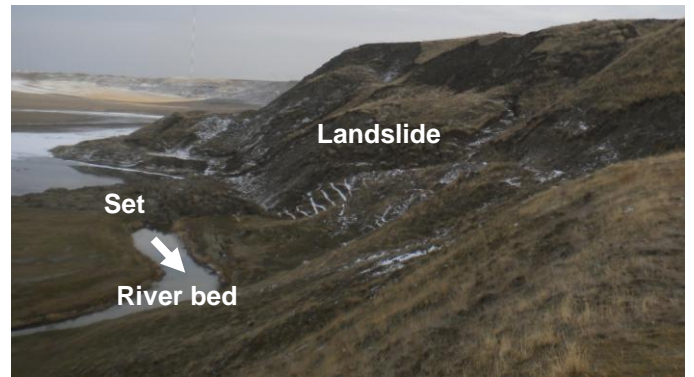
Fig. 5. Seismically-induced landslide near Citoren blocking the Karasu river bed

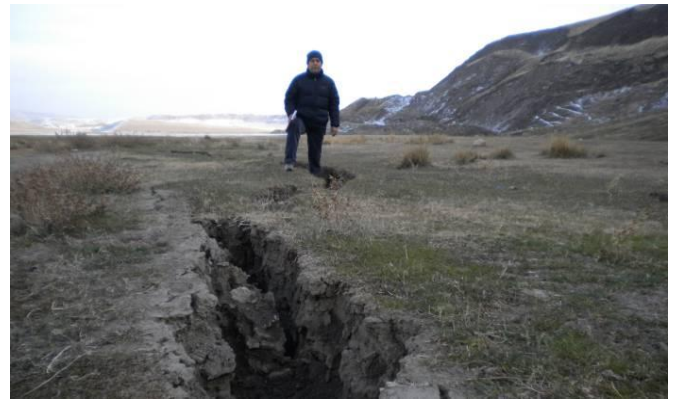
In addition to liquefaction, lateral spreading were also extensive in the same region. In several locations, lateral spreading was accompanied by sand boils. According to the field observations, lateral spreading cracks were parallel to the river bed. The general trend of lateral spreading in the research area was N50W. A maximum of 50 cm separation was measured for one crack whereas a total separation of 70 cm on two parallel ground cracks was noted. The lateral spreading crack reached as deep as 65 cm at several locations (Figure 7). Shallower (<20 cm) ground cracks were also noticed. Lateral spreading was quite persistent (generally >10 m) and a maximum of 30 m persistence was measured in the investigated floodplain.

Fig. 7. Lateral spreading cracks observed after the M_w 7.2 Van earthquake in the Karasu River floodplain

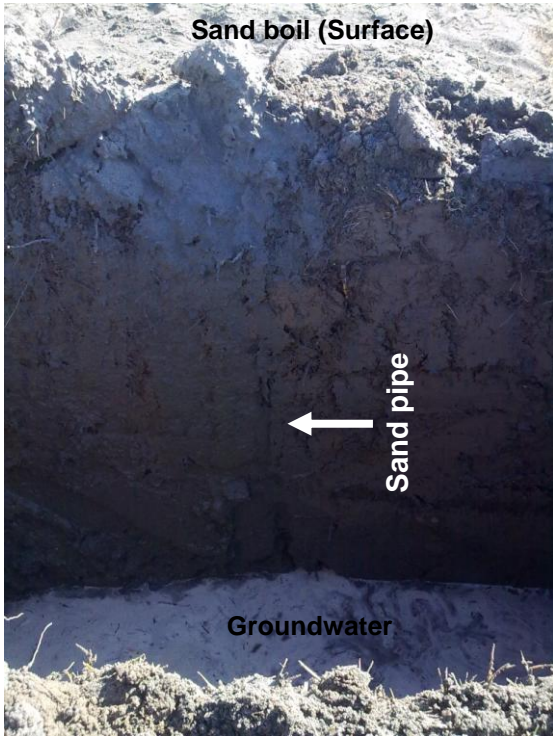
Fig. 8. Cross-sectional view of trial pit excavated on a sand boil

The thickness of clayey cap soil in the investigated area is around 2 meters considering the trial pit data. Although the groundwater level is about 2 m in Figure 8 and was deeper when the pit was first excavated, all pits were filled with water in a short time span and finally the groundwater table (GWT) rose to 40 cm below the surface. Below plastic cap soil, non-plastic, fine-grained loose sandy material which was possibly transported to the surface during liquefaction exists.

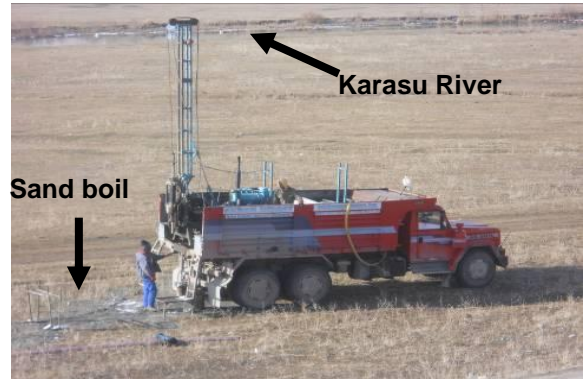
In order to observe the soil profile in the liquefaction zone and to determine the geotechnical properties of the liquefied and non-liquefied layers, a 20 m deep borehole (LBH-1) was drilled next to the boundary of a sand boil after the earthquake (Figure 9). The groundwater depth was 40 cm when drilling was performed in December, 2011. Instead of 1.5 m intervals, standard penetration tests (SPT) were performed at every 1 meter depth in LBH-1 to obtain a continuous soil profile as much as possible. The soil profile of LBH-1 and the SPT blow

Fig. 9. Drilling on sand boil at Karasu River floodplain after the M_w 7.2 Van earthquake

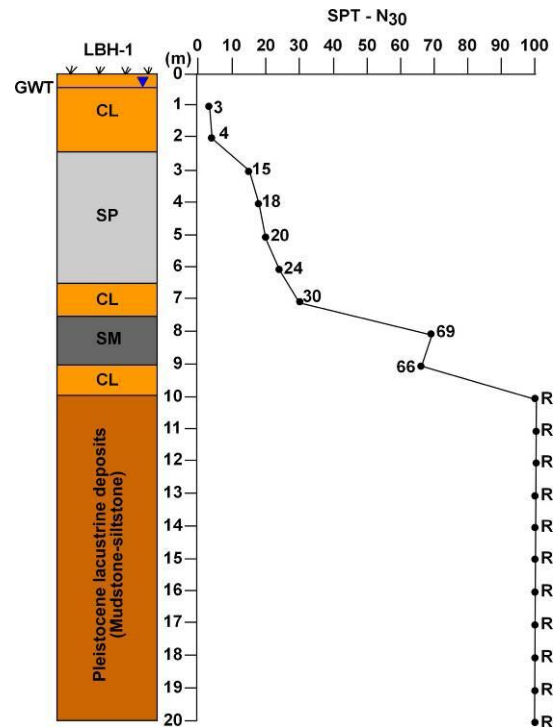
The plastic cap soil (CL) at LBH-1 is around 2.5 m thick as seen in Figure 10. The thickness of poorly graded sand (SP), which is supposed to be the liquefied layer in this location, is almost 4 m. After 6.5 m, thin alternations of low plastic clay (CL) and non-plastic silty sand (SM) exist. Late Pleistocene lacustrine deposits are encountered at 10 m, and are composed of mudstone and siltstone layers. A gradual increase in SPT blow counts is obvious in the LBH-1. SPT N_{30} values vary between 15 and 24 in the liquefiable zone. Refusal (R) values were obtained after 10 m in lacustrine deposits.

Fig. 10. Soil profile and N_{30} values of the LBH-1 drilled on a sand boil (R: Refusal value)

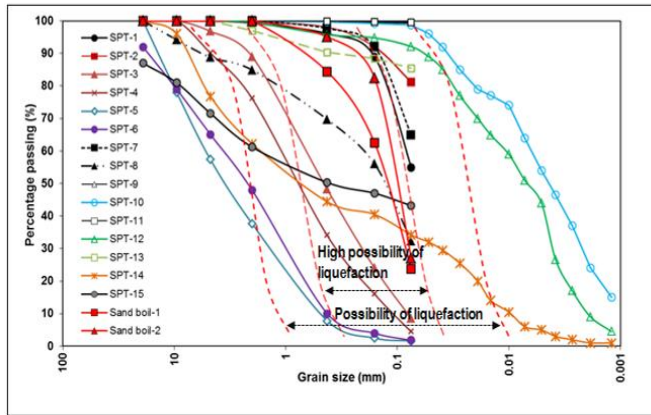
The grain size distributions of the disturbed samples as well as sand boil samples from the surface at the LBH-1 were determined by wet-sieve analyses in the laboratory (Figure 11). The sieve analyses of sand boil samples indicate that the liquefied soil is silty sand (SM). Moreover, the SPT samples of 3 and 4 m (poorly graded sand) exhibit high possibility of liquefaction. The fine content values of the soil layers between 3 and 6 m in the LBH-1 vary between 1.6% and 8.5%. The distribution of the fine content with depth in LBH-1 is depicted in Figure 12. All grain size distributions and SPT blow counts point out that the liquefaction probably occurred in a zone between 2.5 and 6.5 m in the investigated area.

Fig. 11. Grain size distributions of the disturbed (subsurface) at the LBH-1 and the sand boil (surface) samples

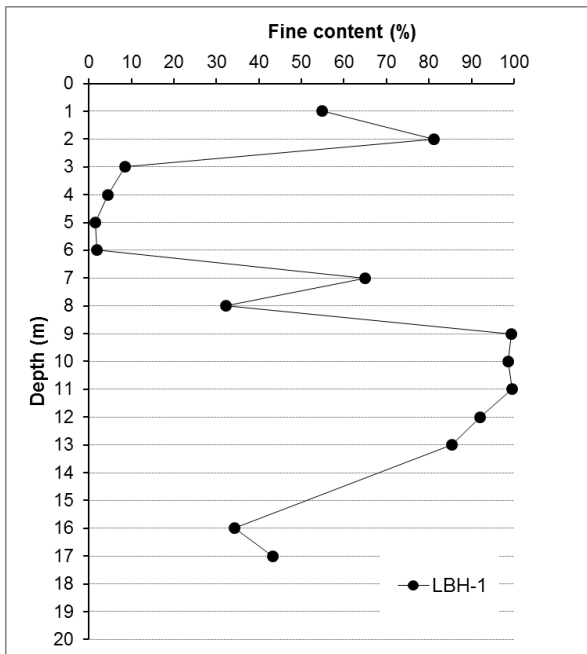
Fig. 12. Distribution of the fine content of the soil samples with depth in LBH-1

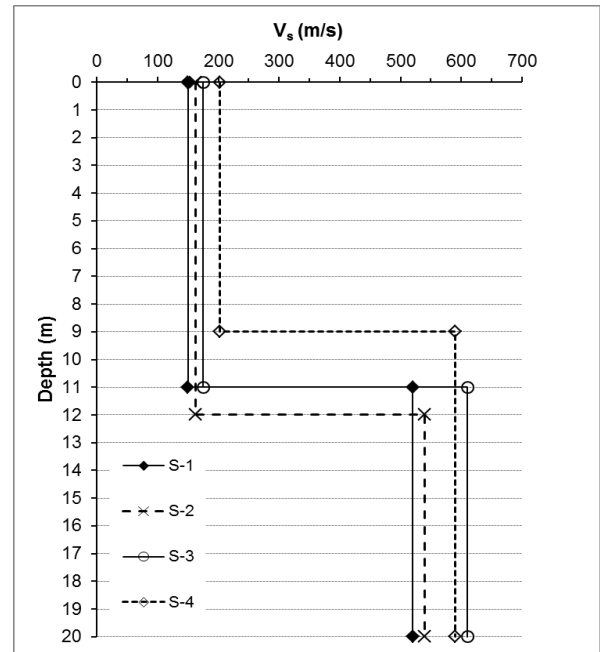
Seismic refraction surveys were carried out at four locations in order to determine the shear wave (V_s) velocity of the subsurface layers in the Karasu River floodplain where the sand boils extensively occurred. WZG-12 type engineering seismograph designed for shallow refraction survey was employed in the seismic studies. Seismic source for testing was gained by a hammer. Two subsurface layers were differentiated in accordance with the seismic investigations. The depth of the unit boundary varies between 9 and 12 m at different seismic survey points (Figure 13).

Fig. 13. Shear wave velocity (V_s) of the subsurface layers in the Karasu River floodplain

As seen in Figure 13, the shear wave velocity of the loose alluvium ranges between 150 and 202 m/s, and the velocity rapidly increases as high as 610 m/s in the lacustrine deposits. As a particular note, the lowest V_p (520 m/s) and V_s (150 m/s) velocities were measured on the sand boil where liquefaction occurred (S-1). In other words, the borehole LBH-1 and the seismic survey point S-1 are on the same sand boil.
