International Conference on Case Histories in Geotechnical Engineering (1984) - First International Conference on Case Histories in Geotechnical Engineering

# Geotechnical Problems and Performance Studies - Chilla Power Scheme, Hardwar

**SYNOPSIS** Thin plastic clay seams existing in the upper Shivalik formations caused hazardous geotechnical problems during the construction of 144 MW capacity Chilla Power House Scheme, Hardwar, India by initiating several land slides. In addition, serious seepage problems occurred with the commissioning of the scheme. The paper describes in detail, the events of slides & seepage problems faced and the remedial measures adopted to counteract them. The data observed on the instruments installed to keep a vigil on the performance of the structure has also been analysed and discussed.

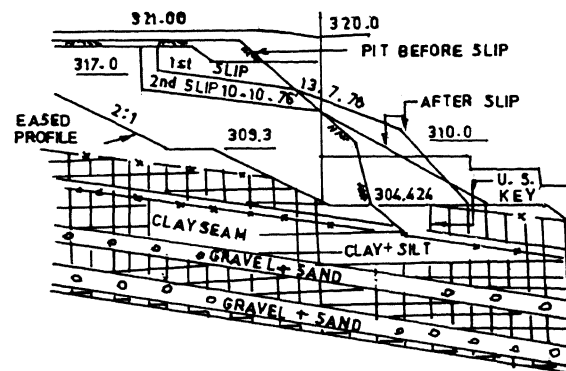
Fig. 2: Orientation of Seams & Slips at Intake

strata comprises characteristic clay shale interspersed with pervious bands of coarse sand, gravel and pebble dipping at an angle of 10-15° towards the power house. The saturated gravelly bands are erratically deposited in the area. Unit 1 and 2 are founded on clay bands whereas unit 3 and 4 are on sandy gravels. Layers of thin plastic clay seams daylighted (CCC-1977) at El. 304.0 and 300.5 m. on the penstock slopes and at El. 300.4 m. in the power house pit during their excavation. The orientation of these seams are shown in Fig.2

along the slopes, a second slip occurred (C 1977) on 10.10.76 which enlarged the zone of previous slip on the upstream side. The slid mass moved towards the downstream side by about 2 m. in a period of about one week. I was then decided to regrade the overall slope to 2:1 with benches at El. 309.3 and 304.4 so as to minimise the earth pressure on the upstream side (Fig. 2). The easing of earth slope was started from the top and proceeded downwards.

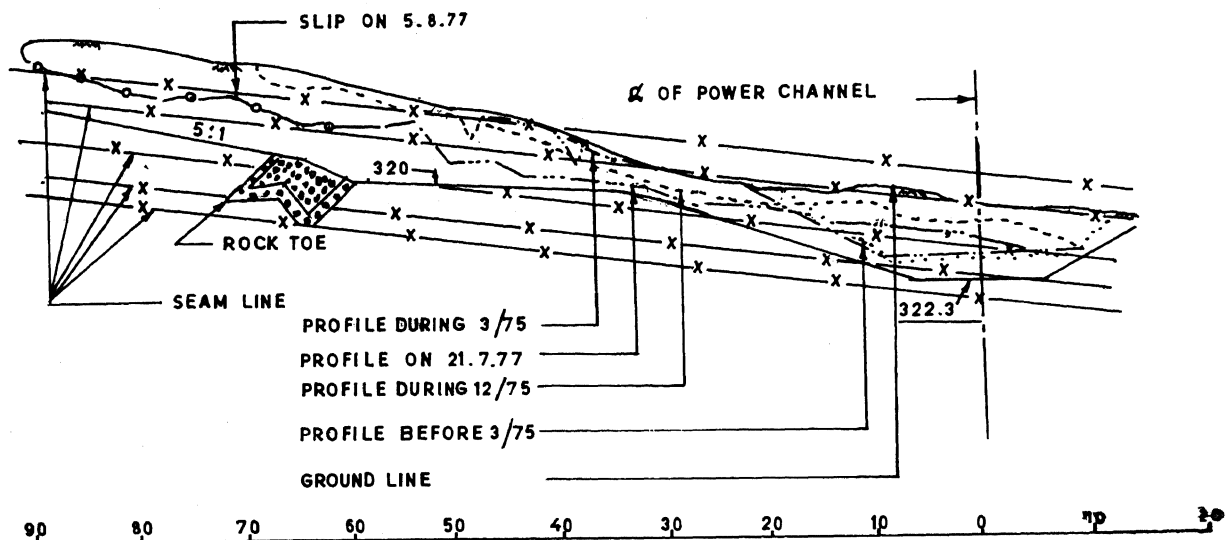
Fig.3 : Disposition of Seams & slips at power channel

on the right, left and central line of the power channel indicated that the strata comprised erratically deposited layers of clay mixed with silt interspersed with layers of boulders, sand etc. These sequences varied with depth and chainage. Like power house site, layers of thin plastic clay seams daylighted at various elevations along the channel and were found dipping from left of power channel towards right in slopes varying from 6:1 to 10:1 (CCC-1978). Later during excavations of the right bank, inverted subsidiary seams were also found to exist on right bank of the channel. These seams were dipping from right towards left at a fairly steep angle of  $45^\circ$ . The disposition of the seams is shown in Fig.3.

ing Feb. 1975, some water was observed oozi out from left cut slope at El. 324.0 followed by a major slide in March, 1975 (CCC-1976). The manifestation of the slips were in the form of the upheaval of the excavated channel bed by about a meter between km. 11.287 and 11.383 with subsidence accompanied by extensive cracking of the ground 50 m. away on the left side of the centre line of the power channel. Later the side slopes were regraded to a slope of 2:1 so that the slope may be stabilized. The work was started from top El. 352.0 m. downwards with a 2.0 m. wide berms at every 5.0 m. depth. The excavation reached to El. 322.0 m. by 21.7.77; but during rains the slip again occurred on the slope with subsidence and crack extending upto the bed of channel. In April 1978 when excavations (CCC-1978) of the right bank near the inner toe between km. 11.30 to 11.375 was in progress, some lateral movement accompanied by upheaval took place in the bed of the channel on the right side. This resulted into development of cracks and ultimate failure of the right bank. These cracks later increased in width and depth from km. 11.300 to 11.400 and the centre line pillar in the bed near km. 11.325 heaved up and mo

by about 1.6m. towards left on right bank. This failure was contrary to any anticipation and were attributed to the presence of thin inverted subsidiary seams running from right to left on right bank located subsequently. The profiles of slips in different dates are shown in Fig. 3.

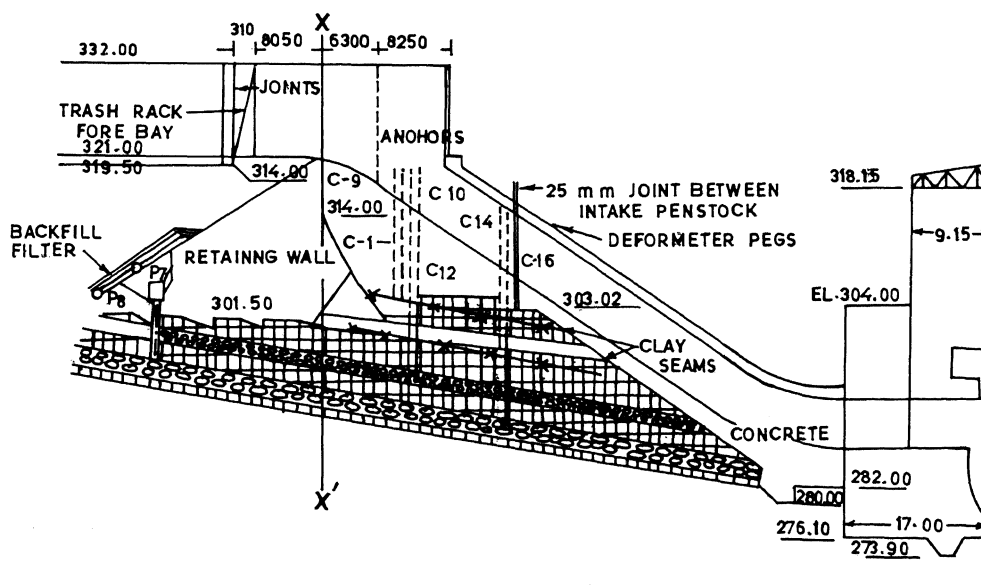
Fig.4: Location of Instruments at Chilla Power House.

between intake and penstock slopes for finding out the movement, if any, of the penstocks were installed. Observation pipes were installed in the seepage affected area along the power channel to obtain the residual pressures. The location of instruments installed at power house site is shown in Fig. 4.

Six hydraulic earth pressure cells were installed on the back of retaining wall (Fig.4). The maximum earth pressure values as indicated by

Four pairs of deformer pins, one in each unit were installed across the joint between intake block and the penstock (Fig.4). The distance between the pins were measured regularly by a mechanical deformer and are plotted in Fig.6

(ii) The material upstream of intake block up to second clay seam was excavated and a RCC retaining wall constructed to avoid transfer of stresses of the backfill to the intake structure and to hold it back by means of steel anchors against sliding along clay seams (Fig.4).

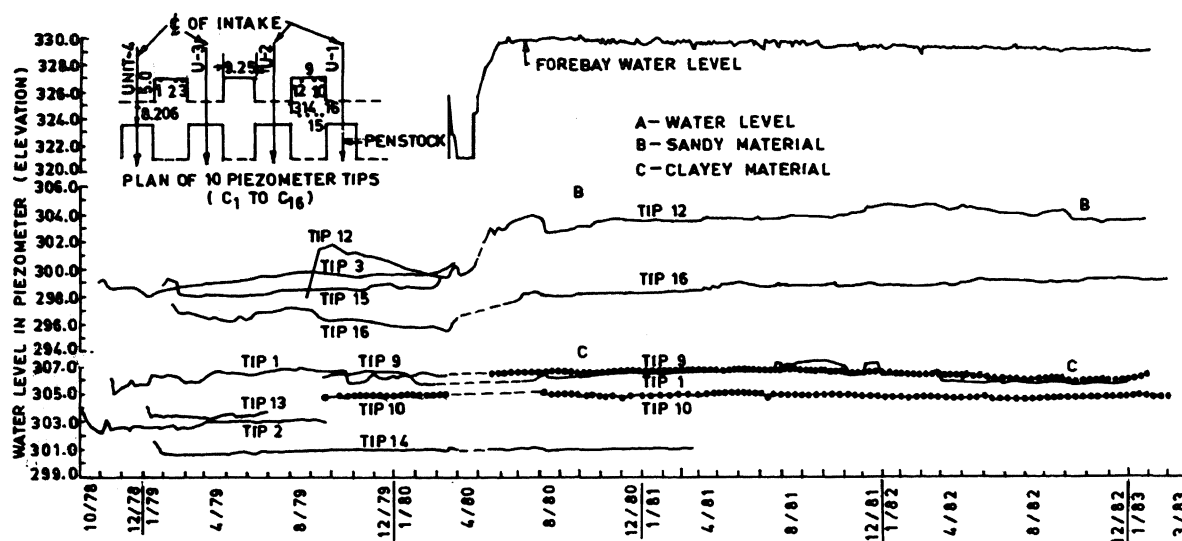
Fig.5: Pore Pressure Observations

Four embankment type USBR piezometers were installed at points where clay seams were daylighting in different units of penstock slopes during its construction in 1977. The observations carried out on these piezometers indicated that maximum residual pore pressures varied between 0.34 to 1.03 m. which subsequently reduced to negligible amount thereby confirming the design assumption of zero pore pressure at the exit point of the seams. Thirteen Casagrande piezometers (Arora et al-1981) were installed in nonflow section between units 1,2 and 3,4 on penstock slopes with few tips resting in gravelly band, some in clay seam and some in clay band. Regular observations recorded are plotted in Fig. 5 for selected tips and the maximum pore pressure values are tabulated in Table II. The observations indicate that (i) in the initial stages, the pore pressure were slightly erratic but after attaining maximum values they decreased. After filling of the channel, pore pressure in tips resting in clayey strata remained almost unaffected, possibly due to low permeability of the strata but pore pressure in tips resting in gravelly bands increased. (ii) the values of pore pressure coefficient 'ru' computed from the maximum pore pressures recorded before and after filling of channel (Table II) varied from 0.25 to 0.30 for clay seam material and from 0.14 to 0.24 for sandy gravelly material which were almost the same as obtained

lier (IRI-1978). After running of the channel, the pore pressure ratio  $r_u$  did not change substantially in clayey strata but increased for

sandy strata (iii) The observed pore pressures were invariably less than the design values (Table II) both during construction and after filling of the channel.

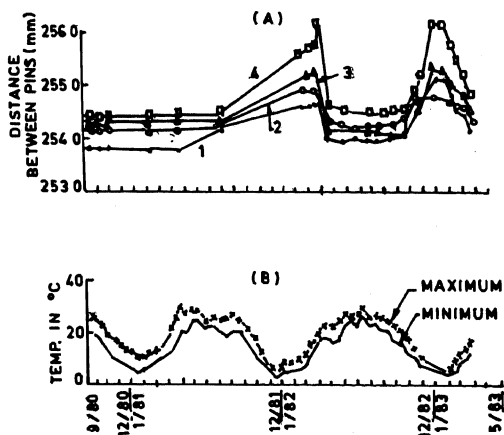
Fig.6 : Deformometer Observations

A perusal of Fig.6 indicates that after July, 1981 the distance between the pins in all units has increased regularly upto Feb. 1982 after which it decreased regularly upto June '82 to March 1983. Possible reasons for such abnormal variation were looked into and it was found that this variation is due to variation in temperature at site. From July to Feb., due to decrease in temperature, the contraction of concrete of intake and penstock blocks have taken place thereby widening the joint whereas in summers, the expansion of concrete has resulted into narrowing the gap and hence decreasing the distance between the pegs. The maximum increase in distance between the pegs was found to be 1.752 mm in unit 4 in Nov.1982 here-as in 1983, the maximum increase was .7636 in the same unit and occurred in the month of November. No conclusions regarding movement of intake or penstock blocks could, therefore, be drawn from these observations.
