Failure of a Dredged Slope in a Sensitive Clay

SYNOPSIS During construction of a new wharf facility in Portland, Maine, an underwater slope failed during dredging and subsequent driving of piles through the slope. The construction and failure of the slope are described. The major factors which contributed to the failure were: 1) high sensitivity of the silty clay, 2) placement of riprap on the crest of the slope to 4 to 6 ft above the design elevation, 3) method of dredging which caused high shear stresses and probable disturbed zones near the toe of the slope, 4) dredging slope steeper than design slope, 5) pile driving causing localized disturbed zones with low strength around the piles, and 6) sequence of dredging and pile driving.

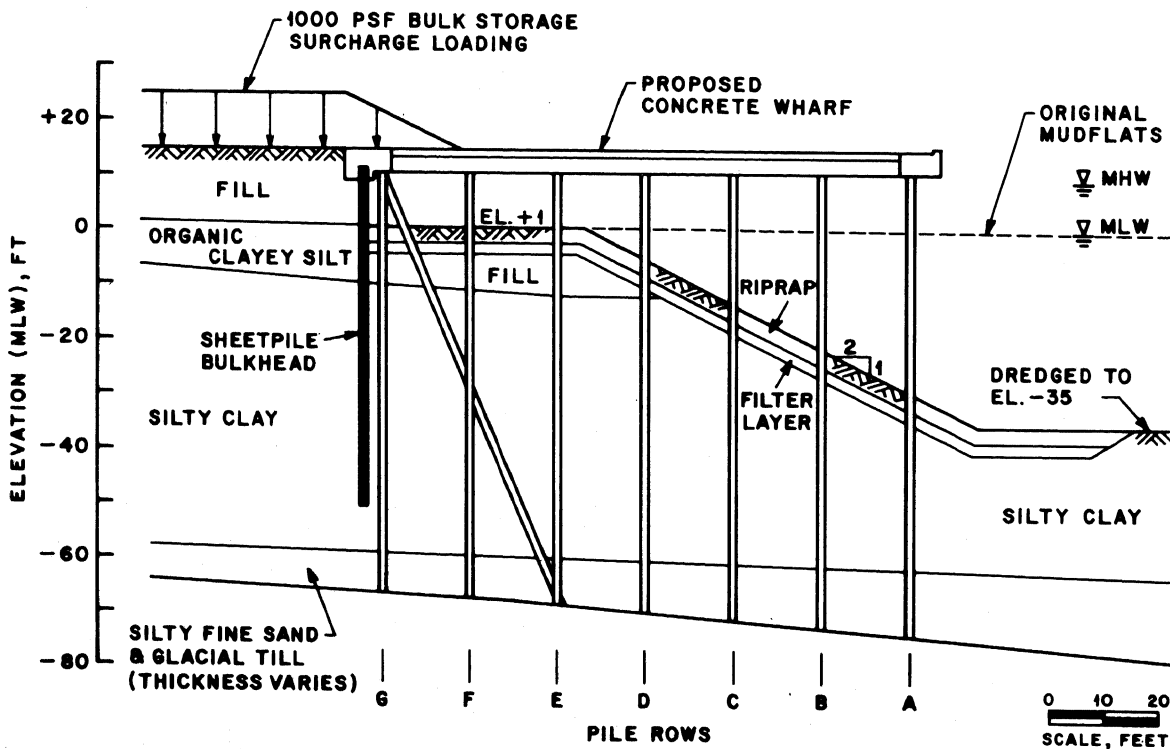
Fig. 2 Design Cross Section of 600-ft Wharf

The wharf was designed as a concrete pile-supported deck with a steel sheetpile bulkhead located at the landward edge of the deck, as shown in Fig. 2. The organic silt and silty clay outboard of the bulkhead were to be dredged on a 2H:1V slope to E1 -35 MLW. The piles for the deck consisted of square prestressed concrete piles spaced at 12 ft on-center parallel to the bulkhead and 16 ft on-center perpendi-

Along the sheetpile bulkhead for the 600-ft wharf, the thickness of organic silt varies from about 5 ft near the west end to about 20 ft at the east end. The thickness of the silty clay ranges from about 35 ft at the west end to about 50 ft at the east end. The soil profile near the middle of the section where the slope failure occurred is shown in Fig. 2.

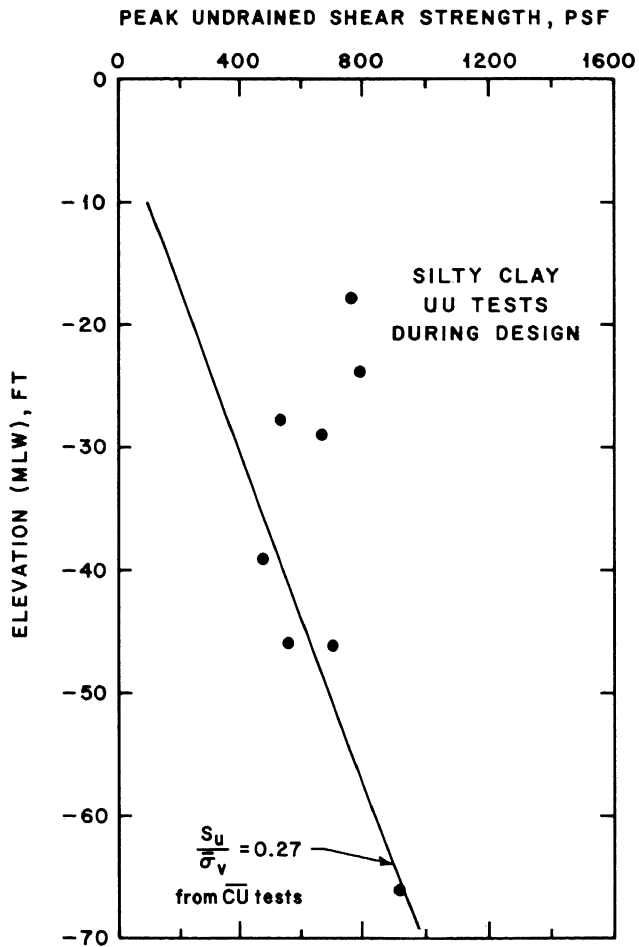
Fig. 3 Silty Clay Undrained Strength Profile From UU Tests Performed During Design

content of the silty clay is greater than the liquid limit (i.e., liquidity index greater than 1.0). Figure 3 shows the undrained shear strength profile from UU triaxial tests performed during the design phase on silty clay samples obtained from the borings in mudflat areas throughout the site. The $S_u/\bar{\sigma}_v$ relationship based on the results of CU tests performed on the silty clay is also shown. The UU test profile shows the silty clay to be overconsolidated above about El -40 MLW. Figure 4 shows the stress-strain curves from the UU tests. The curves in general show a peak strength at relatively small strains and a subsequent dropoff in strength. Two of the curves are relatively flat, but these samples were probably disturbed during sampling or testing. The water contents of these two samples were greater than the liquid limit indicating that the curves should have been more peaked. The shape of the peaked curves along with the high liquidity index indicate that the silty clay is very sensitive and is susceptible to significant loss of strength if the soil structure is disturbed.

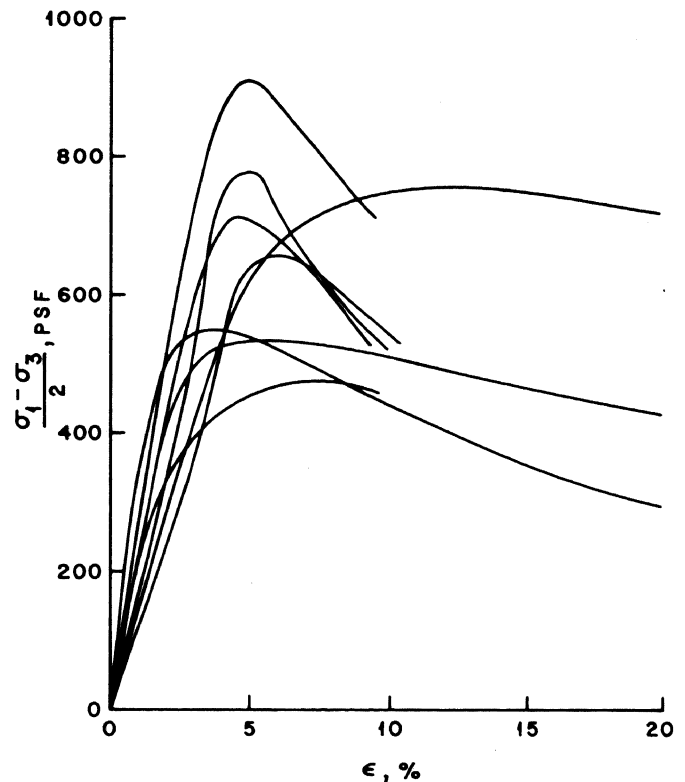
Fig. 4 Stress-Strain Curves from UU Tests Performed During Design

- 1) Sensitivity of the Silty Clay - The silty clay is highly sensitive as evidenced by the shape of the stress-strain curves and its high sensitivity makes the silty clay highly susceptible to disturbance and significant reduction in strength.

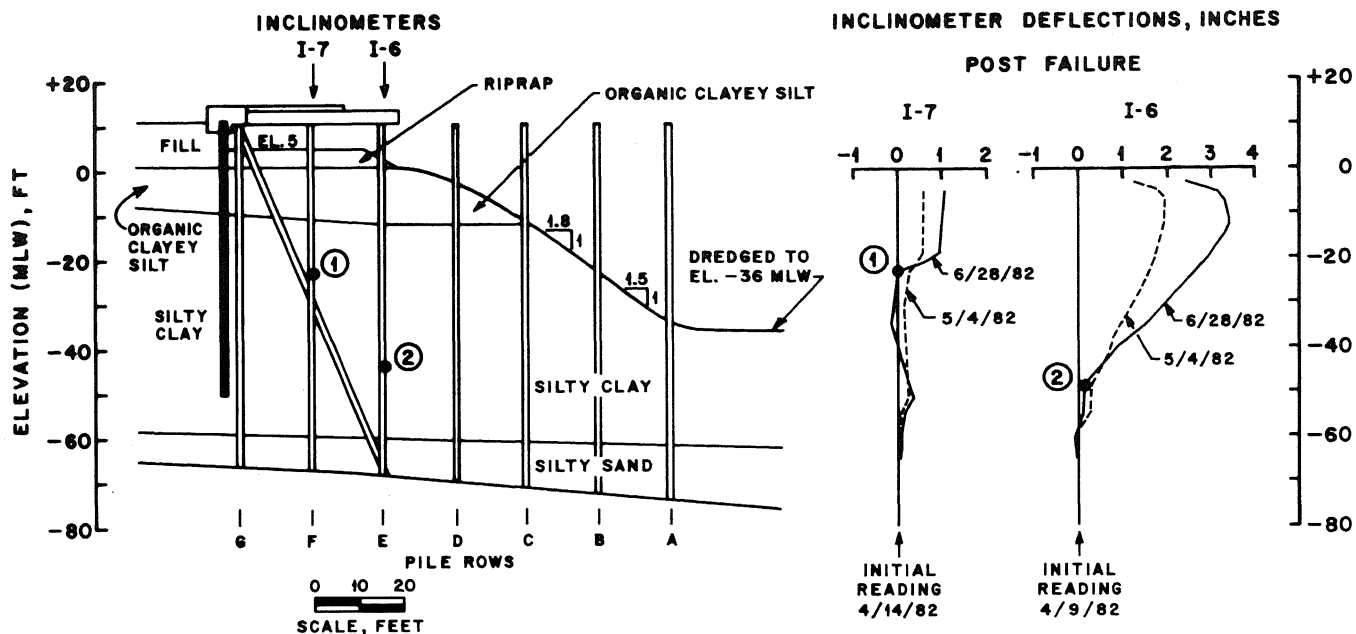
Fig. 5 As-built Cross Section at Line 35

Figure 5 shows the as-built slope geometry at Line 35. The top of the riprap was at about El 5 MLW rather than El 1 MLW. In addition, the dredged slope was steeper than the design slope,

especially near the toe, and was dredged to about El -36 MLW rather than El -35 MLW. After construction was stopped, three slope inclinometers were installed, two in the failure zone at Line 35 and one outside the failure zone at Line 44. The locations of the two inclinometers at Line 35 are shown on the cross section in Fig. 5, along with movements measured at the inclinometer locations.

As shown in Fig. 5, the inclinometer measurements indicated that a deep-seated slope failure was occurring through the silty clay in the outboard slope. It should be noted that a much larger amount of movement occurred before the inclinometers were installed.

Stability analyses were performed to evaluate possible causes for the failure. Analyses were first performed to determine the effect of placing the riprap to El 5 MLW and dredging the slope to a steeper slope and slightly deeper depth than designed. The river was assumed to be at El -1.5 MLW. The strength profile used in the analyses was based on the profile shown in Fig. 6a and was the same used to analyze the design slope geometry. In the first analysis, it was assumed that the riprap was placed to El 5 MLW, but the slope was at the design 2H:1V. The computed factor of safety for this case was about 1.45 as compared to 1.88 computed for the design geometry. Next, the stability was analyzed for the as-built geometry with the riprap to El 5 MLW and the slope dredged steeper and to El -36 MLW as shown in Fig. 5. The computed factor of safety for this case was about 1.25.

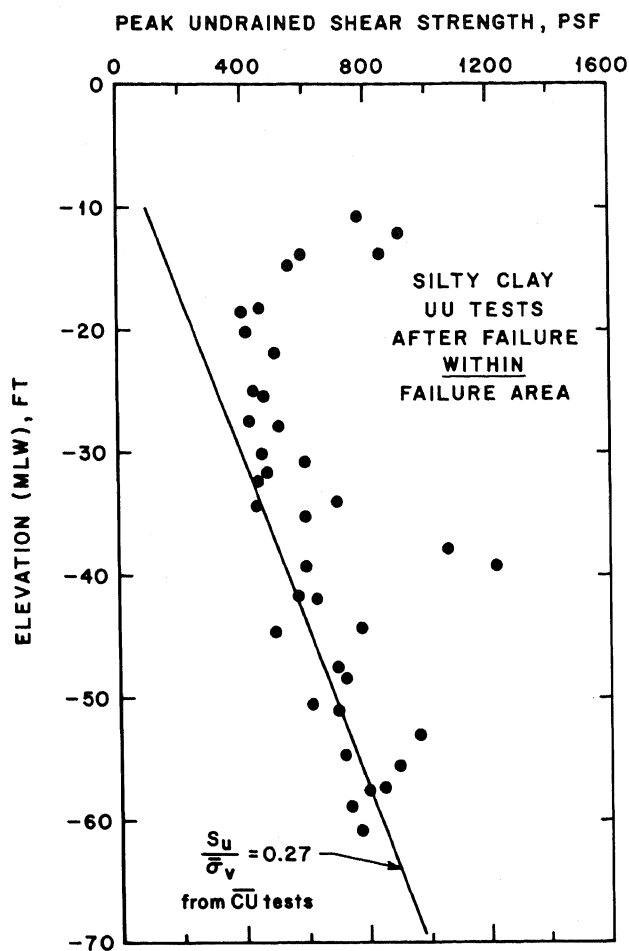
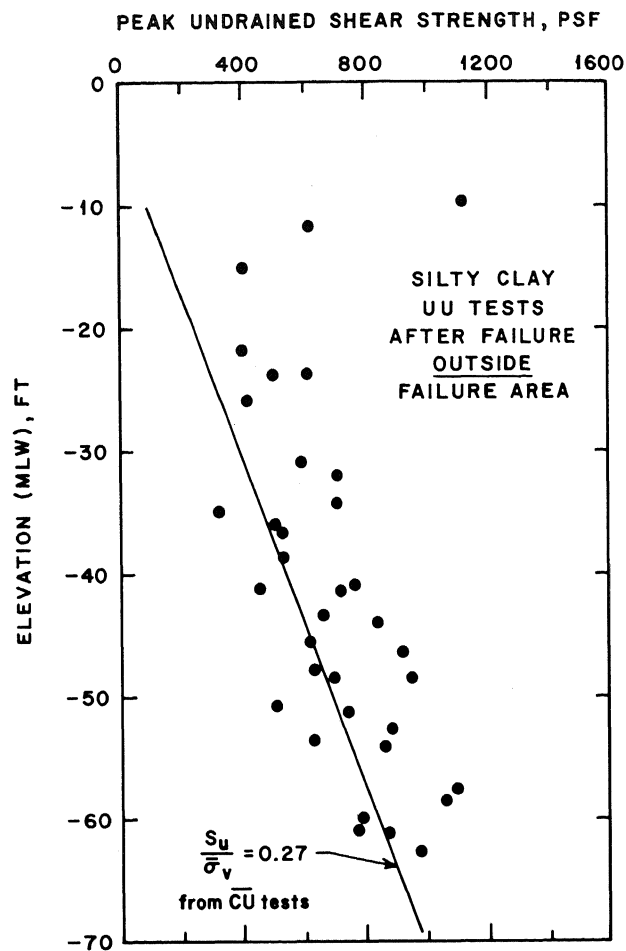
Fig. 6 Silty Clay Undrained Strength Profile from UU Tests Performed After Failure - a) Within Failure Area, b) Outside Failure Area

After the construction was stopped, the designer performed a series of borings to investigate the cause of the failure. The locations of the borings performed in the vicinity of the outboard slope are shown in Fig. 1. UU triaxial tests were performed on undisturbed samples obtained in the borings. The results of the UU tests performed on samples of the silty clay from the borings located outboard of the bulkhead are plotted in Fig. 6. Figure 6a shows the results for the borings performed within the failure zone and Fig. 6b shows the results for the borings located outside the failure zone.

There is no evident difference in the two strength profiles. By comparison with Fig. 3, it can be seen that the strength profiles shown in Fig. 6 are similar to the strength profile measured during the design phase.

The strengths measured in the borings within the failure zone (Fig. 6a) are generally greater than 400 psf. However, these borings were all performed at about Row E. No borings were performed between Rows E and A where the potential for disturbance of the silty clay was the highest due to dredging and pile driving. To evaluate the effect of the sensitivity of the silty clay on the stability of the slope, the post-peak strength measured at 10% strain in each of the UU tests was determined and plotted in Fig. 7. The shear strength at 10% strain was

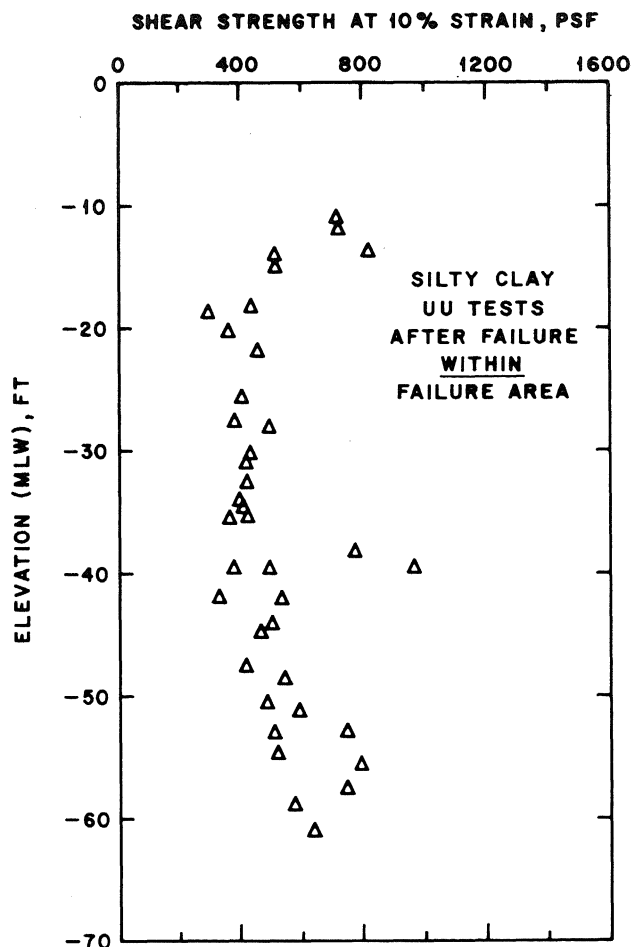
Fig. 7 Silty Clay Strength Profile at 10% Strain from UU Tests Performed After Failure Within Failure Zone

about 400 psf from about El -20 to El -40 MLW and slightly higher above and below this zone. An analysis was performed assuming the clay outboard of Row E had been disturbed to the degree that the strength could be represented by the profile shown in Fig. 7. The computed factor of safety for this case was about 1.10. Localized zones in the silty clay, especially at the toe of the slope and surrounding the piles, would be probably more disturbed with a lower strength in which case the factor of safety would be closer to 1.0.
