(1984) - First International Conference on Case
Histories in Geotechnical Engineering

Settlement Experienced at a Recently Licensed Nuclear Station

J. T. Chen and L. W. Heller

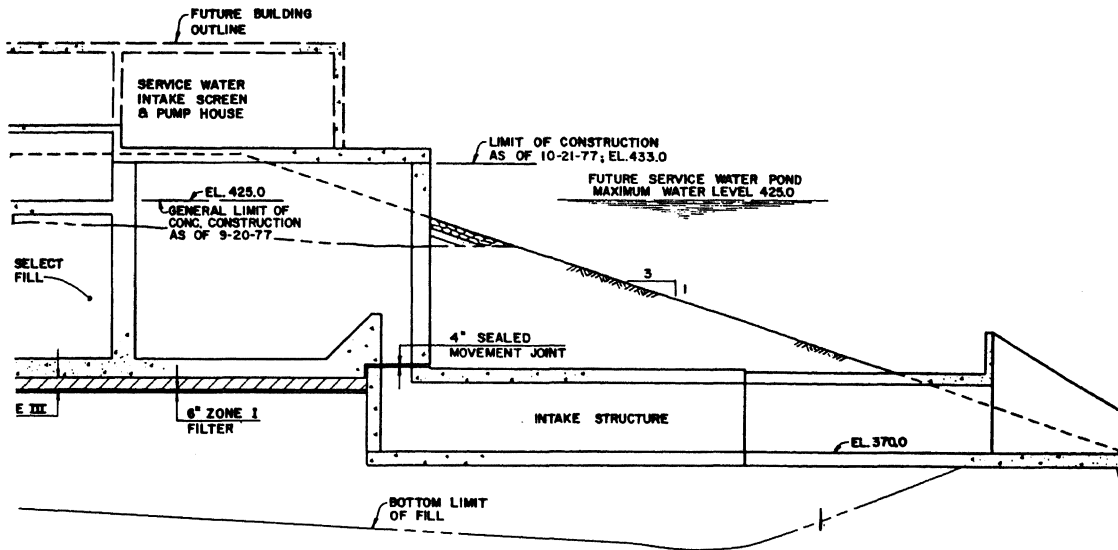
FIGURE 2
SECTION PROFILE
SERVICE WATER INTAKE STRUCTURE
AND PUMPHOUSE

The nuclear service water pumphouse and intake structure are located on the west side of a man-made lake as shown in Figure 1. Profiles through these structures, the embankment slope, and foundation soils are shown in Figure 2. The intake structure has an internal dimension 12 feet wide by 15 feet high and a length of 167 feet with the wall and roof thicknesses varying from 2 feet 6 inches to 3 feet. The pumphouse has a plan dimension of 70 x 80 feet with a height about 80 feet.

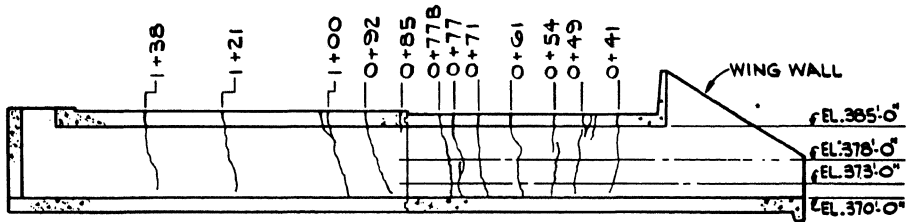
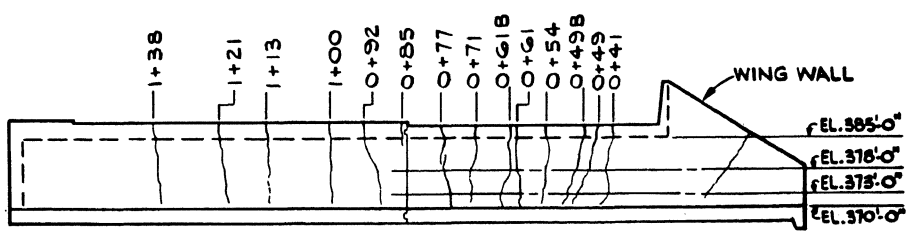
FIGURE 3
CRACKING SURVEY DATA TO DECEMBER 5, 1977
SERVICE WATER INTAKE STRUCTURE

During construction, in August 1977, settlement exceeded the predictions at the settlement points. Two weeks later, cracks were discovered in the walls and roof of the intake structure. These cracks were widest in the roof and disappeared near the bottom of the vertical walls. The cracks penetrated the full thickness of the walls and the roof slab (Fig. 3). The largest observed crack had a maximum width of 1/8 inch.

Soon after the settlement and cracks were observed, construction of the pumphouse and surrounding fill was temporarily halted while the cause of the settlement was investigated. This investigation consisted of additional borings, settlement monitoring instrumentation, laboratory tests and settlement analyses. Based on the results of the investigation, the expected settlement of the pumphouse was revised upward from 4 inches to about 14 inches. A program was begun to reduce the settlement. Preloading of the subsurface materials was accomplished by placing extra fill around the structure and by filling the pump chamber in the pumphouse with water to accelerate the settlement of the soils under the pumphouse. After removal of the preload fill, the cracks, now up to 0.2 inches wide, in the intake structure were pressure grouted. The service water pond was filled about five weeks after the completion of grouting in the intake structure.

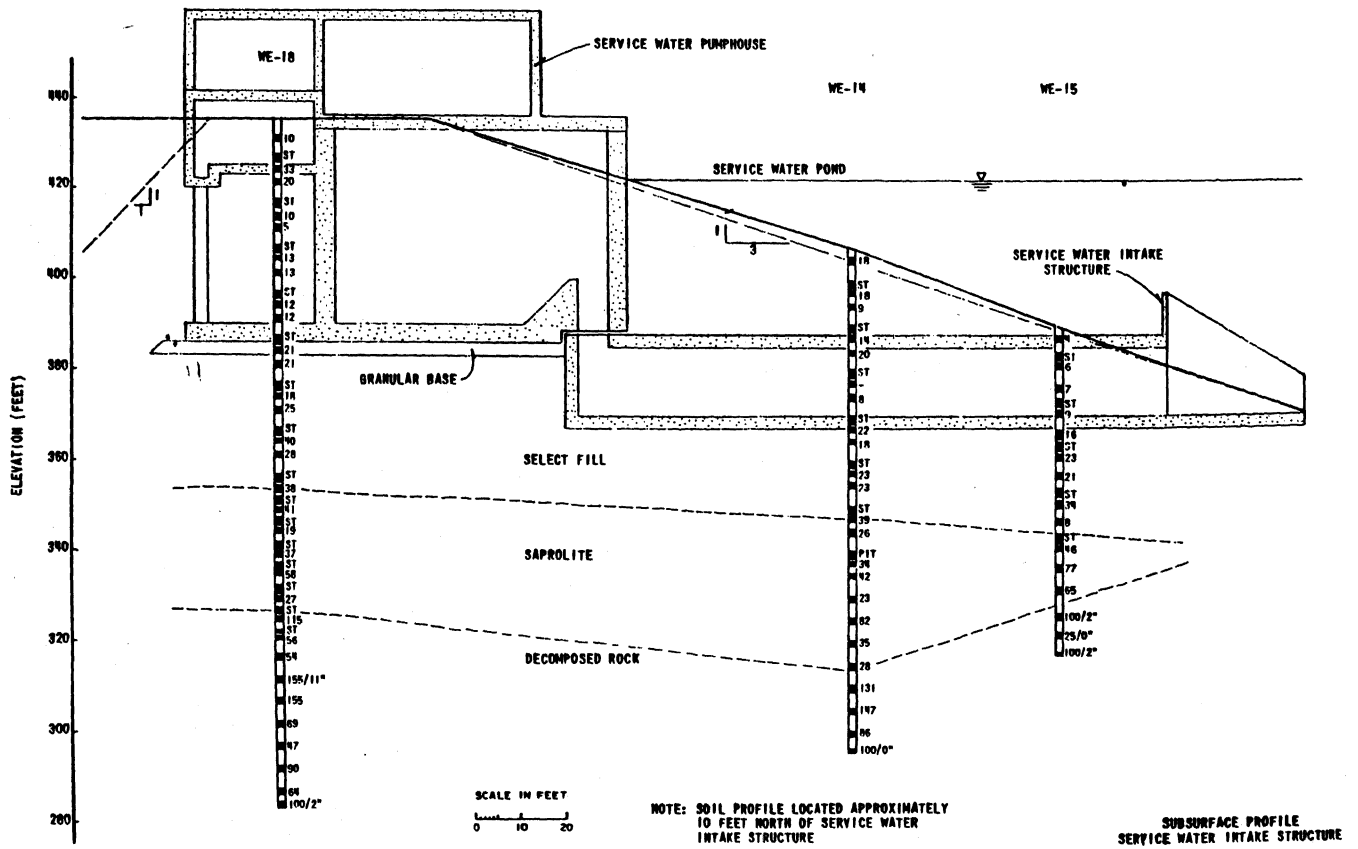
FIGURE

The subsurface profile along the intake structure as revealed by later investigation (Fig. 4) indicates that the fill thickness varies from 20 to 30 feet and the saprolite thickness varies from 17 to 35 feet; this later profile contrasts with the original assumption of about 10 feet of fill and no saprolite underneath the pond end of the intake structure. To locate potential settlement areas, the highly variable nature of saprolite requires a more precise subsurface profile than was provided initially.

With foreknowledge of potential settlement problems, verified perhaps with adequate testing and evaluation of soil parameters, the design of the intake structure could have included longitudinal reinforcement to mitigate the effects of differential settlement and embankment loadings.
