International Conference on Case Histories in
Geotechnical Engineering

(1988) - Second International Conference on
Case Histories in Geotechnical Engineering

Damage to Masonry Structures in the Historic Center of Arezzo (Tuscany, Italy) Following the Excavation of a Sewer Tunnel

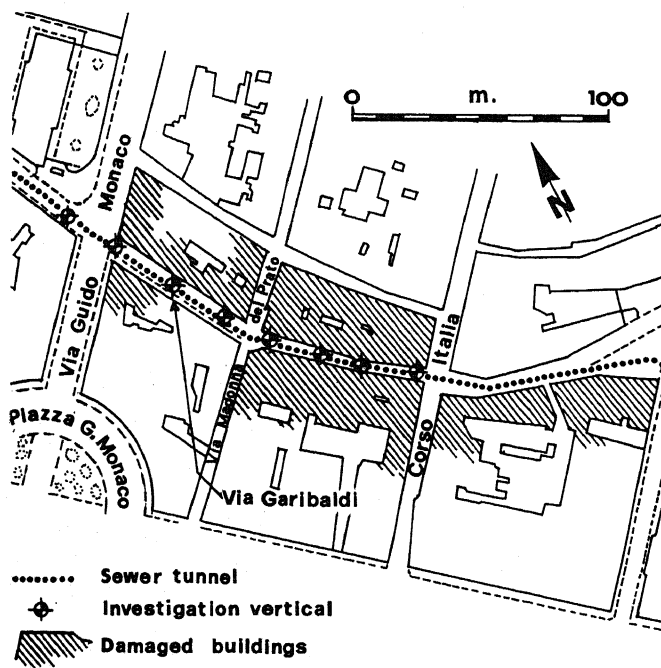
Fig. 2: Close-up to damaged area

During the excavation of the tunnel, several buildings in the historic center suffered damages of varying extents.

The buildings damaged in consequence of the excavation of the sewer tunnel in the historic center of Arezzo rise on both sides of Via Garibaldi, in a section of about 250 m. between Via Guido Monaco and Via Margaritone (figure 2).

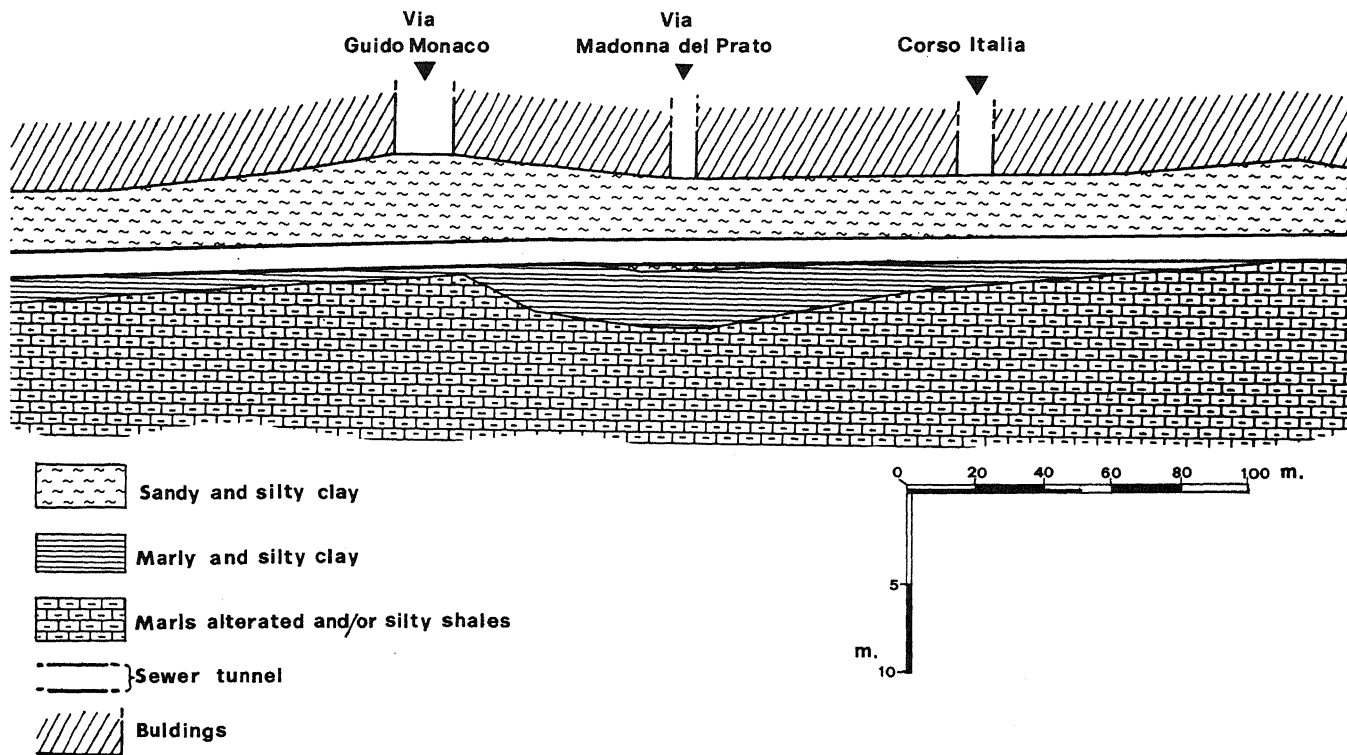
Fig. 3: Geotechnical section of the tunnel in the damaged area

The bottom of the tunnel is located at a level of 4.2 ÷ 5.5 m from street level. Since the finished work has an outside diameter of 1.9 m and thickness of 22 cm, a large part of the excavation took place in the silty and sandy clay surface formation (figure 3).

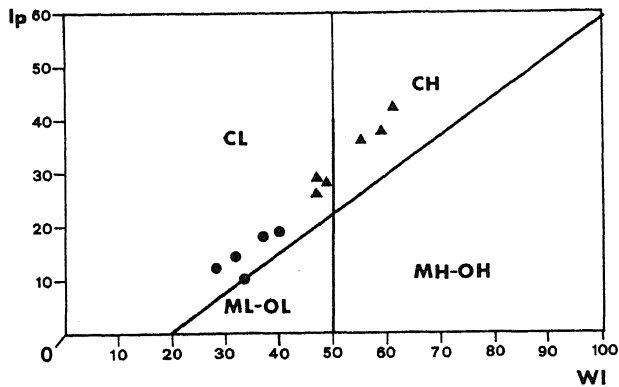
Fig. 4: Plasticity chart

The geotechnical properties of the surface layer vary gradually, passing from the foot hill zone to the hill zone of the city. In the plasticity chart (figure 4), the representative points of the surface soils in the hill zone, marlish in origin, fall within the highest part of the chart, while the representative points of the surface soils in the foot hill zone, fluvial in origin fall within the lower part of the chart: they have a larger silt/sand component and, therefore, lesser plasticity.

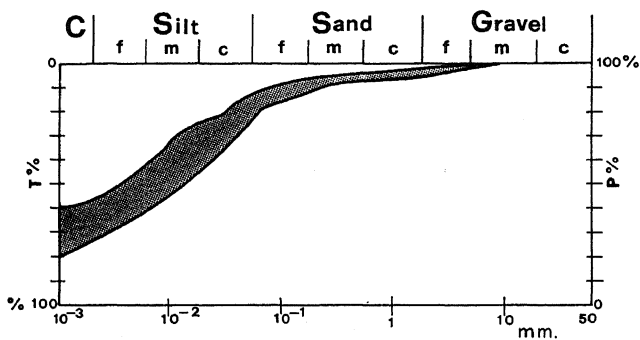
Fig. 5: Granulometric zone of the upper soil

The granulometric zone of the upper soil in the section considered is represented in figure 5.

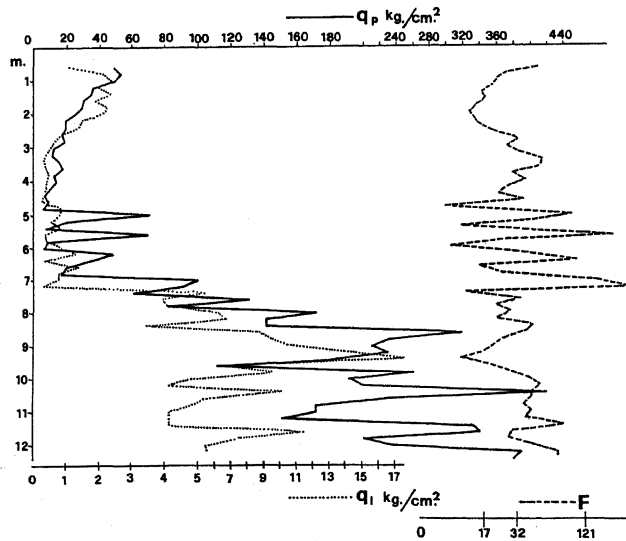
Fig. 6: Typical CPT profile

A typical CPT profile, in which the general stratigraphic outline is recognizable, is represented in figure 6.
