Observations and Performance of a Soil Nail Shoring Wall in Seattle Silts and Clays

OBSERVATIONS AND PERFORMANCE OF A SOIL NAIL SHORING WALL IN SEATTLE SILTS AND CLAYS

ABSTRACT

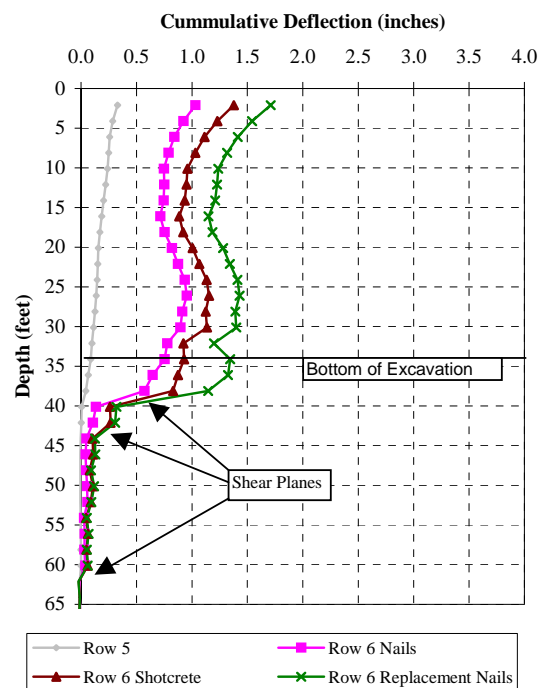
Significant horizontal and vertical wall movements were measured on both the optical survey points and the inclinometer when the north half of the existing wall was undermined (row 6 nails). The vertical and horizontal movements of the east wall were about 1.2 and 0.6 inches, respectively, as shown in Table 1. The inclinometer data, as shown in Fig. 4 and Table 2, showed that almost all of the incremental horizontal wall movement occurred 6 feet below the bottom of the excavation.

Fig. 4. East wall inclinometer data after completion of row 6.

When the shotcrete for row 6 had been completed, the total wall movement was 1.2 inches horizontal and 1.6 inches vertical (see Table 1 and Fig. 4). The proof tests were then completed on the row 6 soil nails. All four of the proof test nails failed in pullout (between 65 and 130 percent of the design pullout of 3.5 kips/foot). Because the design required a factor of safety of 2 on the pullout, replacement soil nails were installed. The replacement nails were installed in between the original nails. With the additional of the replacement soil nails, the effective nail spacing was reduced from 5 feet to 2.5 feet. The replacement nails were installed through the existing shotcrete facing. A rock hammer was used to break through the existing shotcrete. The vibrations of the rock hammer resulted in an additional 0.4 inches of horizontal wall movement and 0.4 inches of vertical wall movement. Proof testing of the replacement nails indicated that 4 out of 5 nails failed in pullout (again between 65 and 130 percent of the design pullout of 3.5 kips/foot), but the sum pullout capacity of the initial nails plus the replacement nails met the required row 6 pullout capacity.

At the completion of row 6, the total vertical and horizontal wall movements were 1.9 inches and 1.6 inches, respectively. At the inclinometer, the total horizontal movement was 1.7 inches, of which 1.1 inches occurred on three shear planes located at depths of 6, 10 and 28 feet below the bottom of the excavation (depths of 40, 44 and 62 feet below the top of the wall)(see Table 2 and Fig. 4).

As a result of the rapid movement of the wall, the southern half of the wall was shotcreted using a staggered excavation approach. Each excavation, or slot, was approximately 20 feet in length. The slots were spaced such that the adjacent slots were either protected by a soil drill berm or completed shotcrete wall.

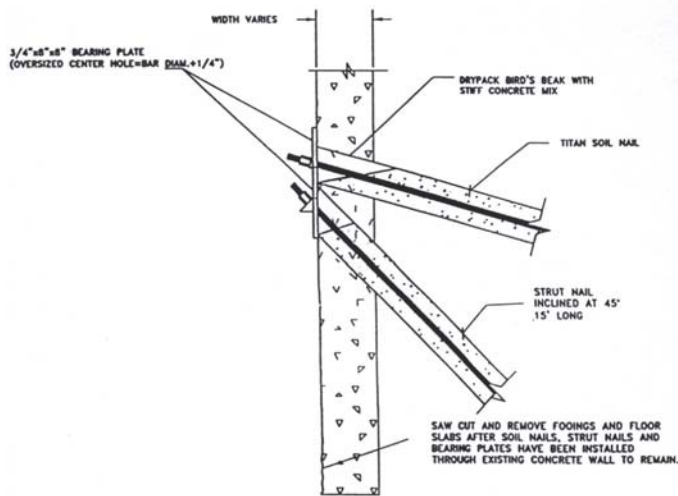
During the shotcreting of the southern half of the wall, a visual survey of the wall and 5th Avenue was completed. The survey revealed that the several of the row 1 through 5 soil nail nuts were loose. In addition, the accessible strut nail locations were observed to determine if the strut nails had been damaged as a result of the vertical movement. A detail of the strut nail connection is shown in Fig. 5 (strut nail is shown inclined at 45 degrees from horizontal). Half of the strut nails evaluated showed either relative slipping/movement between the grout and wall or very weak grout connection (soil/grout mixture) that could easily be removed with hand tools. The relative movement was small and did not account for the 1.2 inches of vertical wall movement measured, but did call into question the integrity of the connection of the strut nails to the existing wall.

Fig. 5. Strut nail connection to the existing concrete wall

During the installation of core holes in the existing wall, it was observed that the gravel drain at the base of the wall was partially filled with grout. It appeared that the neat cement grout from the strut nail installation had contaminated the gravel drain, contributing to the buildup of groundwater behind the existing wall (the continuity of the drain pipe had already been compromised as discussed above). This also may have contributed to a poor structural connection between the strut nail and the existing wall. Without a continuous grout column around the strut nail, the nail would not be able to support the weight of the existing wall by functioning as a compression member as intended by the design. It is the author's opinion that this poor structural connection led to the

failure of the strut nail system and the resulting vertical wall movement. In essence, the soil nails (both regular and strut nails) were supporting the existing wall in a bending mode (similar to nails supporting a picture frame on a wall).

Row 7 Observations. Because of the continued vertical movement of the wall, the contractor proposed installing a series of micropiles to replace the strut nails. The micropiles were installed at the bottom of the row 6 shotcrete. The micropiles consisted of near vertical, 6-inch diameter, 32-foot long, post-grouted nails. After installation of the micropiles, the vertical wall movements slowed significantly, but did not stop.

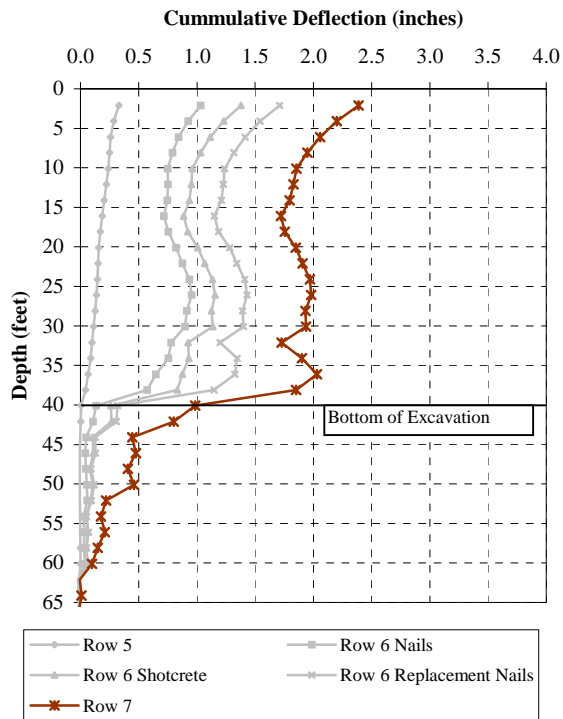
During construction of row 7, the movement of the wall continued. The wall moved vertically approximately 0.3 inches, for a total cumulative movement of 2.2 inches. The horizontal wall movement increased from 1.6 inches to 2.1 inches. As with row 6, a significant amount of the additional movement occurred below the bottom of the excavation. A fourth shear plane also developed 12 feet below the excavation (52 feet below the top of the wall) and accounted for about one-half of the horizontal movement observed during row 7 installation, as shown in Fig. 6.

Fig. 6. East wall inclinometer data after completion of row 7.

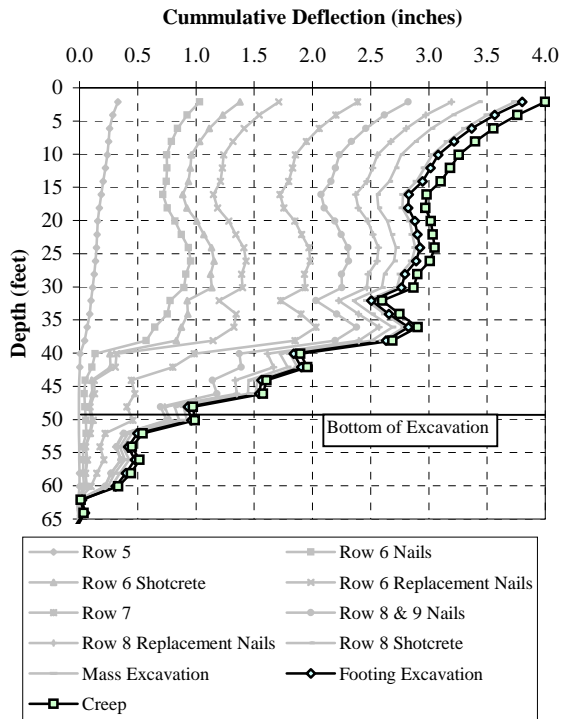
Following Construction. Movement of the east wall, both horizontal and vertical, continued to occur after all earthwork construction activities were completed in front of the wall. Movement was measured over a period of several months. The movement essentially stopped when enough building structure (i.e. permanent walls and floor slabs) had been constructed in front of the shoring wall. The horizontal and vertical wall movements that occurred during this period were 0.36 inches and 0.12 inches, respectively (see Tables 1 and 2 and Fig. 9). Very little of the horizontal movement (0.03 inches) occurred below the bottom of the excavation. The majority of movement was outward rotation of the wall.

These movements were occurring with little or no additional load being applied to the wall, which is the definition of creep movement.

Fig. 9. Final east wall inclinometer data.

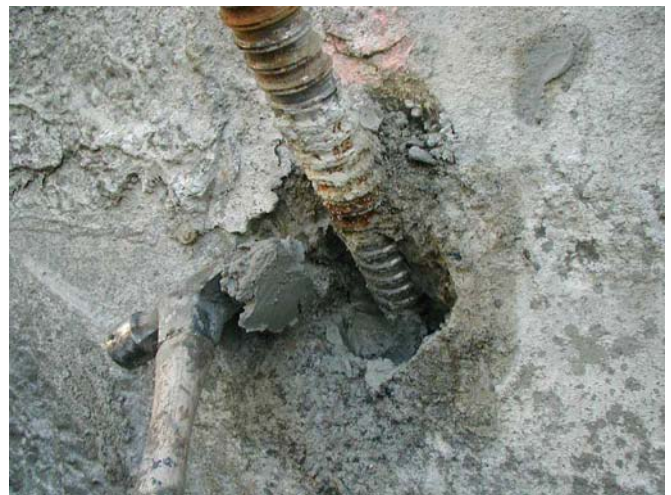
It is the opinion of the authors that the vertical wall movements were the result of failure of the strut nails installed along the bottom of the existing east concrete basement wall to perform as intended. The strut nails were designed to support the full weight of the existing wall. However, when the wall footing was initially undermined, the wall dropped vertically 1.2 inches over a short period of time (3 days). Vertical wall movements continued throughout construction, even after micropiles were installed to resupport the wall. The vertical wall movement at the end of construction was 2.64 inches.

It appears the strut nails failed to support the existing basement wall because of a poor connection with the existing wall. The design theory of strut nails is similar to a truss system. With a rigid connection at the wall face, the strut nails (which were installed at 45 degrees from vertical) are a compression element. A rigid connection would require a continuous column of grout in the annulus between the nail bar and the hole drilled through the existing wall and around the nail bar directly behind the wall. A continuous grout column was probably not achieved because the strut nails were grouted with a neat cement grout, which likely flowed into the gravel drain rock directly behind the wall before setting up around the nail bar. As discussed above, we also observed a considerable amount of soil within the grout of the strut nail connection. A photograph of one of the connections observed is shown in Fig. 10. When the existing wall was undermined, the poor connection did not allow full compression of the strut nail and the strut nails, along with the regular soil nails, were loaded in bending.

Fig. 10. Observed strut nail connection at existing wall.
