Case Histories of Earthen Dam Failures

R. P. Sharma
BIT, India

Ali Kumar
Govt. of Jharkhand, Ranchi, India

CASE HISTORIES OF EARTHEN DAM FAILURES

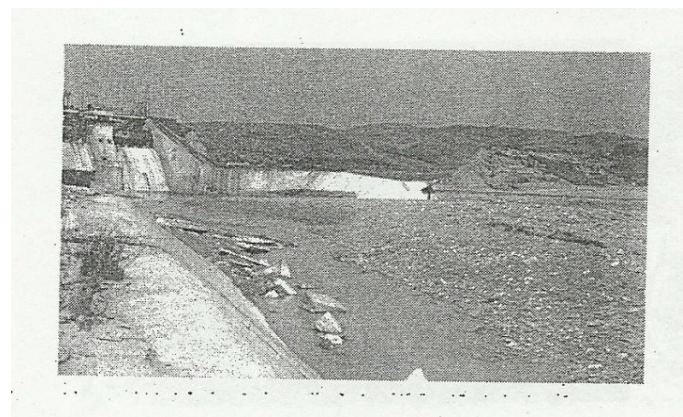
On 28 July 1991 heavy rainfall occurred, which caused the failure of main telephone lines and power supply. Due to failure of the main telephone lines no prediction of flood warnings could be sent from the upstream catchment areas to the dam site. The bottom outlet could not be opened more than 40cm due to power failure at the site. Emergency power was also unavailable and the gates could not be opened manually as timber and debris were blocking the bottom outlet. At 02.15 am on 29 July the dam began to overtop and the reservoir was emptied by 07.15 am. Twenty five people were killed by the flood wave caused by the dam break and 119 houses were destroyed.

The peak inflow of 1200 m³/sec measured by a water gauge located at downstream was lower than the later estimated 1-in-100-year flood of 1515 m³/sec. The initial dam break occurred at the same point where the dam had been affected by erosion in 1970. The final size of the breach was about 112 m long and 15 m deep (fig.1). Post-failure measurements of the intact dam crest near this initial break showed that the repair works had produced the effect of a natural overflow section. A cable trench that had been dug along the dam crest also had a negative and accelerating influence with regards to the process and dynamics of the breach formation. The dam has not been reconstructed.

Fig. 1. *The Belci dam after failure.*

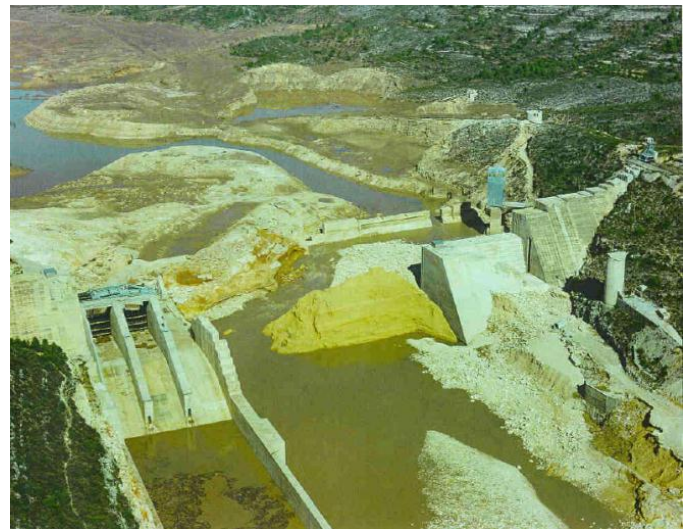
The overtopping started at 17.00 pm; the water overcame the dam reaching about 1.10 m above the crest at 19.15 pm. About 16 h after recognizing the impossibility of overtopping the flood gates, the dam was overtopped and washed out after 1 h by erosion of a greater part of the shoulders and of the central rock-fill. After such an extraordinary flood, in the downstream basin 8 people lost their lives and about 100,000 people had to be evacuated. The damages were estimated to reach 400 M\$, even if part of these damages were likely to be caused by the floods before the arrival of the break wave (fig. 2).

Fig. 2. *The Tous dam after failure.*

A new Tous dam was built on the same site and part of the clayey core material, which had shown a relatively high resistance to water flow, was reused for constructing the new dam.

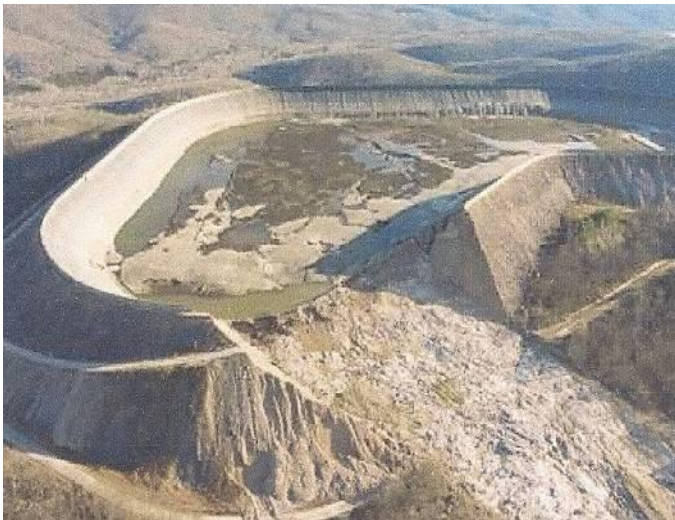
A variety of design/construction flaws, instrumentation error, and human errors contributed to a catastrophic failure of the upper reservoir on Dec 14, 2005. Malfunctioning and improperly programmed/placed sensors failed to indicate that the reservoir was full and didn't shut down the facility's pumps until water had been overflowing for 5-6 minutes. This overflow undermined the parapet wall and scoured the underlying embankment, leading to a complete failure within 5-6 minutes due to overtopping. Figure 3 shows the breach through embankment of the dam. The peak flow from this event is estimated at 289,000 cfs.

Fig. 3. *Breach through Taum Sauk embankment*

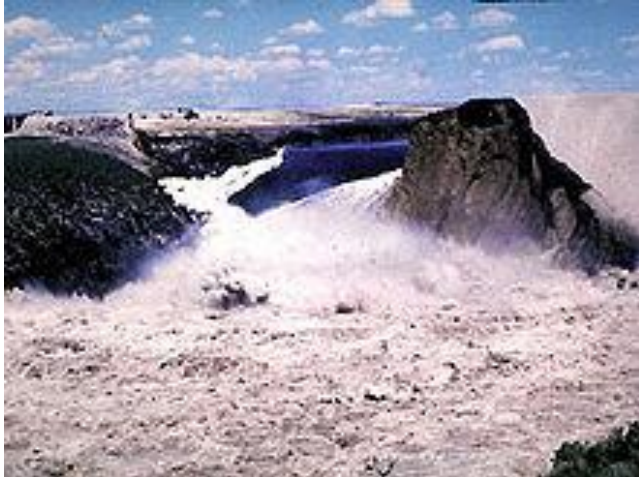
Teton Dam, a 93 m (305 ft.) high with a crest length of 975 m (3200 ft) earth fill dam across the Teton River in Madison County, southeast Idaho, failed completely during first filling at 11:57 AM on June 5, 1976. The water surface was 9 m below the crest of the dam. Failure was initiated at 7.30 AM by a large leak near the right (northwest) abutment of the dam, about 39 m (130 ft) below the crest. The structure was breached 4.30 h later as a result of internal erosion (Fig. 4), causing the loss of 11 lives and extensive flooding in the farmland and towns below the dam. Peak flow at the time of breaching was estimated at 42,500 m³/s.

The dam, designed by the U.S. Bureau of Reclamation, failed just as it was being completed and filled for the first time. This failure of a modern dam so soon after construction was a shock to the engineering community. It prompted one of the most intensive investigations of any dam failure. A panel of experts investigated that the failure of dam was related to erosion and piping phenomena which occurred in the key trench fill on the right abutment possibly caused by seepage through cracks.

The expert's panel supposed that the seepage occurred due to either deficiencies of grouting in the sealing of rock joints or differential settlements in the key trench fill itself, or a combination of both causes. Further investigations carried out on the remains of the left embankment detected the presence of 'wet seams' (horizontal lenses varied in thickness from 75

to 200 mm) in some of the construction layers. Such wet seams possibly caused by the unsuccessful attempts to mix dry and wet soils during the construction of core layers, thus creating low-density zones undetected during the earth work controls. The seepage through the key trench fill could have been the seat of intense flow leading to erosion and piping of the core.

Fig. 4. *The Teton dam after failure.*

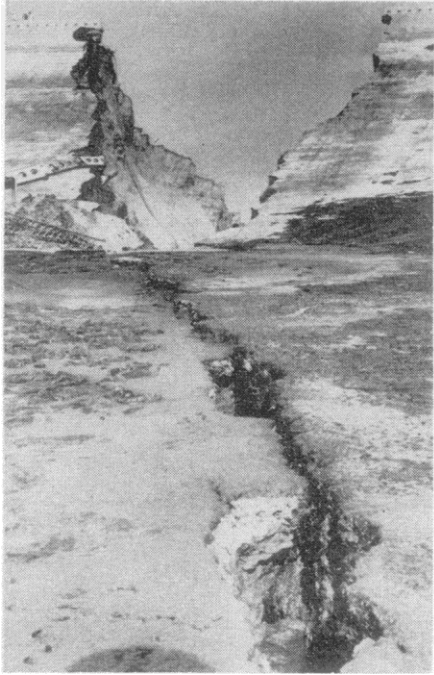
After 12 years of operation, on December 14, 1963, at about 11:15 A.M., an unprecedented flow of water was heard in the spillway pipe at Baldwin Hills Dam. The water came from drains under the reservoir lining. At approximately 1:00 P. M., muddy leakage was discovered downstream from the east abutment of the dam, which formed the north side of the reservoir. At 2:20 P. M. lowering of the reservoir water level revealed a 3-ft-wide break in the reservoir's inner lining. A futile attempt was made to plug the hole with sandbags. Water broke violently through the downstream face of the dam. By 5:00 P.M., the reservoir had emptied, revealing a crack in the lining extending across the reservoir bottom in line with the breach in the dam (Fig. 5).

Mr. R. B. Jansen, Chairman Engineering Board of Inquiry Baldwin Hills Reservoir Failure, immediately after failure of the dam constituted a panel of experts to investigate the cause of failure of the dam. Expert's panel in his investigation report stated that a gradual deterioration of the foundation took place during the life of structure and culminated with sudden failure on December 14, 1963. The porous concrete drain was damaged by early small movements at the fault, and leakage water found its way into the fault. These earth movements were mainly caused by land subsidence, locally concentrated along the fault which was a weak plane. During the life of the reservoir, erosion took place in the fault under the undamaged blanket and partially damaged drain. The narrow width of the fault permitted the porous concrete drain to span openings that were developing under the drain. These occurrences were gradual and progressive. The perviousness of the fault permitted the water to disappear into the hill without emerging on the downstream abutment. Movement occurred at the fault on December 14, rupturing the impervious blanket and admitting full reservoir pressure to the fault and to the drainage system for the first time. The full reservoir pressure in the fault forced an outlet to the surface at a point low down on the east abutment of the main dam. Flow developed in the pervious and erodible fault zone and foundation rock. The flow and erosion increased rapidly, a cavernous opening piped through the abutment, the overlying foundation and embankment collapsed into this opening and the reservoir drained quickly and completely.

In summary, the reservoir and its immediate environs were subjected to many adverse forces, including horizontal and vertical displacement due to subsidence; local breaking of the weak foundation; some erosion at the faults and rebound effects due to oil field re-pressurization, reservoir loading and unloading in 1951 and 1957, and the final inrush of water into the Fault I-II zone at time of failure.

Fig. 5. Breached Baldwin Hills dam Embankment.

careful design, construction and constant surveillance, the reservoir failed, and lessons are to be learned from the failure. Facing the same site conditions now, and equipped with the knowledge of what went wrong at Baldwin Hills, designers could make several improvements. The obvious first step would be to avoid rigid drains so close to the water face and to the unstable and erodible foundation. Drains should be amply sized and provided with access, where possible, to facilitate maintenance, and earth linings should have appreciable plasticity. Erodible embankment and foundation elements must have adequate filter protection. Foundations in erodible

rocks must be thoroughly explored to disclose any pre-existing cavities or other defects. Finally, the use of heavy construction equipment must be carefully controlled to avoid the damage of critical reservoir feature on soft foundations.
