Twenty-Year Performance of Soil-Cement Dam Facings

T. J. Casias

A. K. Howard

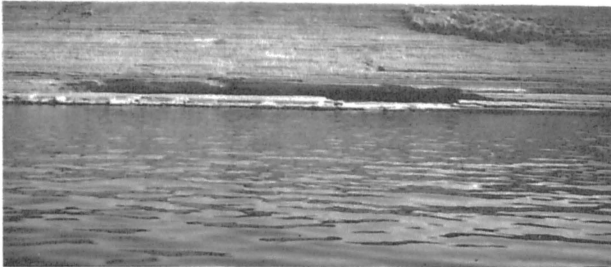
The water surface at the time of the storm was at elevation 1421.4. The damage occurred between elevations 1415 and 1420. Damage was severe between stations 60 and 110. A total of about 300 linear feet of the clay embankment was exposed at three different locations between stations 95 and 105. A total of about 600 linear feet in three locations between stations 80 and 95 had only two lifts of soil-cement remaining. Figures 1, 2, and 3 illustrate some of the damage.

Figure 1. - Damage to soil-cement at Cheney Dam.

Repairs required about 1,100 yd³ of lean concrete at a cost of about \$34,500. The procedure was similar to the 1970 repairs using rebar grouted into place and transit-mix concrete.

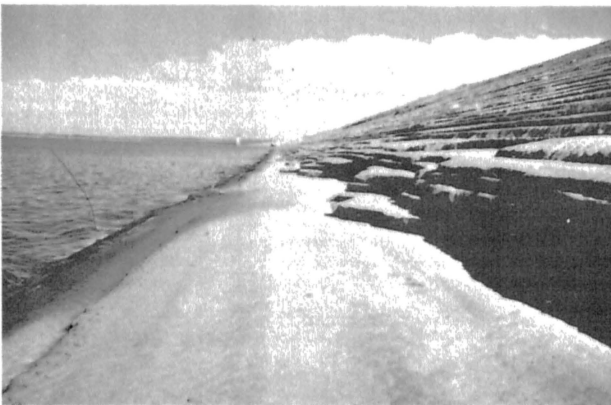
Figure 2. - View of most severely damaged soil-cement at Cheney Dam.

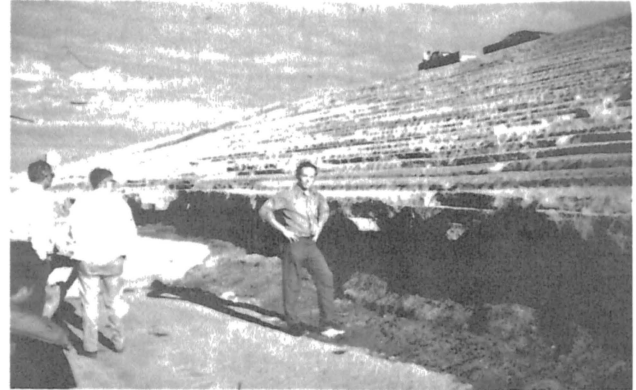
Figure 3. - Exposed embankment behind soil-cement at Cheney Dam.

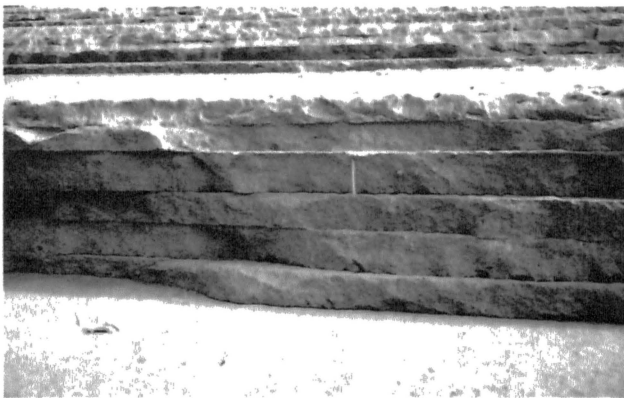
The bond between soil-cement layers is generally weak. As a result, when the stresses created due to severe wave action are considered, the soil-cement facing may be thought of as a series of horizontal slabs stacked on the slope of the embankment as shown in figure 4.

Figure 4. - Lifts of soil-cement shown at back of break-out.

If the exposed portion of the slab acts as a cantilevered beam during strong wave action, the low tensile strength of the soil-cement would result in a vertical crack. Combined with the vertical shrinkage cracks, smaller slabs are created that can be washed away. As each exposed portion is cracked and washed away, the layer below it has an additional

exposed portion. The process can continue until the soil-cement has been completely removed as happened at a few locations at Cheney Dam.

The shrinkage cracks cannot be prevented, but bonding the layers together would create more massive sections of soil-cement that will not wash away and would protect the underlying layers.
