International Conference on Case Histories in Geotechnical Engineering (2004) - Fifth International Conference on Case Histories in Geotechnical Engineering

## LANDSLIDE STABILIZATION AT MISSOURI ROUTE K BRIDGE OVER BLACKWATER RIVER

### ABSTRACT

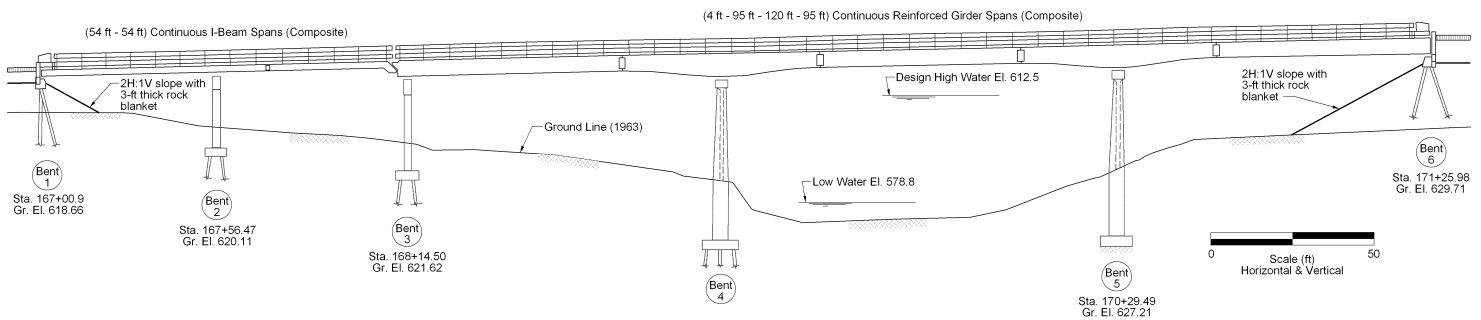
The Missouri Route K bridge over the Blackwater River is a five-span steel girder structure near the town of Blackwater, Missouri (see Fig. 1). The bridge was built in the late 1960's and the bridge piers are founded on H-piles driven to bedrock or footings on bedrock. Figure 2 presents a design cross-section of the bridge.

Fig. 2. General Elevation of Missouri Route K Bridge over Blackwater River (Elevations in feet, NVGD).

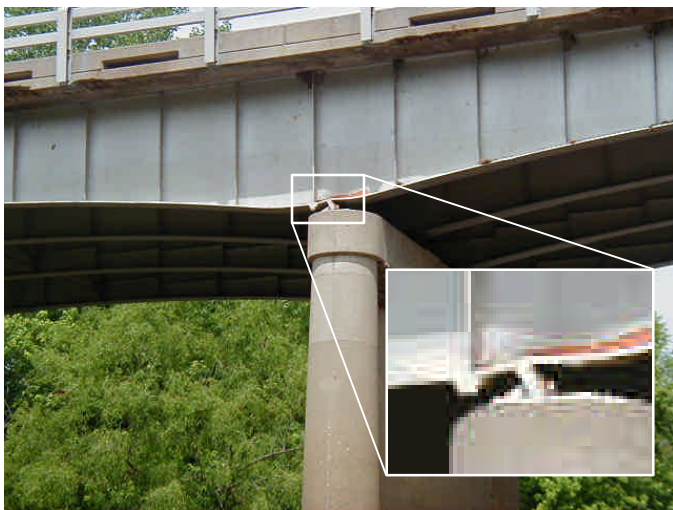
In May 2002 during a flood event on the Blackwater River, a landslide occurred on the south riverbank. The landslide caused bridge Pier 4 to move approximately 12 to 15 inches horizontally toward the river and 1 to 1.5 inches vertically upward. The pier movement caused the bridge girders to drop off the rocker bearings. The damage caused by the slide resulted in the Missouri Department of Transportation (MoDOT) closing the bridge to vehicular traffic.

In late May 2002, local residents of Blackwater and the surrounding area noticed a sag in the Route K bridge deck and railing. The residents alerted MoDOT. On May 29, 2002, MoDOT emergency personnel observed that the rockers supporting the main span girders had “rolled over” at all the bearings at Pier 4 of the bridge (see Fig. 3). MoDOT personnel suspected that a landslide had occurred and closed the bridge to vehicular traffic. MoDOT retained URS Corporation to investigate the landslide and recommend stabilization options.

Fig. 3. Damage to Rockers at Pier 4.

Replacement Pier Design

To withstand these lateral pressures, two 9-ft diameter drilled shafts were required for the Pier 4 replacement foundation. The shafts required 8.5-ft diameter sockets drilled 17 ft into limestone bedrock. Because of an accelerated construction schedule, construction of the shafts was to be done concurrently with slide stabilization work.

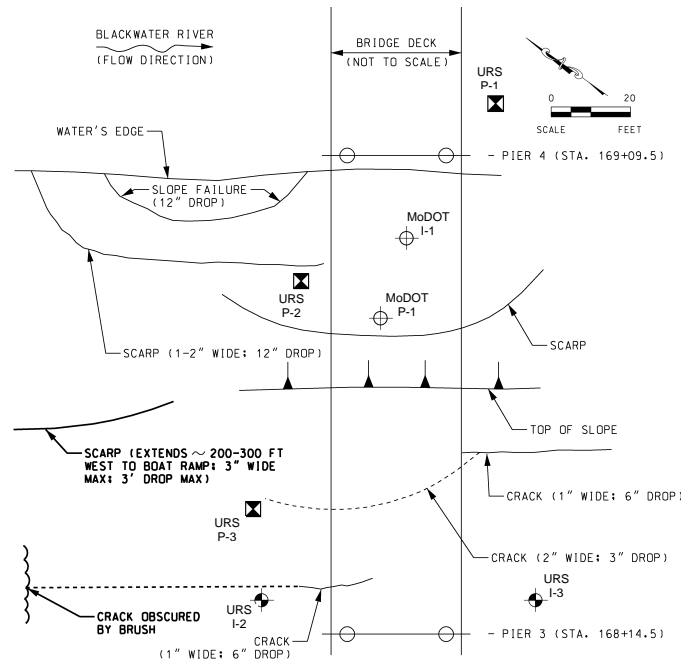
On June 7, 2002, we observed a number of scarps striking roughly parallel to the river extending from the riverbank to approximately 10 feet north of Pier 3, as shown in Figs. 4 and 5. Lateral movements at the scarps were about 1 to 2 inches and some showed vertical displacement of up to 12 inches. By July 1, 2002 many of the scarps were more visible as a result of dry weather. We observed another major scarp (originally obscured by vegetation) that was located approximately 40 feet north of Pier 3 and extended approximately 300 ft to the west to a concrete boat ramp (see Fig. 5). The scarp appeared to be pre-existing and showed lateral and vertical displacements of about 3 inches and 3 ft, respectively.

In early July 2002, URS drilled four borings at the site as shown in Fig. 5. URS installed inclinometers (socketed into bedrock) in two borings to evaluate the extent of the existing slide and monitor slope movements during stabilization work at the bridge. URS also installed vibrating wire piezometers at three locations. One piezometer was installed to monitor groundwater conditions in the gravel layer overlying bedrock, and another was installed to monitor the surficial clayey and silty soils. URS installed the third piezometer in a 30-ft long steel casing that was lowered from the top of the bridge into the river to monitor river levels. One end of the casing was laid on the south riverbank while the other end extends about 25 feet into the river. All recent (2002) borings were drilled using rotary wash techniques. Samples were obtained using a split spoon sampler in accordance with the standard penetration test (SPT; ASTM D-1586) or a 3-inch O.D. thin-walled Shelby tube (ASTM D-1587).

Fig. 5. 2002 Boring Location Plan and Site Observations. (Note observations in bold made July 1, 2002.)

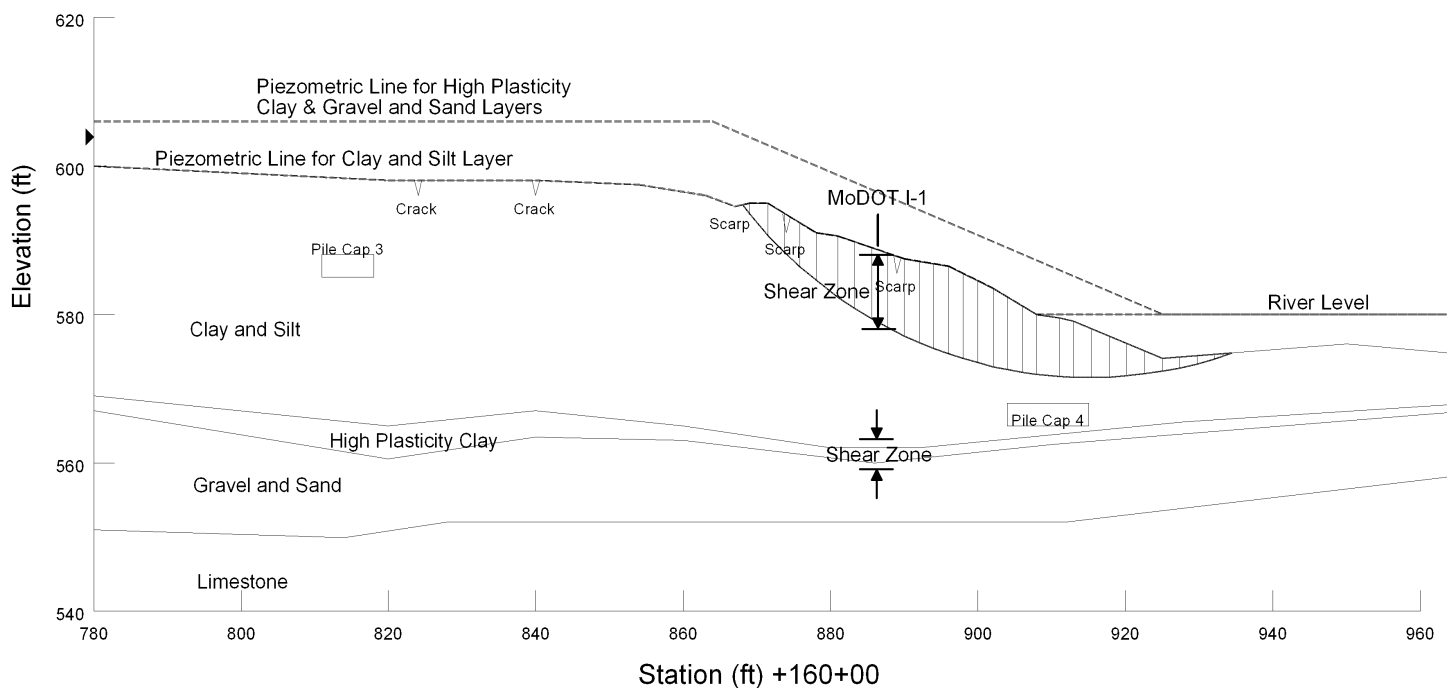
**Shallow Slide.** Figure 8 presents the back-analysis results for the shallow, rapid drawdown failure. As indicated in the figure, the head of the critical slip surface corresponds to the large scarp at the edge of the bank. Furthermore, the depth of the critical slip surface corresponds to the upper zone of movement measured in MoDOT I-1. We believe that this slide occurred after the deep failure as the floodwaters had receded, and that this slide did not influence the movement of Pier 4.

The analyses indicated that the shallow slide was marginally stable, with a factor of safety (FS) of about 1.1. This FS is consistent with the minor creep movements observed in MoDOT I-1. As such, the drained friction angle of 28° assumed for the clay and silt layer appeared reasonable.

Fig. 8. Back-analysis of "Shallow" Slide.

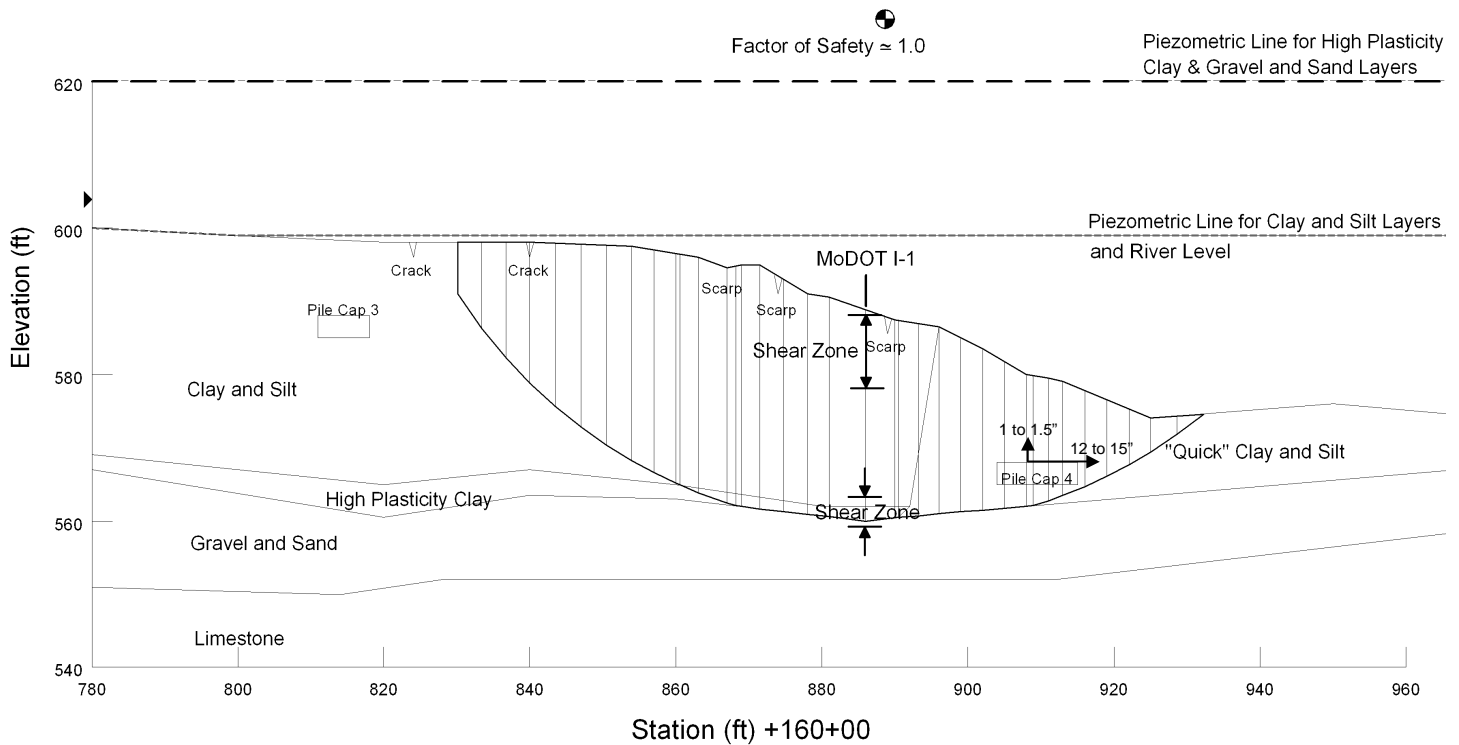
**Deep Slide.** Figure 9 presents the back-analysis results for the deep failure related to artesian pressures. As indicated in the figure, an artesian water level in the gravel layer of El. 620 is required to yield a factor of safety of about unity. This implies that the flood levels were higher than El. 612.5 and/or joints in the limestone charged the artesian pressures. This artesian head triggered quick conditions over a wide zone in the gravel layer. The soil labeled "quick" clay and silt indicates the extent of quick conditions in the gravel layer. In addition, a tension crack to the depth of the more permanent watertable (about El. 590) was added to reduce tensile forces in the slices. Figure 9 indicates that the head of the critical slip surface falls between the cracks observed just north of Pier 3 and the bottom of the critical slip surface corresponds to the lower zone of movement measured in the inclinometer.

Because the stability analyses provided factors of safety close to unity, these conditions (i.e., an approximate head difference of about 20 feet between the river and gravel layer) were

The analyses also indicated that the deep slide had stabilized, with a FS of about 1.3. This FS was consistent with the inclinometer data in MoDOT I-1 and survey measurements of Pier 4 that indicated essentially no continuing movement of the deep slide or Pier 4.

Fig. 9. Back-analysis of "Deep" Slide. Note that Pile Cap 4 was Moved 12 to 15 inches Laterally and 1 to 1.5 inches Vertically.

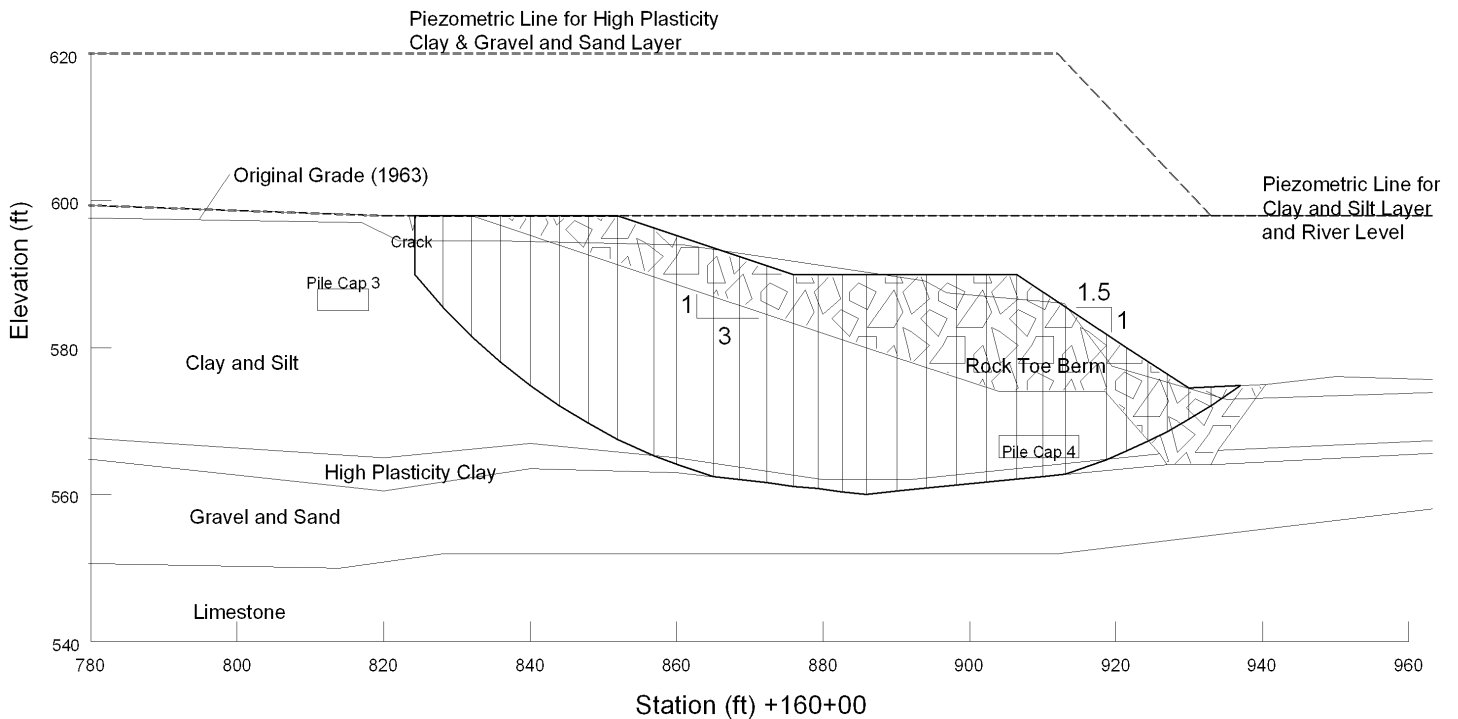
Fig. 10. Rock Toe Berm Design Section and Example Trial Sliding Surface.

Figure 10 shows the design configuration of the rock toe berm. The only restriction for the toe berm was that the final berm configuration was limited to the geometric limits of the riverbank at the time of bridge construction in 1963. The final slope of the toe berm is 1.5H:1V and the top of the berm is at El. 590. This configuration was developed to provide a factor of safety against slope failure of at least 1.3 throughout construction and during a repeat of the water conditions that caused the failure in Spring 2002 (i.e., river level at El. 599, artesian head at El. 620). To prevent scour and erosion of the toe berm material, it was decided to utilize MoDOT Type 2 Rock Blanket material (about 3-ft diameter rock).

The rock toe trench provides a drainage path for artesian pressures during flood events. This element of the repair will prevent a quick condition from developing in the gravel layer and prevent a "blowout" near the berm toe. Furthermore, the

toe trench protects the berm from being undercut by local erosion or scour of streambed soils at the toe of the berm. Lastly, the weight of the berm prevents a shallow rapid drawdown failure of the riverbank clays and silts.
