Case History of Labor Accident Due to Slope Failure During Slope Excavation and Its Countermeasure Work

Kazuya Itoh

National Institute of Occupational Safety and Health, Tokyo, Japan

CASE HISTORY OF LABOR ACCIDENT DUE TO SLOPE FAILURE DURING SLOPE EXCAVATION AND ITS COUNTERMEASURE WORK

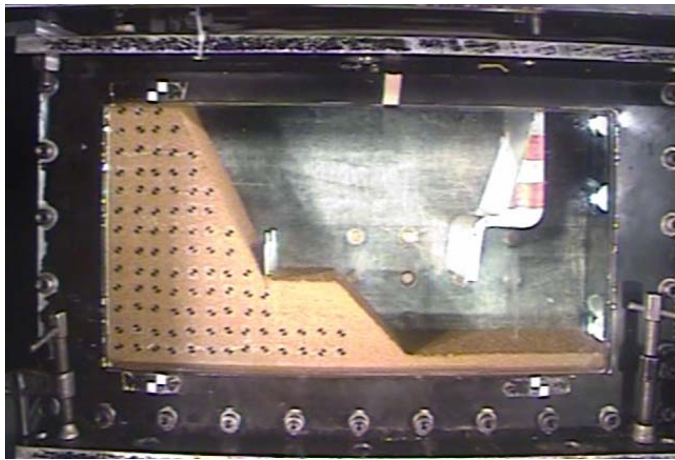
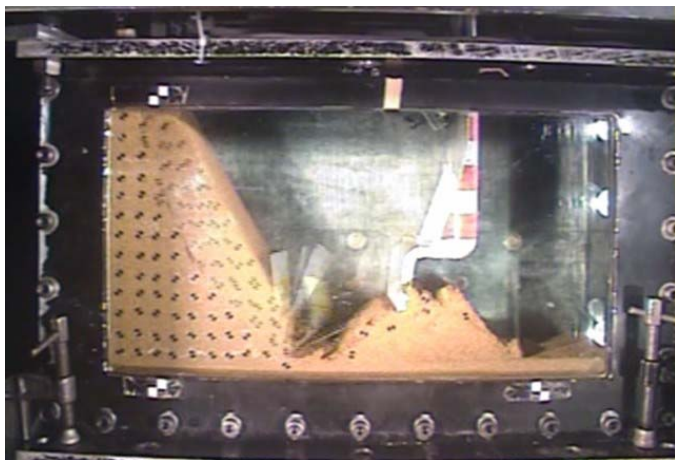
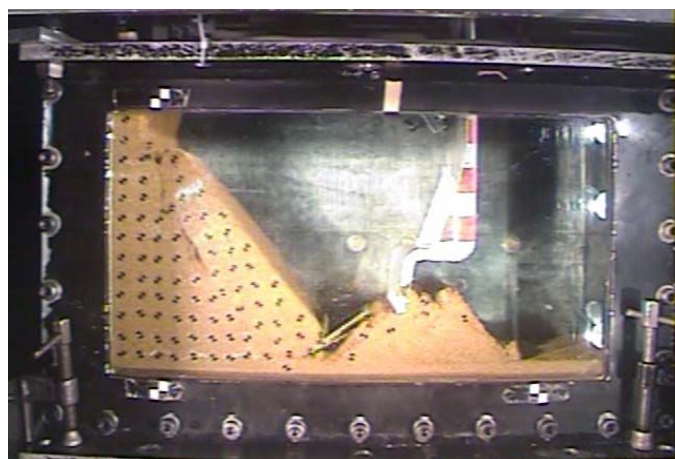
Fig. 12. Model slope during the centrifuge test (case 2).

(a) Initial condition

(b) Just failure (before 1.4 m excavation)

(c) After failure

Figures 11 and 12 show the recorded images of the model slopes during the centrifuge tests for the simple temporary wall with the embedded depth of 0.8 m and 0.4 m, respectively. In the model slope case 1 (actual condition at the time of labor accident), rapid deformation and slope failure were observed at the excavating process of 1.4 m as can be seen from the blurring failure images captured by the digital CCD camera. (Fig. 11(b)). In the model slope case 2 with a shallower embedded depth, slope failure occurred rapidly after the excavating process of 1.3 m (Fig. 12(b)).

This indicated that the toppling failure of simple temporary wall is likely to bury workers in the trench and there was no sufficient time for the workers to escape from the trench. In addition the plastic deformation of model steel pipe, which is considered to be caused by yield strength of the model steel pipe due to large load by slope failure, was also clearly recognized. In other words, the simple temporary wall used during the trench excavation in this case history could not protect to worker from the slope failure.

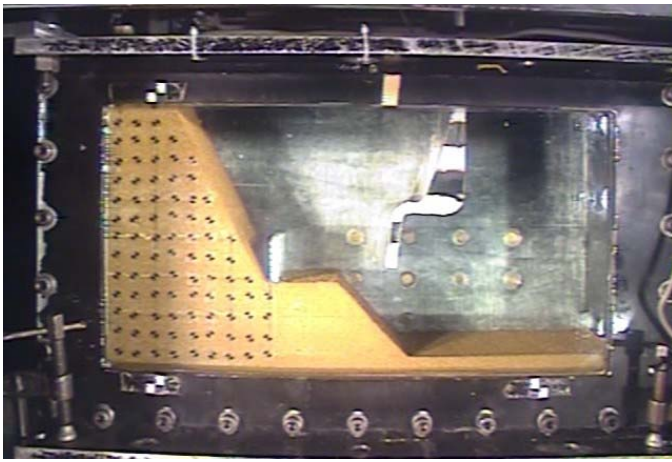
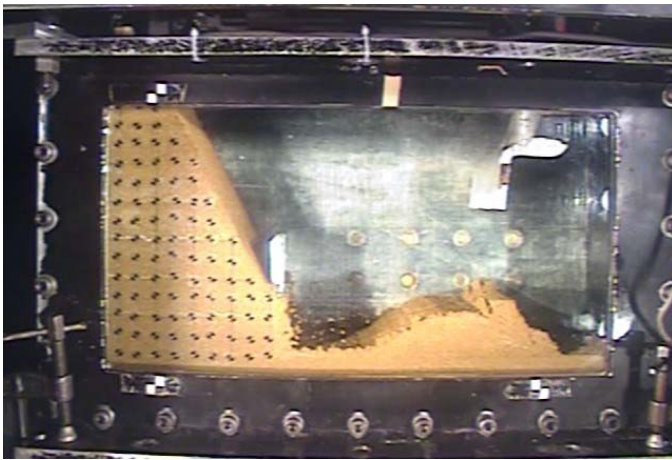
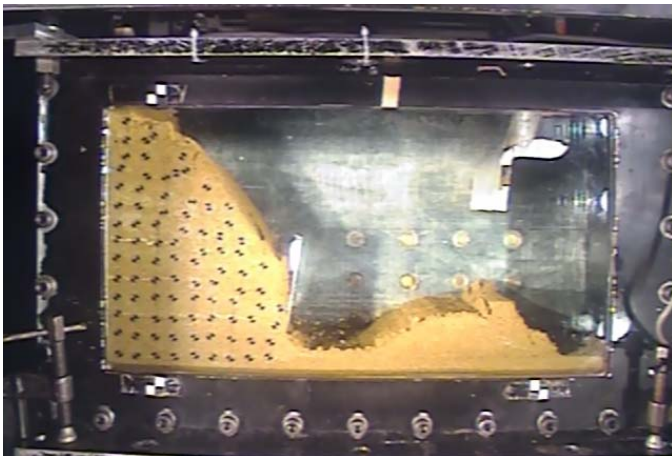
Fig. 13. Model slope during the centrifuge test (case 3).

As mentioned above it is necessary to provide a better shoring system to prevent the worker from the slope failure. In this paper the sheet pile wall method was purposed. Figure 13 shows recorded images of the model slope case 3 at different stages. In this case, slope failure did not occur with the excavating of 1.4 m at 25g, and the model sheet pile wall rarely or never develop to large deformation as can be seen in Fig. 13(b). In order to investigate the mechanism of slope failure in this case, the self-weight of the model slope was gradually increased until failure occurred.

When the centrifuge acceleration reaches to 36g where the excavation depth was about 5.8 m in the prototype scale, it can be seen that the displacement increase gradually such as in the case of landslide, it indicates that the slope reach the failure state (Fig. 13(c)). By comparing to the failure in the simple

(a) Initial condition

(b) After 1.4 m excavation

(c) Failure at 36 g

temporary wall, it was found that the use of sheet pile wall as a shoring system can protect the worker's life from the slope failure. In addition it is possible that the workers can escape safely from the trench because deformation caused by slope failure is suppressed by the sheet pile wall.
