Pit Slope Failure Problems in Goan Iron Ore Mines, Goa, India

A. Santha Ram

Indian Bureau of Mines, Nagpur, Maharashtra, India

PIT SLOPE FAILURE PROBLEMS IN GOAN IRON ORE MINES, GOA, INDIA

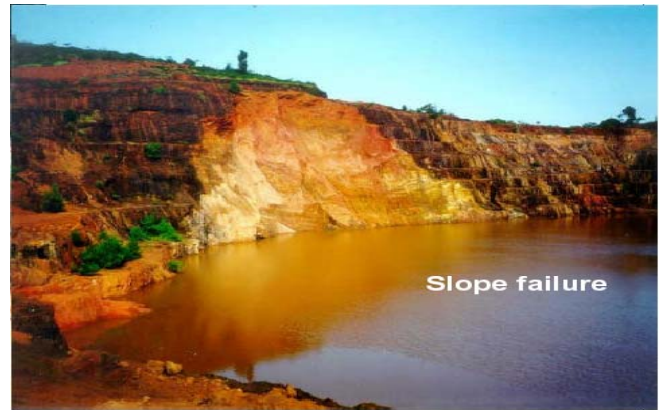
The pit slope which is 90 m in height is maintained by bench height of 5-6 m and 6-7 m bench width, maintaining an overall slope angle of 30°. Near the surface, 15-20 m comprise of hard laterite followed by 20 m of transitional zone of limonite/ferruginous clays followed by 25-30 m thick blackish brown plastic shale material which is located in the immediate footwall portion. The clays are of porous in nature and after getting highly saturated, there will be increase in pore water pressure and consequent loss of internal friction reduces the load bearing capacity and material behaves like a mud like material resulting in plastic flow/mud flow type failure. This, in turn causes crumpling of benches in hard laterite in the surface.

Pit Slope failure: Gross instability of benches

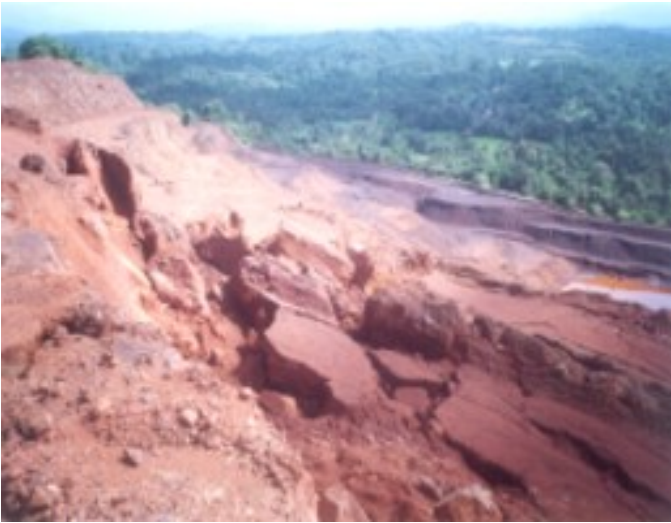
Pit Wall Collapse: Saniem Iron Ore Mine
