## Causes and Circumstances of Red Mud Reservoir Dam Failure In 2010 at MAL Zrt Factory Site in Ajka, Hungary

David Turi  
*FUGRO Consult Ltd., Hungary*

## CAUSES AND CIRCUMSTANCES OF RED MUD RESERVOIR DAM FAILURE IN 2010 AT MAL ZRT FACTORY SITE IN AJKA, HUNGARY

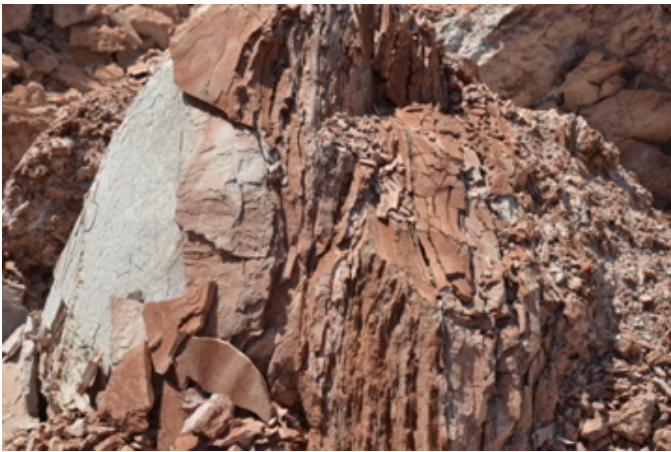
Defining the strength parameters of the dam was also vital and was absolutely unknown before. Our site surveys showed that dams built with the hydro-mechanization technology and are utterly inhomogeneous, and thus the structure became stratified. The layers can be observed on Figure 7.

Fig. 7. Dam section by the rupture

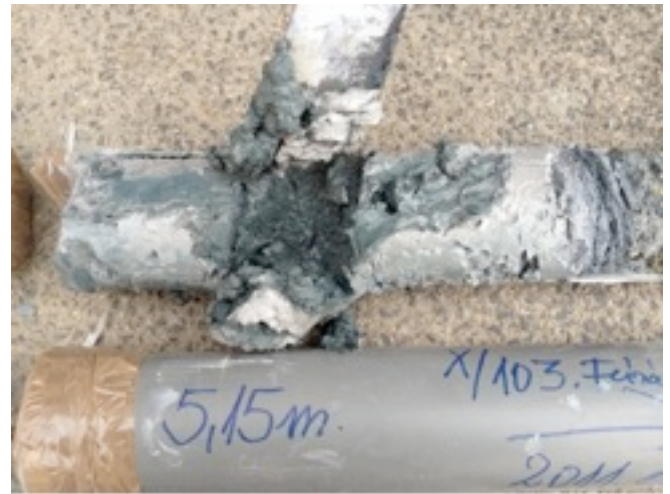
Fig. 9. Completely soft dam part

There is a wide range of differences in the strength parameters of the intact northern dam wall ( $\bar{\sigma}$ =200-3500 kPa). Based on the measurements and results the average strength of the collapsed western wall was no more than  $\bar{\sigma}$ =200-600 kPa. Figure 9. demonstrates the sensitivity to moisture content change in the dam. The core of the boring near the failure contains slag and ash losing its strength due to alkaline water, and thus becoming soft and degrading.

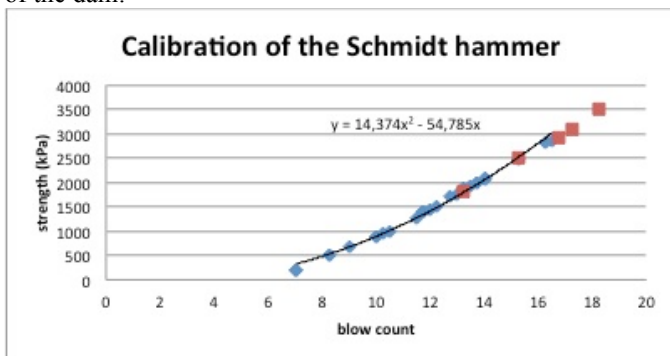
To determine the dam's strength properties we performed the so called Schmidt hammer tests (widely used for testing structural strength of concrete structures), an in-situ non-destructive test. The correlation between the dam's strength properties and the measured Schmidt rebound numbers has been established according to EN 13791:2007 referring to concrete structures. The applied relation, and the matching strength parameters and rebound numbers of the tested dam elements is shown on Figure 8, where the red dots are the calibration values, and the blue dots are the measured values of the dam.

Fig. 8. Strength of the dam

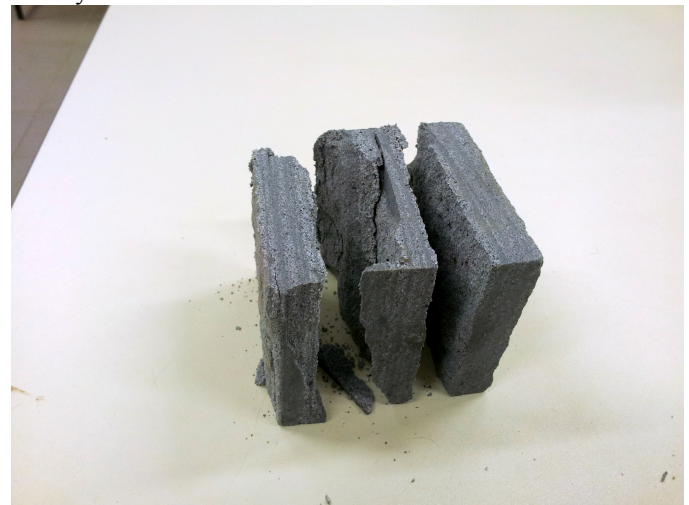
Laboratory tests have also been performed, complementing the in-situ measurements. It was possible to obtain solid blocks of slag and ash from the failure surroundings. The following conclusions were made based on the performed unconfined compression tests. The samples gained from the borings were loaded perpendicular to the stratigraphy. After the first cracks the sample could not bear more load and brittle fracture happened, as shown in Figure 10.

Fig. 10. Cracked dam sample

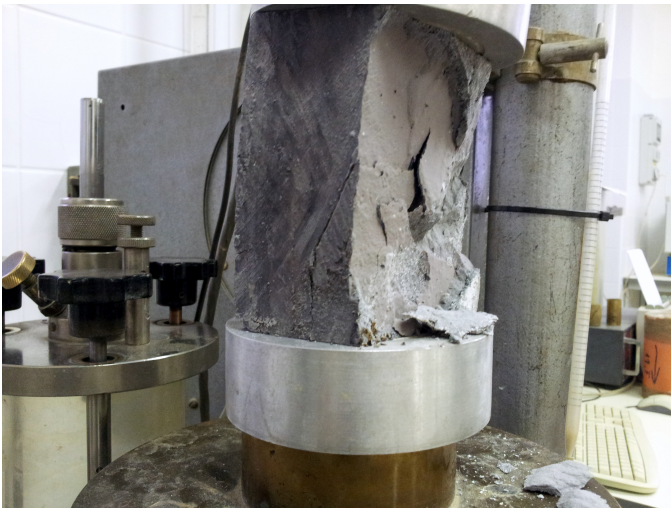
Samples of the blocks were also loaded parallel to the stratigraphy. After the first vertical cracks appeared the samples could still bear load (see Figure 11). Failure only occurred after the fracture of the strongest plate or layer, usually with brittle fracture.

Fig. 11. Unconfined compression test

Based on the in situ and laboratory tests the slag and ash dam proved to be a rigid structure due to hydro-mechanization. Small deformations are followed by an abrupt brittle failure without any warning sign.

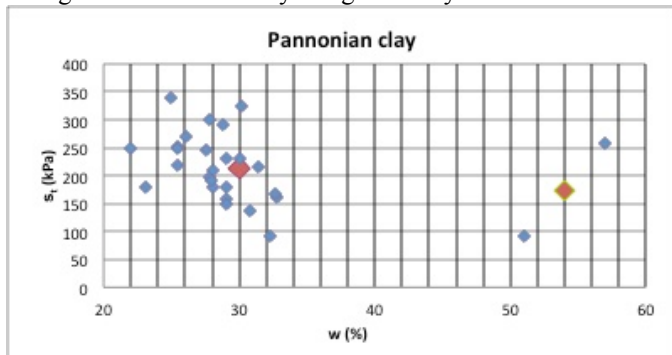
It became vital to find relationship between the strength and deformation parameters of the dam and the clay deposit laying and supporting underneath. Figure 12. shows connection between the strength and moisture content of the clay subsoil, pointing out how strength reduces while moisture content rises, regardless of the plasticity. The average values of the tests are  $\bar{\sigma}=213$  kPa;  $w=30\%$ . On a sample from the 80 cm thick layer of clay under the failure, these parameters are  $\bar{\sigma}=174.6$  kPa;  $w=54\%$  (see red dots on Fig. 12.), meaning the strength of the soaked clay is significantly lower.

Fig. 12. Strength properties of the clay

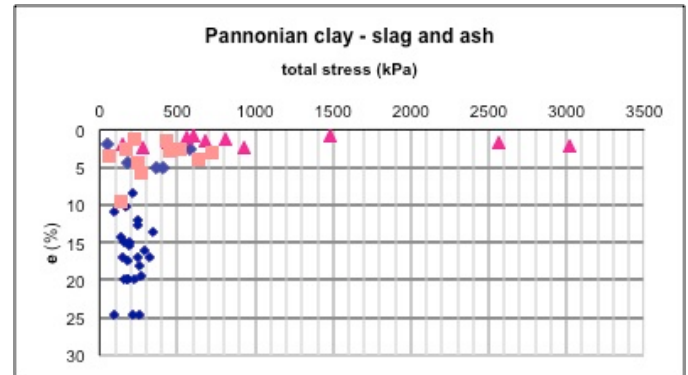
It is essential to be familiar with the deformations in order to understand the brittle fracture mechanism. Figure 13. shows the unconfined compression test results both on slag and clay samples. While the dam's strength ends around  $\epsilon=1-4\%$  by an abrupt brittle fracture, clays' strength ceases after a slow creeping phenomenon after  $\epsilon=10-25\%$  vertical deformation.

Fig. 13. Strain values of the clay and the dam

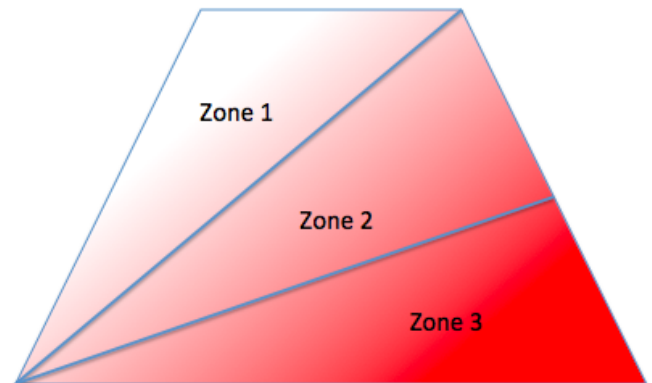
From the crest near the flooded (inner) part to the toe of dam on the protected (external) part the dam's strength varies between 1000-3000 kPa. This consists of approximately one-third of the dam's section, and is likely to be mainly unsaturated (see on Figure 14. Zone 1). The strength of the remaining two-third part is around 100-500 kPa. From the crest to level 202.0 mBf the strength of the saturated part is around 300-500 kPa (Zone 2.), and underneath that level, until the bottom, it is even lower, at around 0-500 kPa (Zone 3.). It is understood that these estimated strength values do not have a uniform distribution, but appear highly varying throughout the dam structure. Since the dam structure is highly inhomogeneous, the strength values differ by at least 1 but rather 2 orders of magnitude.

Fig. 14. Strength distribution in the dam

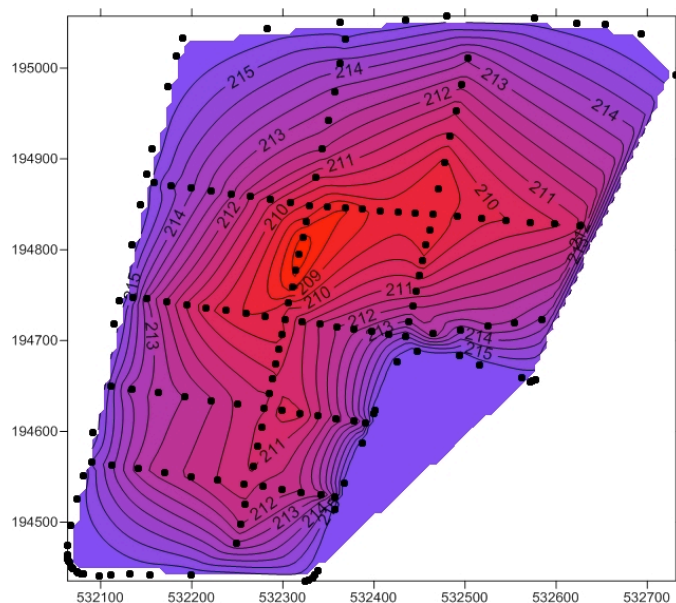
Fig. 19. Depth of the water over the reservoir X.

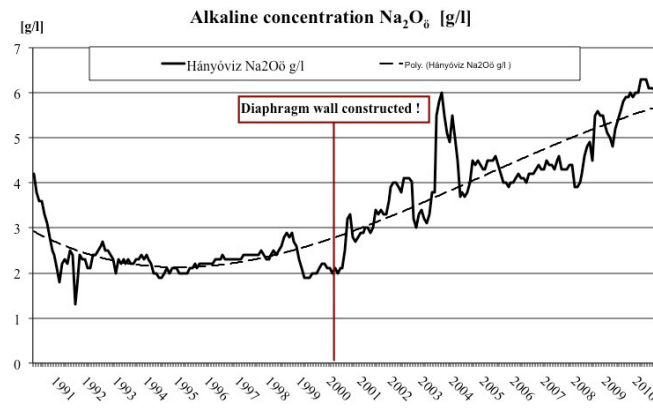
It is important to note that diaphragm walls were erected in order to seal the area of the reservoirs. The walls were finished in 2000 and, as the diagram shows, the alkaline

concentration began to increase afterwards, up to 100 per cent. The bottom of the reservoirs were not lined thus the NaOH could continuously dissolve from the red mud.

Fig. 20. pH increase from the year 2000.

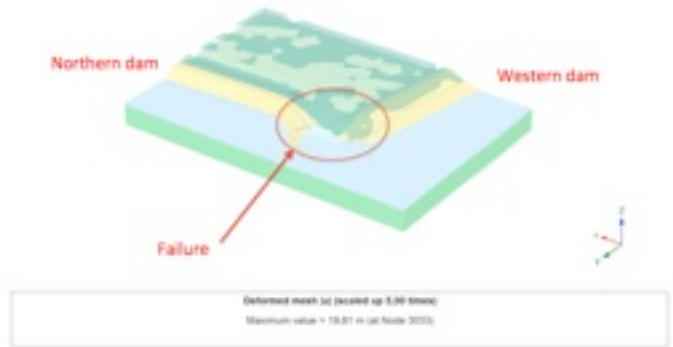
This could bring forth the question: why was the dam stable for many years? A logical explanation is that the corner of the dam was acting like a rigid spatial structure able to bear high specific tension, unlike soils. We run the 3D calculation both with the original and the new data. Assuming the reservoir is filled up until level 215.88 mBf, the result with the original parameters was n=1.02. The maximum allowed level was 216.00 mBf. Using the new parameters, according to our calculations the dam corner cannot resist the load from the 215.88 level fill, and collapses (see Figure 22.).

*Fig. 22. 3D FEM Analysis*

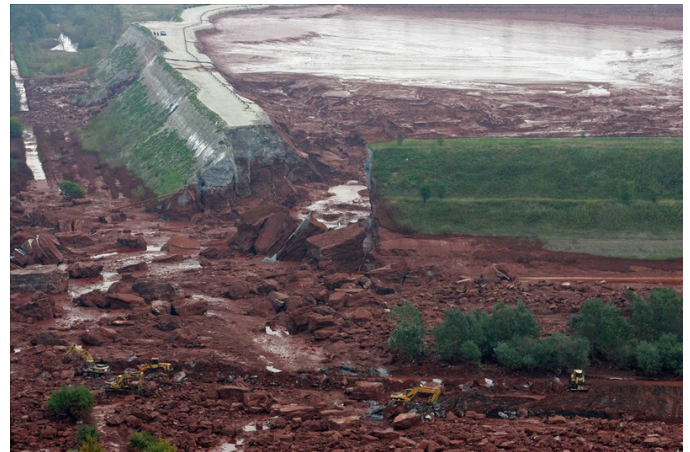
The comparison of the failure mode from our calculation and the actual pictures taken after the catastrophe confirms our calculation method (see Fig. 23).

*Fig.23. The cracked dam corner*
