The Agua Prieta Powerhouse Slope Instability

F. Gonzalez-Valencia and S. Herrera-Castañeda
Federal Commission of Electricity, Mexico, D.F.

The slope instability that endangered seriously the powerhouse of the Agua Prieta Hydroelectric Project and involved about one million cubic meters of soils and breccias is described. The evolution of the geotechnical instrumentation measurements done from October 1987 to date, the geomechanic analysis performed and the stabilization works are discussed.

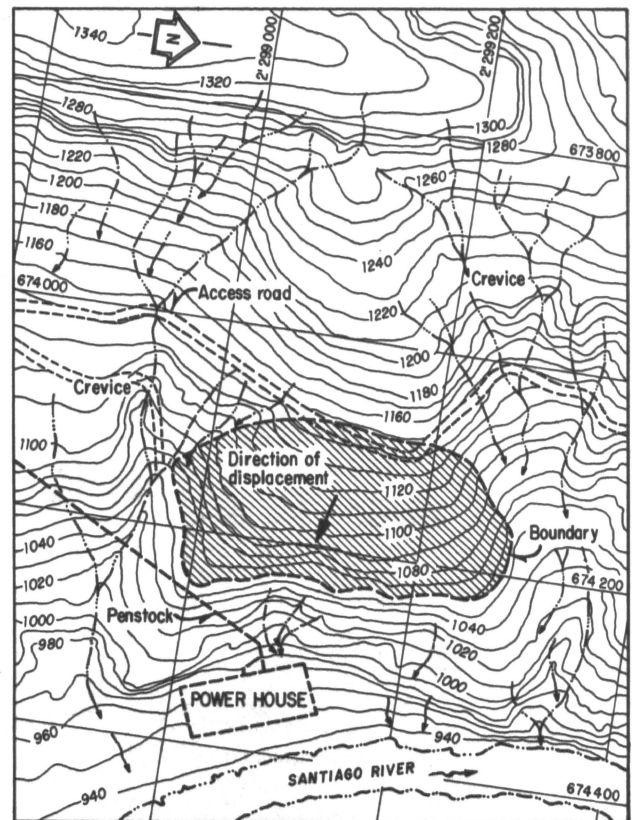
Fig. 3 Site topography and boundary of the sliding mass

Differential erosion by the Santiago River on the diverse geological units described below produced the topographic characteristics of the site shown in Fig 3, including steep slopes and scarps. The sliding mass is located between elevations 1055 and 1150 m and is laterally limited by two diverging crevices which are 150 m apart at the top and 250 m at the base. At elevation 1055, the approximately 35° slope turns down to an almost vertical scarp 100 m deep.

material Bv and limited by the clay layer (Ar Unit) at the base and the contact with the andesite basalt material (Tom-ata Unit) at the back (Figs. 3 and 4).

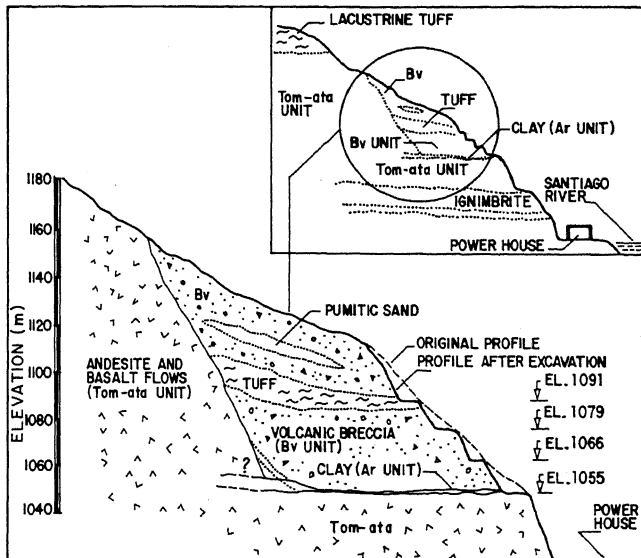
Fig. 4 Geological cross section of the uphill slope

In the site there are basically three lithologic units shown in Fig 4:

Tom-ata Unit. Is made up by vesicular andesite and basalt flows with two interbedded layers, one of ignimbrite 25 m thick and another of tuff with thickness varying from 10 to 20 m. There are also some layers of petrified clay between lava flows present in this unit.

Bv Unit. Is a volcanic breccia characterized by fragments of basalt between 40 and 100 cm in size, in a clayey sand matrix. Lenticular layers of pumitic sand and an horizon of tuff are also present. The unit weight varies from 2.3 to 2.5 ton/m³ and the internal friction angle was estimated between 40° and 45°. The sliding mass is constituted by this material which exhibits the properties of a well compacted rockfill.

Ar Unit. Located on the base of the Bv Unit, this material is a highly plastic clay derived from weathering of the lacustrine tuff. The x-ray diffraction test reveals that the predominant constituent mineral is montmorillonite. This layer shows striations and slickensides.

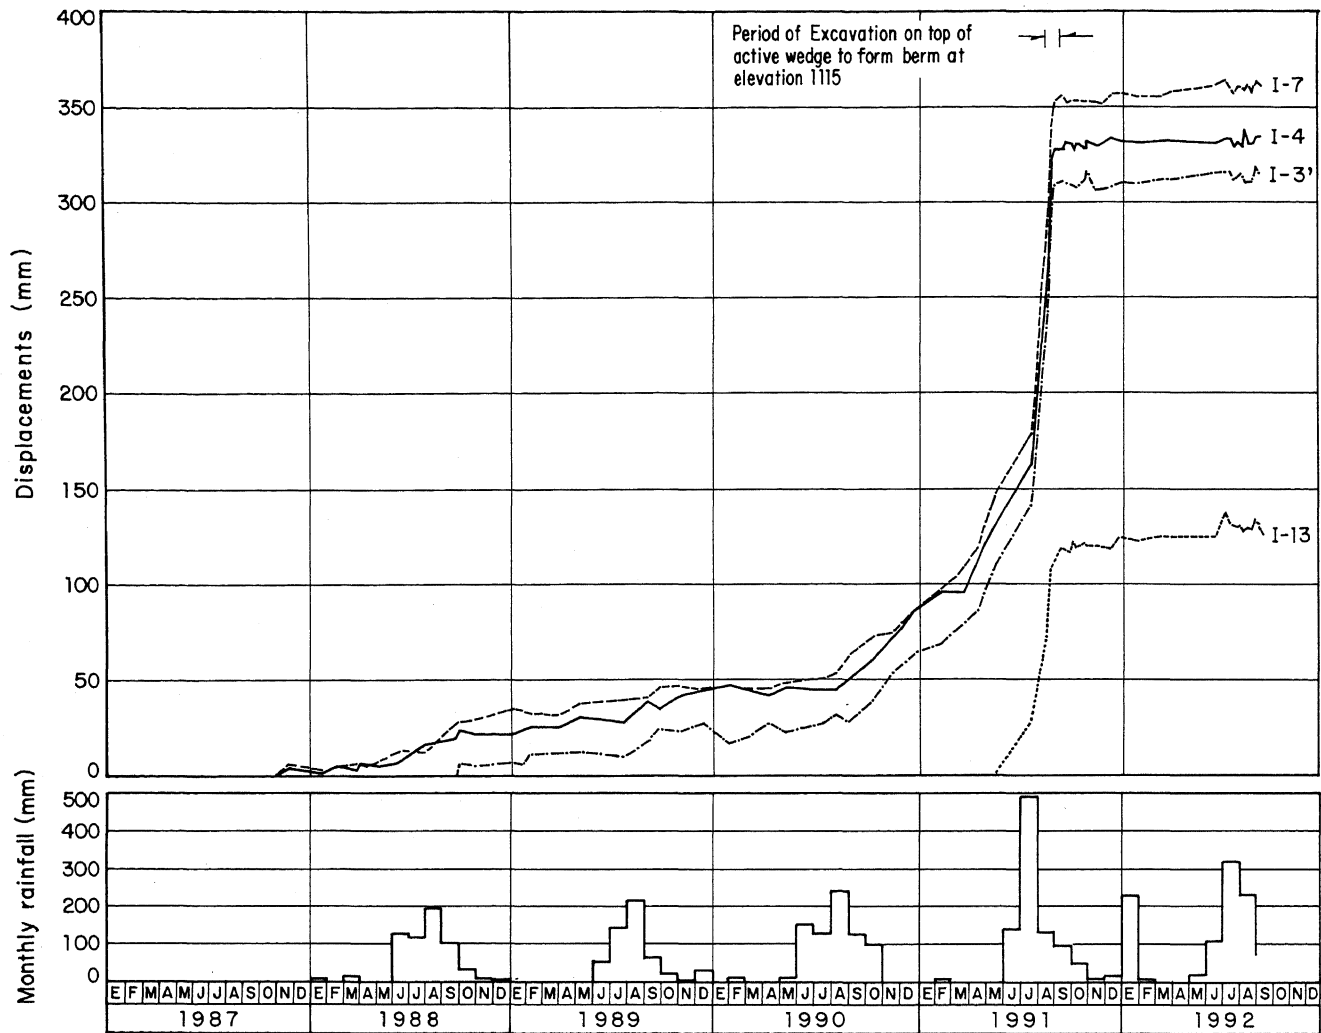
Fig. 6. Horizontal displacements of the mouth piece of four inclinometers

The displacements of the tip of inclinometers obtained by surveying are shown in Fig 6, along with the monthly rainfall records.

As said before, the slope moved at a rate of 1.8 to 2 mm per month during the dry season and accelerated to about the double during the rains. But in September 1990, the slide continued to move at the same rate even in the absence of rainfall and accelerated again in the next raining season up to 118 mm per month, showing clearly the beginning of a failure.

In August 23, 1991, after reaching a total displacement of 358 mm, the movement stopped as result of the stabilization actions described later. Little oscillating movements were observed from July 1992 to date as a consequence of the new instrument's incertitude and methodology used to determine faster the coordinates of the reference points.

The slide stopped in August 23 (Fig. 6) when the excavation volume was $37,200 \text{ m}^3$ approximately, equivalent to about 89,300 ton. This was the force needed to stop the slide and that means that the slide could have not been stopped economically and in time by other means. As the final excavation volume was $99,708 \text{ m}^3$ it is estimated that the static safety factor increased 25%.

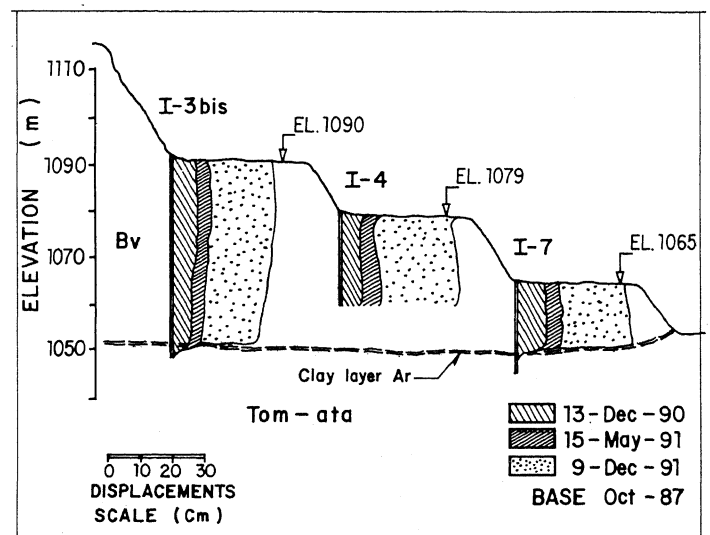
Fig. 7 Deformations along three Inclinometer casings

Because the telescopic initial array of inclinometers, three instruments (I-4, I-5 and I-6) did not show significant displacements while the others did. This obscured the first data analysis until when with the longer inclinometers an almost horizontal sliding plane was detected. Then the data was reprocessed considering the topographic coordinates of the mouthpiece of the casings as the fix point and then by integrating downwards the inclinometric geometry. The presence of a rigid block moving over the clay layer became then clear. Figure 7 shows the simplified deformation profiles for

three inclinometers along the central section of the slope. It can be observed the great magnitude of the slide between May and December 1991.

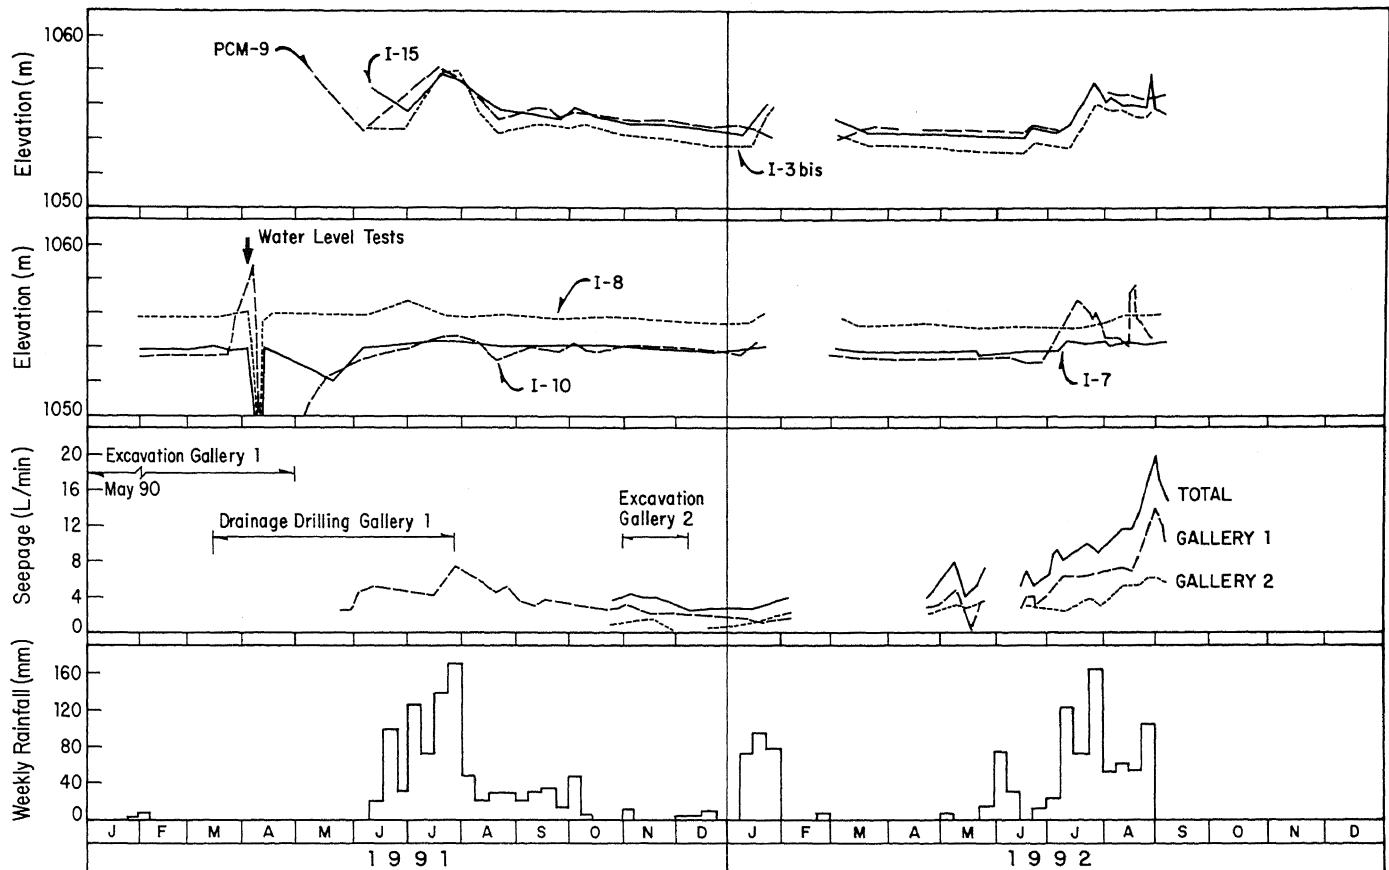
Fig. 8 Piezometric levels, seepage through drainage galleries and rainfall

The piezometric levels inside the sliding mass registered by several instruments from 1991 to date are shown in Fig 8. It is clear the raising of these levels during the raining seasons. Although their values vary according to the location and type of each instrument. The data are consistent and reliable and permit the evaluation of water pressures inside the slope.

The seepage water collected by the new drainage galleries is also shown in Fig 8. It can be seen the increase of the drained water volume during the rainy season, as another evidence that the galleries are working as planned.

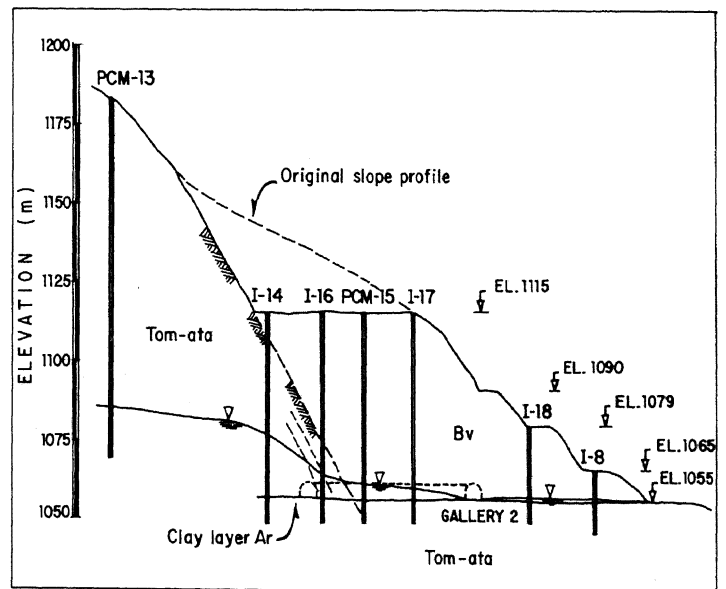
Fig. 9. Piezometric profile along the main instrumented section

The piezometric behavior inside the slope are governed both by the permeability differences between the Tom-ata and Bv Units, and by the impermeable layer formed by the Clay Ar Unit. The first keeps high the piezometric level at the back of the sliding block and the second allows the water table raising inside this block.

To down the piezometric level two drainage galleries were excavated in 1991 (Fig 11). The profile along the main instrumented section for the readings made in September 7, 1992 is shown in Fig 9, where it can be observed both the permeability effect and the water table lowering at the block as result of the drainage gallery construction.

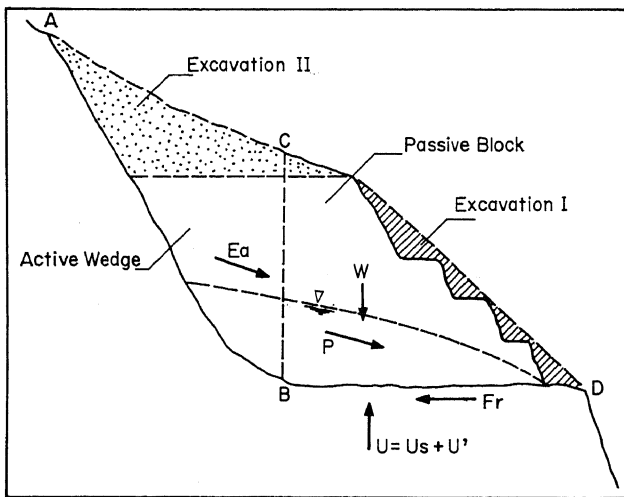
Fig. 10 Failure mechanism adopted for stability analysis

The failure mechanism conceived is presented in Fig. 10. The active wedge of the block (ABC zone) pushes outward the passive block (BCD) with a force E_a which slides horizontally against the shearing resistance F_r of the clay layer. The other acting forces are the weight of the block W , the percolation water force P and the upward reaction U from the underlying rock, including effective stress plus pore pressure. When the trimming cuts were performed (Excavation I), the movement began because the decrease in F_r due both a reduction of the block weight and the decrease of the angle of internal friction of the clay after the occurrence of some displacements. The slide accelerated during the rainy seasons due to the increase in percolation force by accumulation of water above the clay layer. Moreover, from June to December 1990 five boreholes were drilled to install more inclinometers and piezometers using bentonitic mud as perforation fluid. Due to the high permeability of the breccia systematic loss of perforation fluid happened, thus introducing about 40 ton of bentonite. It is presumed that this mud created low permeability zones within the breccia block therefore increasing the percolation water force P during the rainy season of 1991, resulting in the great block displacements measured.

The analysis results leads to recommend the excavation of $100,000 \text{ m}^3$ at the top of the active wedge (Excavation II in Fig. 10) forming a platform at elevation 1115. Because of the weakness of the rock, this was performed immediately without the use of explosives and achieved from August 11 to September 9, 1991.
