Investigation of Settlements of a Trunk Road Embankment in Hong Kong

SYNOPSIS : A 25 m high fill embankment was constructed as part of a Trunk Road scheme in Hong Kong. In June 1985, large settlements of the order of 250 mm were observed in the embankment. This was followed by a local slippage of surface material from the downstream slope face. To meet the schedule for opening the trunk road in late September, a number of emergency measures costing about HK\$1 M (US\$0.13 M) were implemented to stabilize the embankment. An investigation was subsequently carried out to assess the cause of the movement and the long term stability of the embankment.

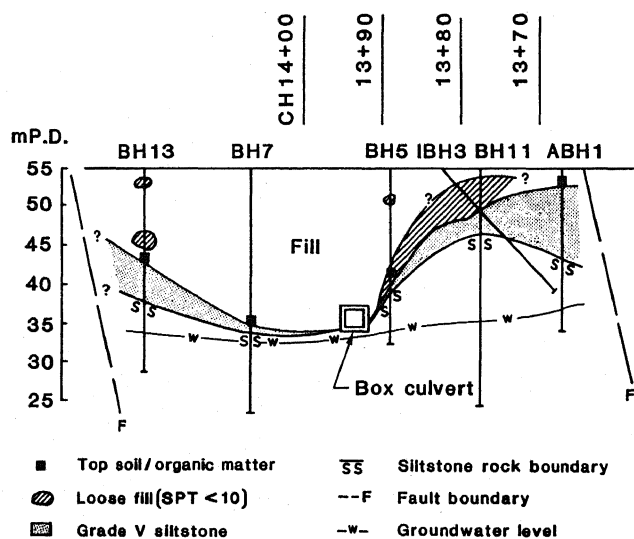
Figure 1 - Cross section through trunk road showing the geological and groundwater conditions

The foundation rock is a highly fractured (RQD = 0 to 25%) sedimentary siltstone of Upper Jurassic age, the fracturing being due to faulting. The top layer of rock has been completely decomposed to a well-graded clayey sandy silt. The rock mass is fairly permeable ($k = 10^{-5}$ to 10^{-6} m/s) compared with the residual decomposed rock ($k = 10^{-7}$ m/s). The groundwater table is situated well down in rock. Though bouldery colluvium exists up-stream of the embankment, no colluvium was found under the fill. Figure 1 depicts a cross section through the trunk road showing the geological and groundwater conditions.

data and records of emergency measures were scrutinised. Aerial photograph interpretation and field geological mapping were carried out. Trial pits, inspection trenches, GCO probings (GCO, 1987), drillholes and piezometers were ordered to assess the geological and ground-water conditions and the density of the fill. Air foam was used as the flushing medium for the drillholes that were sunk through the embankment body, to minimize the possibility of any adverse effects on the stability of the side slopes (Phillipson & Chipp, 1981; 1982). Drilling was closely supervised. Standard penetration tests carried out in the drillholes revealed the presence of a patch of loose material above the eastern valley face (Figure 1).

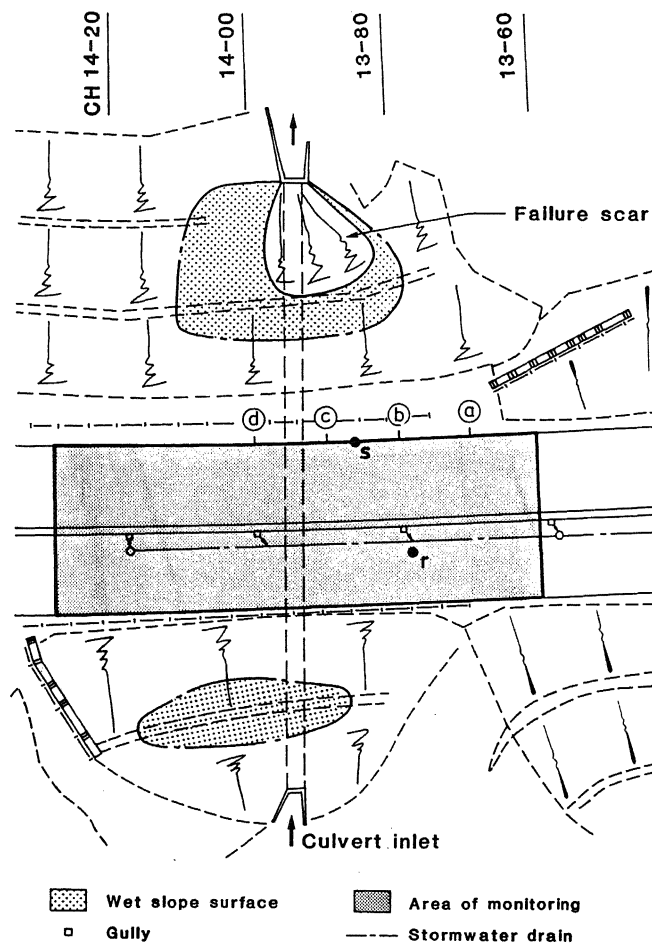
Figure 2 - Plan showing area of road surface monitored

In early June 1985, after a few days of rain, settlements were observed at the central divider of the road near Chainage 13+82. Monitoring of the settlements commenced on 6th June. Figure 2 shows the area of monitoring. The embankment was then test loaded to 20 kPa.

In early July, a defective gully close to point r (Figure 2) was found - the base of the gully had settled 20 mm relative to its side walls. The slope surface was observed to be wet. Cracks were also evident at the surface channels and catchpits on the slope. By late July, settlement at point r had reached 250 mm. The gully and a length of cracked stormwater drain were subsequently replaced. However settlement monitoring in late August indicated that the road was still settling.

In September, a series of grouting were carried out, both within the embankment body and at the interface of the fill and the insitu ground. Altogether 86 grout holes were formed and about 300 m³ of cement were used. During drilling for the grout holes on 6th September, the insitu ground/fill interface was found to be 'saturated'. On the morning of 7th September, a shallow slip, involving a 1 m deep layer, occurred at the downstream slope face (Figure 2).

Various sources of water have been examined during the investigation. The cracked gully was identified to be the main possible source. Its location is remarkably close to point r, where maximum settlement had taken place (Figure 2).

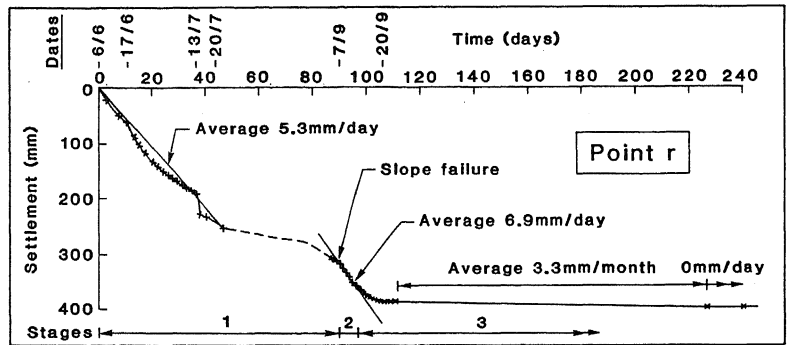
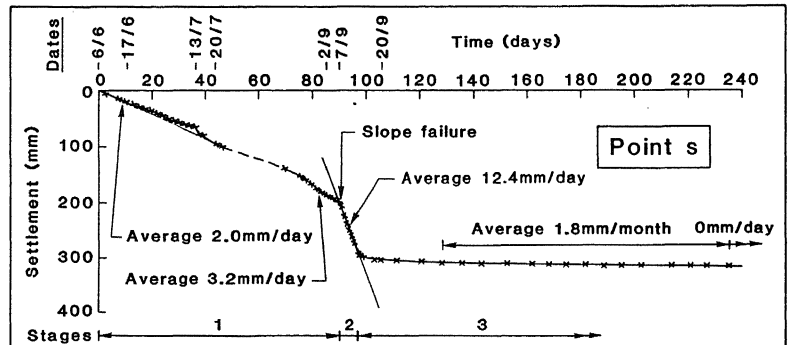
Figure 3 - Settlement histories of points r and s with summary of events

The settlement histories of points r and s are shown in Figure 3.

Dates	Events
6/6/85	Monitoring started.
17/6	Test load of 20 kPa applied.
13/7	Leaking gully at Ch. 13+78 found. Testing revealed leaking stormwater drain.
20/7	Removal of test load.
Late July to Late Aug.	Replacement of defective gully and cracked stormwater drain. Road reinstatement.
6/9	Grout hole drilling commenced.
7/9	Part of downstream slope failed. Slope fully saturated.
10/9	Carriageway grouting started. Seepage from slope face during grouting.
16/9	Grouting completed.
19/9	Road surface reinstatement started. Crack observed in repaired gully. Three gullies and a manhole were blanked off.

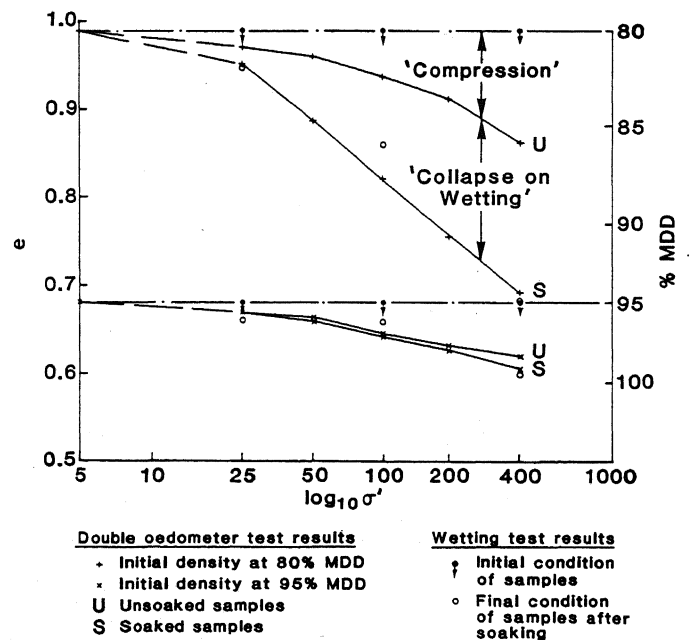
Figure 4 - Results of oedometer tests

The results of these tests are summarized in Figure 4. It can be seen that there are two components of settlement, viz compression of the unsaturated material, and collapse due to wetting.

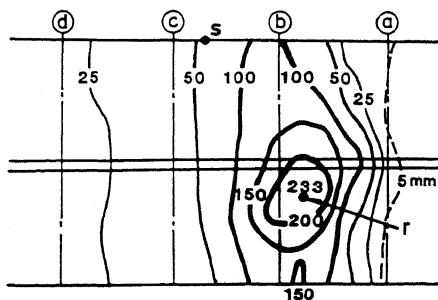
Figure 5 - Settlement contours for stage 1

- (a) Stage 1 settlements had a dish-shape and appeared to have resulted from a point disturbance around point r (Figure 5). They had a stick-slip relationship with time (Figure 3a), i.e. a 'collapse' type of settlement. Calculations indicated that the 20 kPa test load could have induced up to about 10% of the total settlements in this stage.

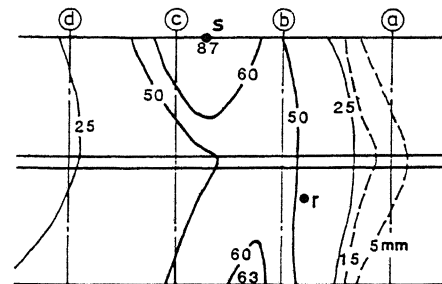
Figure 6 - Settlement contours for stage 2

- (b) Stage 2 settlements were much more rapid (Figure 3b) and were likely to be related to slope instability (Figure 6). Stability analyses of the side slopes assuming 'dry' condition, i.e. zero pore pressures, gave factors of safety in excess of 1.2. However, measurements taken in the grout holes after drilling indicated high water levels in the holes. In one of the holes, water was found to be only 5 m below the road surface. Further stability calculations using the measured 'phreatic surface' revealed factors of safety close to unity. There was heavy rainfall between 4th and 6th September. The rain could have had some effects on the slope, but it could not be the main cause of failure as the slope had survived previously harsher rainstorms.

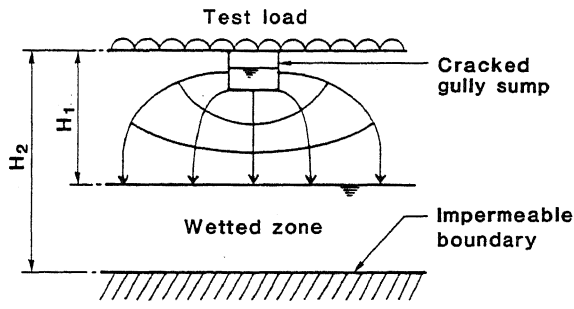
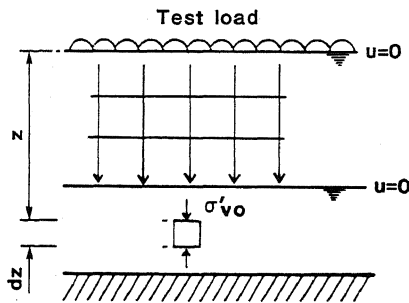
Figure 7 - Proposed hydrocompaction mechanism for collapse of loose fill

stone, with some top soil and organic matter at the base of the fill. This fill/insitu ground interface would allow any descending water from the gully to perch on, thus permitting the formation of a wetted zone that can advance upwards to initiate hydrocompaction of the loose patch of fill (Figure 7). An idealised 1-D model was used to compute the order of settlement, using the oedometer test results. The following summarizes the analytical approach adopted.

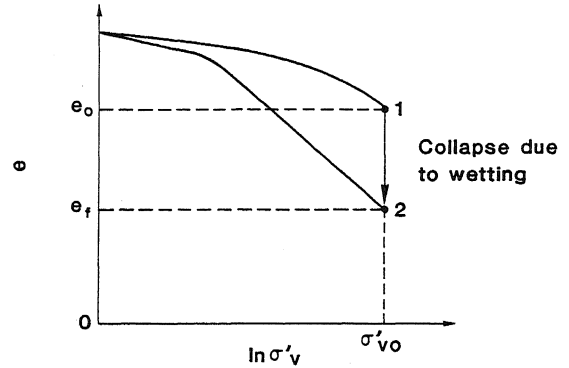
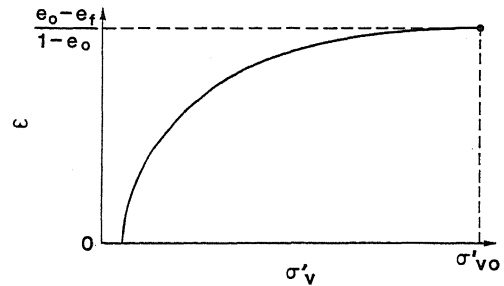
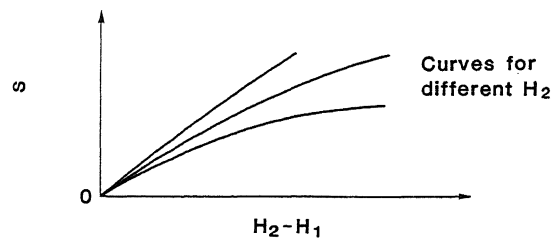
Figure 8 - Interpretation of oedometer test results

Figure 8a shows a typical set of wetting test results. A soil element denoted by point 1, upon wetting, will collapse to a denser state denoted by point 2. In the field, this will occur when the wetting front has advanced beyond the soil element at depth z (Figure 7b). The compression, ds , of the element is given by :

where $\epsilon = (e_o - e_f)/(1 + e_o)$ is the strain due to collapse, e_o and e_f are the initial and final void ratio of the soil element respectively. From the results of wetting tests, a relationship between strain ϵ and vertical effective stress σ'_v can be derived (Figure 8b).

Using the above equations, a series of base curves were produced (Figure 8c) and these curves were used to evaluate the wetted depth H_1 at each settlement monitoring point.
