## Failure of an Excavation Support System

## FAILURE OF AN EXCAVATION SUPPORT SYSTEM

The design, construction, and collapse of an excavation support system constructed through layered soils are presented in this paper. The braced soldier-pile and lagging shoring was installed through soft clay, with the base of the excavation in hard glacial deposits. Complicating factors included the use of soil berms for temporary support, construction sequencing, weather conditions, and the location of the failed section near a re-entrant corner of the shoring system. Rapid responses of all contract parties and careful evaluation of the failure causes limited subsequent safety and damage concerns, and no claims were made. Post-failure examination of the preceding events provides several insights into potential better specification practices. Theoretical comparison of soil strength and structural engineering principles demonstrate the true failure mechanisms in spite of several implied causes suggested at the outset of the investigation.

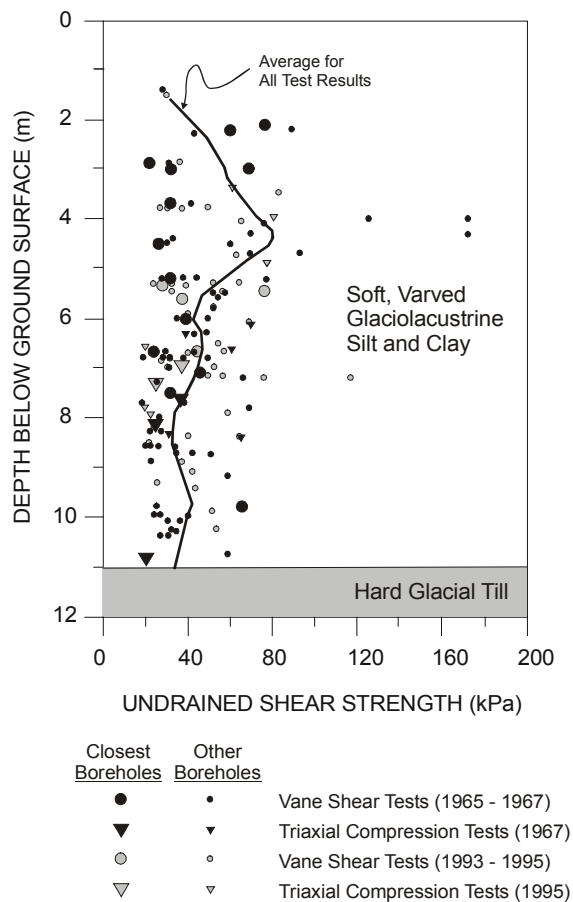
Construction of a new subway station required an 11 m deep, shored excavation through a thin layer of fill, varved silt and clay of variable strength (see Figure 1), and a hard cohesive glacial till underlying the soft deposits. Undrained shear strength of the hard glacial till deposit was about 300 kPa or greater.

Figure 1. Subsurface conditions in area of shoring collapse.

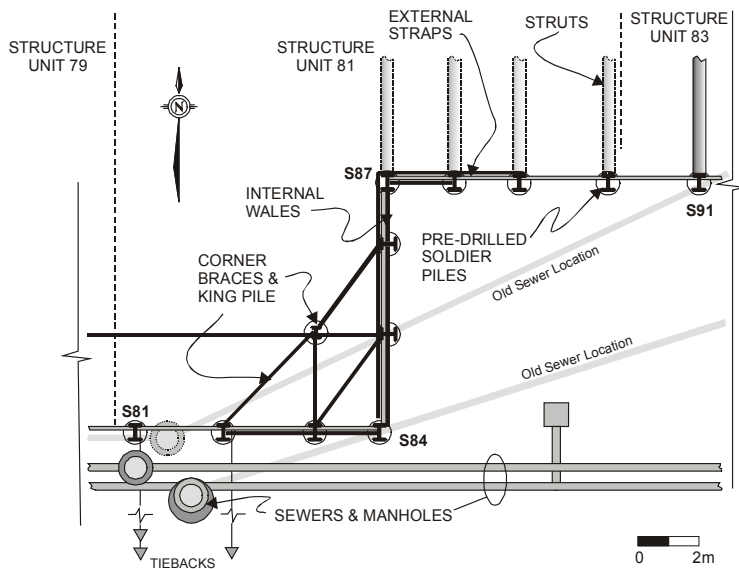
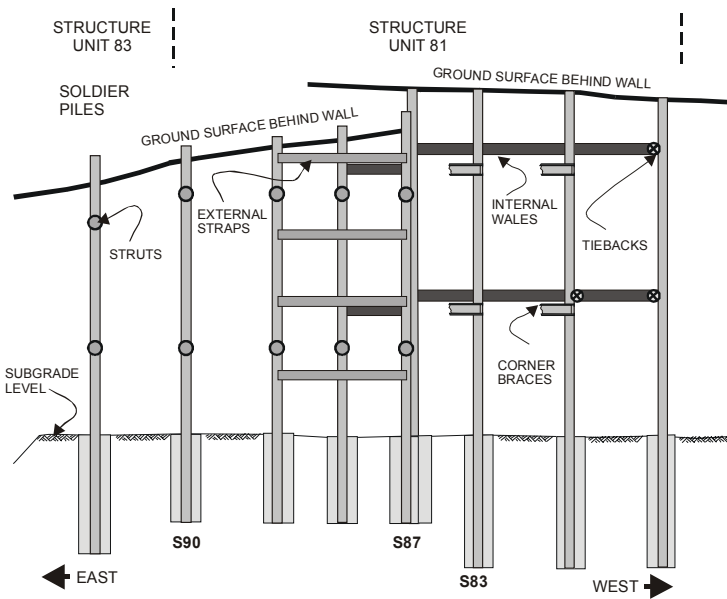
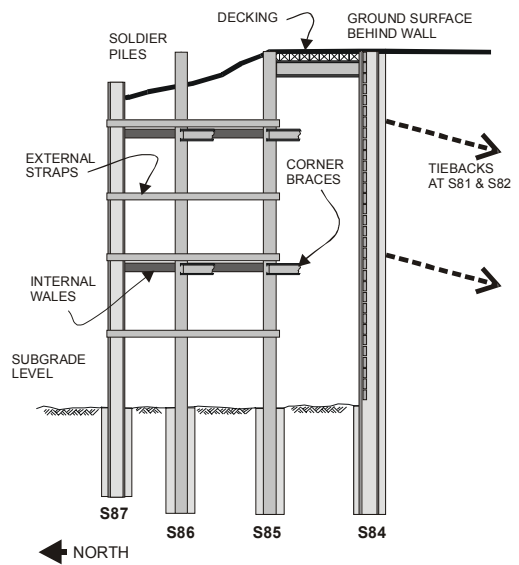
PLAN VIEW OF SHORING DESIGN

Figure 2. Shoring design in area of corner failure. Locations of soldier piles are noted as S81, S82, etc.

Case A: Construction up until the time of failure had not included installation of the steel straps along the north face, between piles S87 and S91, as indicated in Figure 2 and 4. In this case, there was no support to pile S87 in the east-west direction except for the pile's own bending resistance.

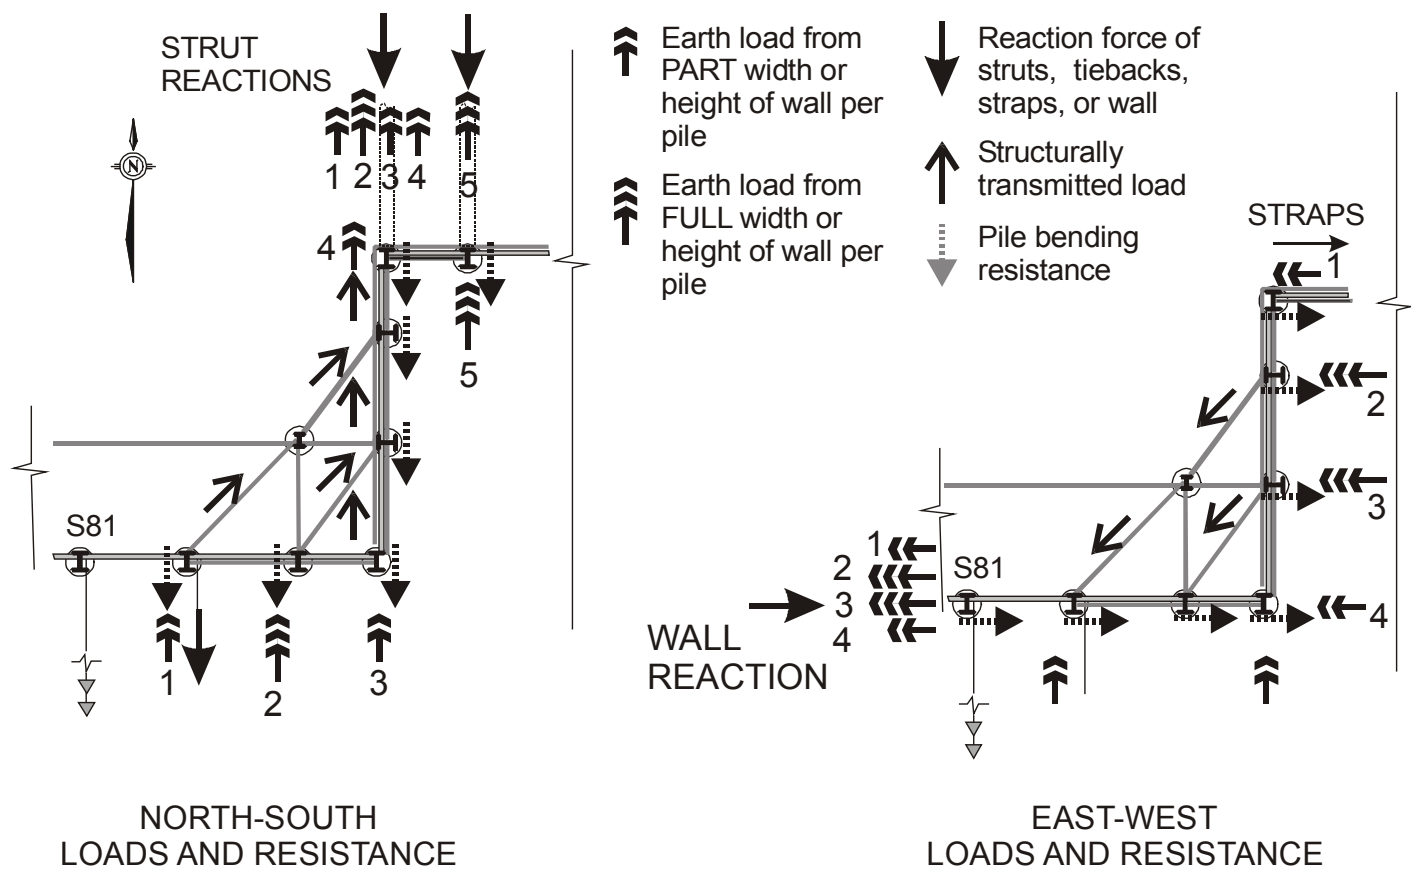
Figure 3. Earth loads and support mechanisms for shoring corner had all structural members been in place.

The NS load component in this case has to be resisted ultimately by the struts placed against pile S87 and the bending resistance of the piles S82 through S87. Prior to the failure, the contractor’s personnel and advisors considered that the northward loads would be resisted by earth berms left in place in front of piles S87 to S90.

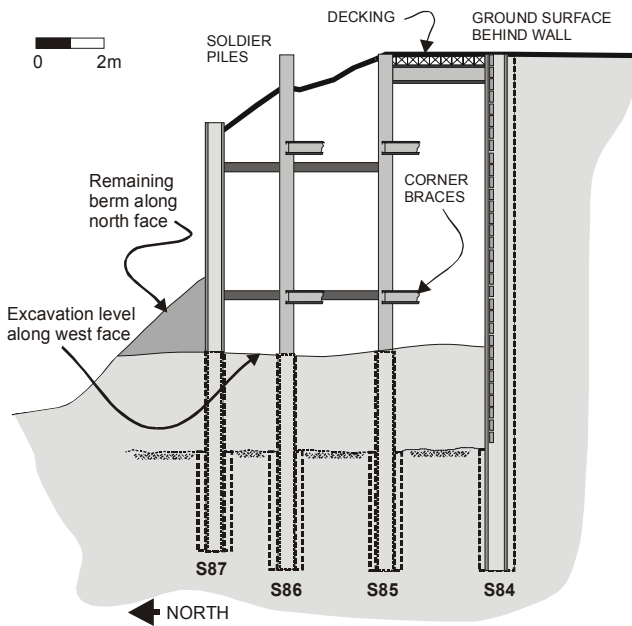
Day 9. Following the weekend and holiday, excavation was resumed. The lower tie-backs were stressed from pile S76 to S82, inclusive. Earth berms were left in place to support the retaining structure prior to placement of struts, as illustrated in Figure 4. This practice is typical of local construction, and is a practice used elsewhere (e.g. Clough and Denby, 1977).

Day 10. Excavation continued on the north side of Unit 79 and 88 and lagged between piles S71 to S83 and N73 to N81 (not shown in Figure 2). Figure 4 illustrates the conditions on Day 10 prior to failure.

Figure 4. Conditions prior to failure.

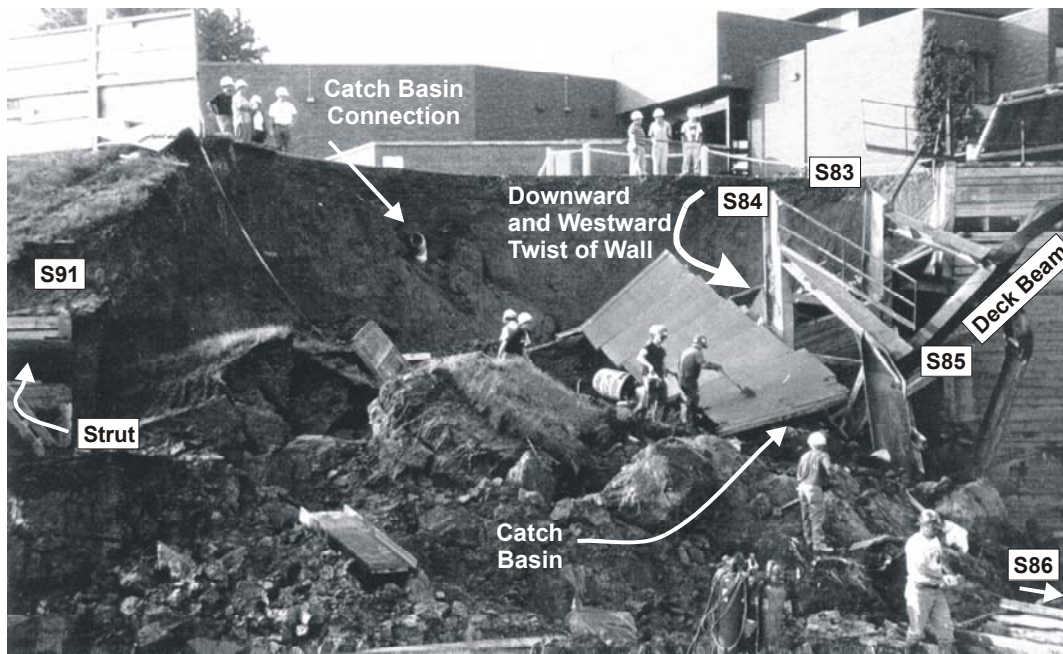
Day 16. The shoring collapsed in the early morning hours prior to crews arriving on site. Figure 4 illustrates the conditions immediately prior to the collapse and Figure 5 illustrates conditions on the morning the collapse was discovered.

The conditions and geometry of the failed earth mass behind the shoring were generally consistent with an active failure of the earth mass behind the wall with subsequent progressive failure of the unsupported soils. The maximum distance from the wall to the failure scarp was approximately 1 to 1.5 times the maximum vertical height between the glacial till layer and the ground surface elevation. The scarp formed a circular pattern with a radius originating near the location of the corner pile (S87). All of the piles destroyed by the failure also appeared to be bent in the direction of failure near the interface of the glacial till and glaciolacustrine soils.

Figure 5. Photograph of collapse looking south.

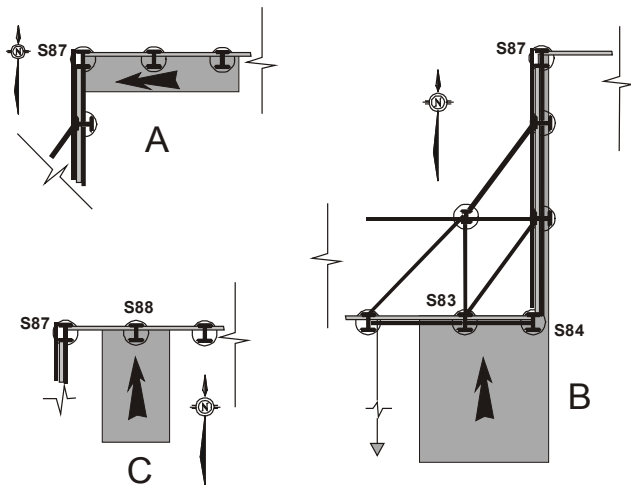
Case B: The absence of struts placed against pile S87 at the time of the failure meant that only the cumulative bending resistance of the piles was available to resist the northward component of the loading on piles S83 to S87.

Case C: North-south loading was also examined for pile S88 as representative of piles S88 through S90 that also failed. Load resistance for these piles was to be provided by the two levels of struts that spanned the excavation to the north side. Because the

Figure 6. Analysis cases.

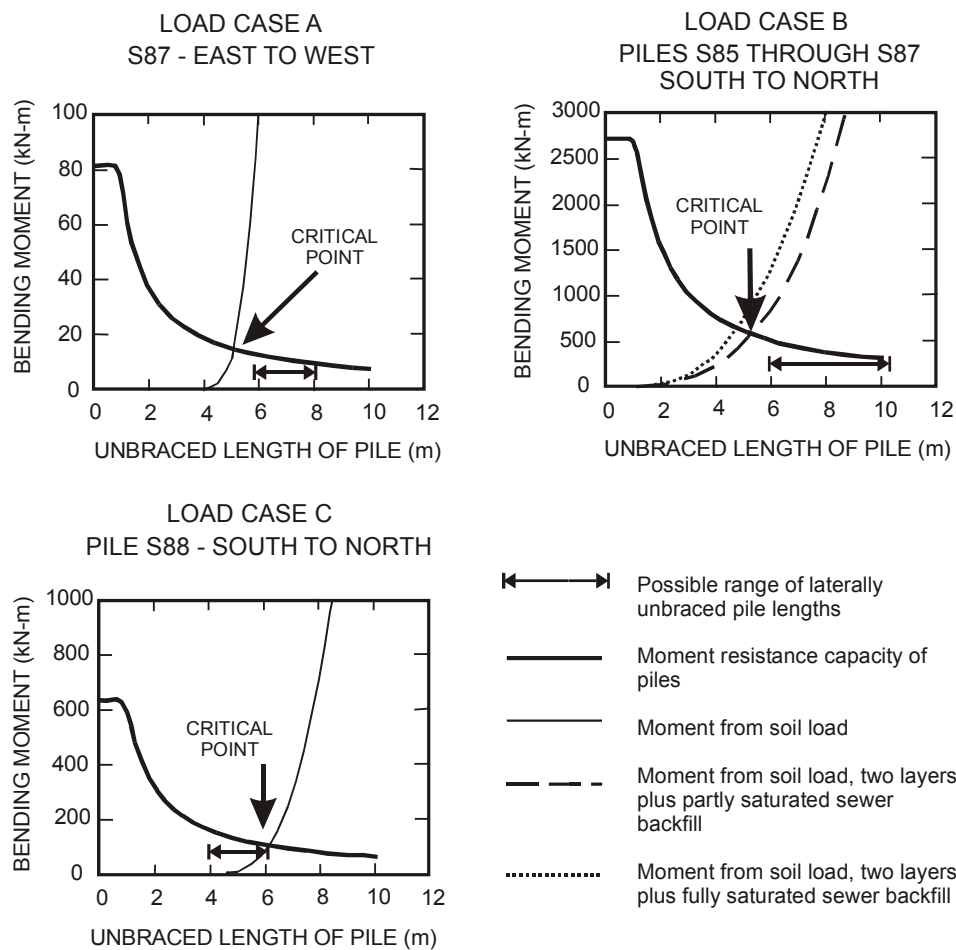
Figure 6 illustrates the loading conditions on the piles for Cases A, B, and C. The point on the “unbraced length of pile” axis, below the intersection of the lines plotted for structural bending resistance and the lines plotted for soil loading indicates the point at which pile collapse could be expected to occur (critical point). In assessing the results of the analyses, the lateral bracing conditions were considered to be between the two extremes of unbraced length where partial bracing was present, e.g. pile S87 where the internal wales are present on the south side but no support is provided on the north (see Figure 7). As illustrated in this figure the calculated critical point for Load Case A occurs at an unbraced length less than the possible field conditions. The difference between the calculated critical point and the smallest of the possible unbraced lengths for Case A is greater than that of either Cases B or C. The results clearly indicated that collapse of the piles due to static loading would be likely for both load Case A and B, with Case A being the most critical. There is greater uncertainty with respect to soil strength and earth pressure loading than for the structural conditions at failure, particularly considering the effects of time. It is therefore considered that the actual active earth pressure acting on the wall at the time of failure was slightly less than or the passive earth resistance slightly more than assumed in the structural analysis (see Figure 7).

Figure 6. Comparison of cumulative ultimate lateral-torsional pile bending moment capacity to moments induced from soil loads.

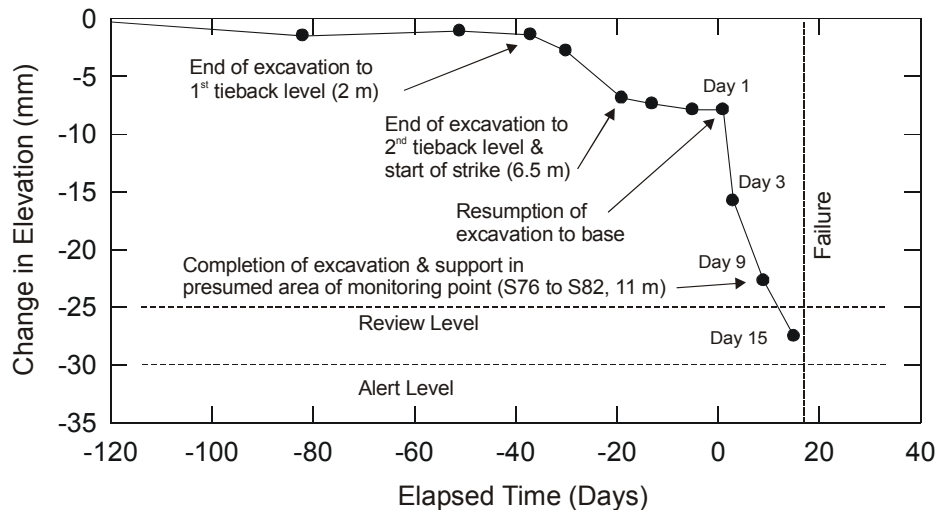
Figure 8. Settlement monitoring data for mislabeled survey point located 3 m east of S84, previously presumed to have been at the position of another point located between S81 and S80 (labels were mistakenly switched in the field).

- aggressive excavation and disagreements related to the equipment access ramp confused construction in the immediate area;
- other activities demanded the attention of the shoring foreman and on-site geotechnical representative; and
- one of the monitoring points in the immediate area of the collapse had been mislabeled and was thought to be in an area already fully supported (see Figure 8) and, according to design expectations, the measurements had not reached a previously determined critical level until one reading was taken late in the day immediately preceding the failure.
