Analysis of Piled-Raft Foundation for CAI MEP Container Port, Vietnam

Nguyen Minh Hai
Thu Dau Mot University, Binh Duong, Vietnam

Bengt H. Fellenius
Consulting Engineer, Canada

ANALYSIS OF PILED-RAFT FOUNDATION FOR CAI MEP CONTAINER PORT, VIETNAM

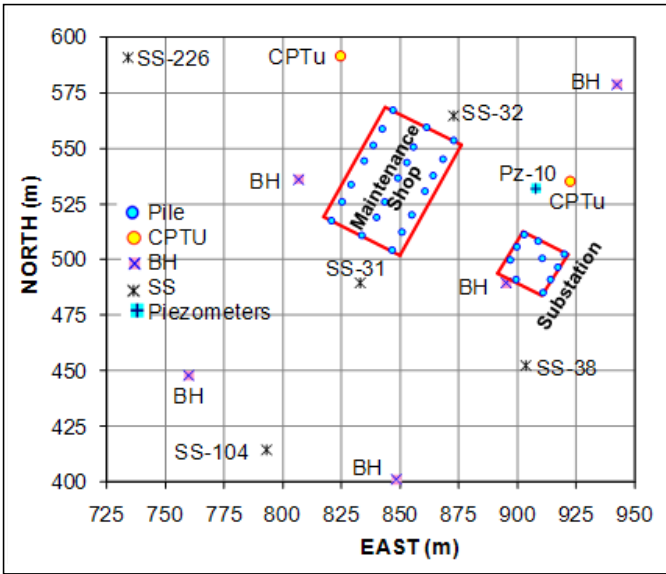
Fig. 2. Plan view of location of field instrumentation, the two buildings, and the monitored piles

The site lay-out of Maintenance Shop and Substation is indicated in Figure 2 together with monitoring stations around the buildings. After the piles had been driven, the pile head elevation of several piles was monitored by surveying and these piles are marked out in the figure. The building footprints are 1,680 and 419 m², respectively.

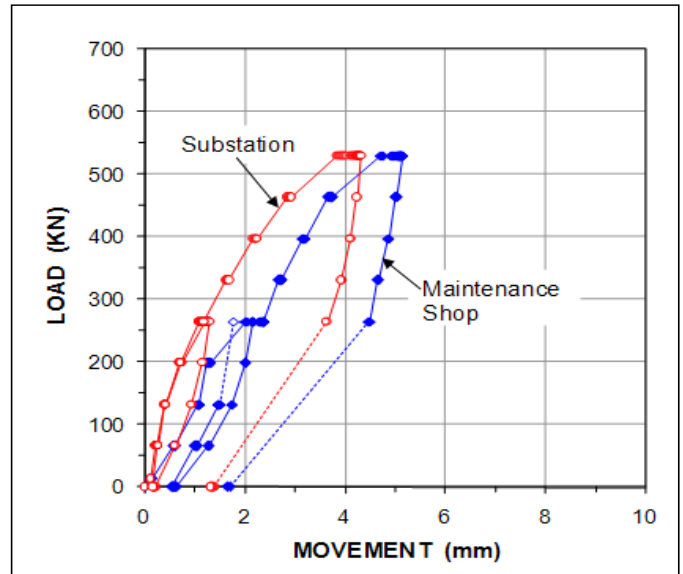
Fig. 3. Pile-head load-movement curves from static loading tests performed 17 days after driving

The total number of piles supporting the Maintenance Shop and Substation buildings was 256 and 52, respectively. The average pile spacing center-to-center was about 2.7 m and the pile to building footprint ratios were 2.4 % and 2.0 %, respectively. On September 17, 2010, about three months after the surcharge had been removed, two 400 mm diameter piles were driven at each building location to an embedment of 18.4 m and 18.8 m embedment depth, respectively. Seventeen days later, a static loading test was performed on each test pile to twice the intended working load of 265 kN. Figure 3 shows the pile-head load-movement curves of the tests. The tests indicated that the piles showed no sign of having exceeded or even reached capacity. Therefore, all piles for the buildings were chosen to be 18 m long. The production piles were driven during November 16 through December 01, 2010.

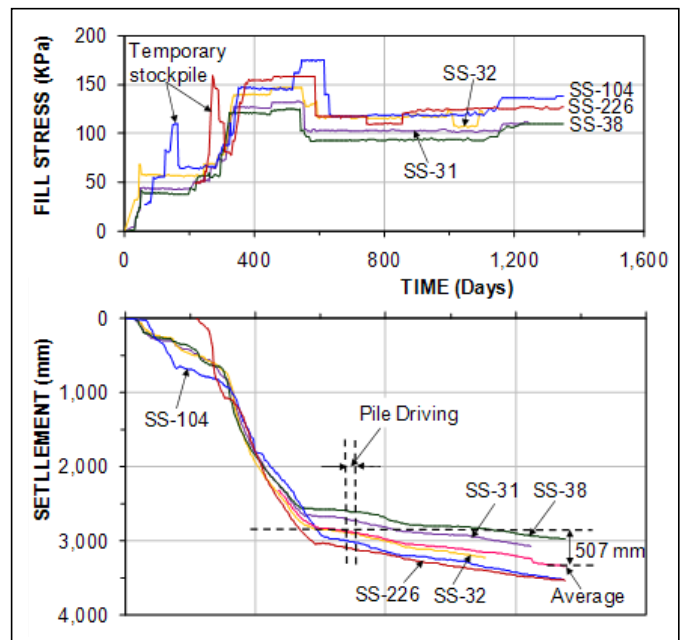
Fig. 4. Fill stress and settlement vs. days after start

Figure 4 shows the fill stresses and settlements measured at the five plates near the two buildings (benchmarks SS-31, SS-32, SS-38, SS-104, and SS-226) from the start of placing reclamation fill in early January 2009, placing of the surcharge in September through November 2009, removal of surcharge in May-June 2011, and until September 15, 2012; i.e., 0 to ≈ 300 days, ≈ 300 to ≈ 600 days, and 600 to $\approx 1,300$ days. The total average settlement before removal of the surcharge was about 3,000 mm. The average settlement during about 700 days after completion of the pile driving was about 500 mm.

The continued settling of the area was quite a surprise to the project. After the removal of the surcharge, it was expected that the consolidation would have been completed and settlement would have ceased. The reason for the ongoing settlements has been discussed by Fellenius and Nguyen (2013) and shown to be due to the fact that the wick drains used for the project were not stiff enough to resist the large soil stress at depth and did not function below about 20 m depth. That is, below about 20 m depth, the consolidation of the soft compressible soil was incomplete. Indeed, the consolidation continued even after the removal of the surcharge to finished ground elevation, Elev+.5.5 m. Above about 20 m depth, the consolidation was completed. Therefore the measured settlements are those continuing below 20 m depth.
