Punch-Through Foundation Failure of Oil Drilling Platform in the Deltaic Plain of the Niger River

PUNCH-THROUGH FOUNDATION FAILURE OF OIL DRILLING PLATFORM IN THE DELTAIC PLAIN OF THE NIGER RIVER

This paper presents the records and events that led to the collapse of the drilling platform, the findings of the post-failure investigation and the proffered solution for the reconstruction of the platform.

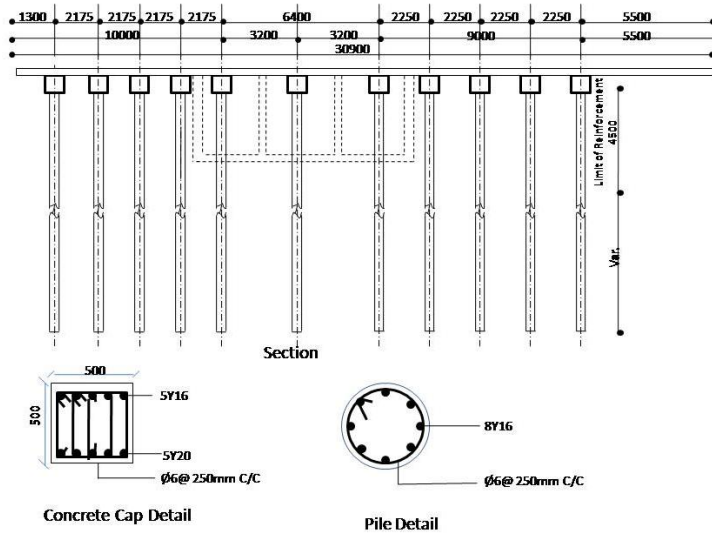
Fig. 3: Drilling Platform showing the cellar slab, hardstand area and piling layout

Four cone penetration tests were conducted at the site using light weight cone penetrometer and according to the report all the four cone soundings terminated at 7.0m. The report recommended the use of piles for the foundation suggested that the piles be driven to depths of 15.0m, but was not explicit on the type, size and safe working load of the piles. However, the platform was constructed with 44 tubular steel piles, 250mm diameter and 21.0m long underneath the cellar slab section. No pile loading test was carried out to confirm the load carrying capacity of the piles (fig.3)

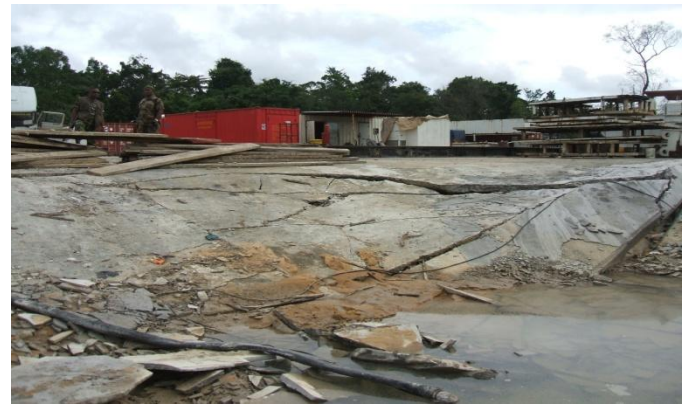
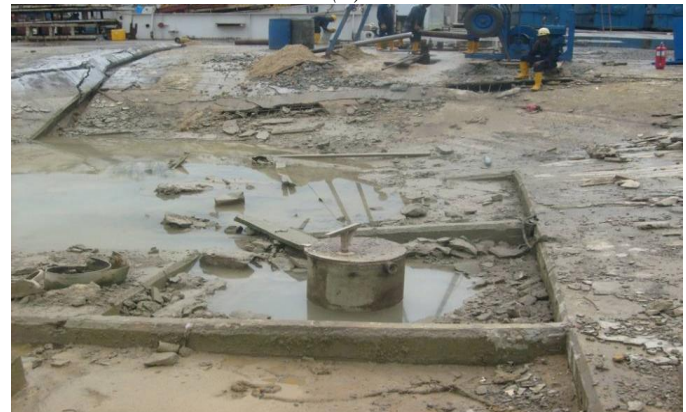
Fig. 4. Collapsed slab and cellar pit.

The drilling of the well continued without any noticeable event until the hole had achieved a depth of 1000m. At this depth the drilling string with the attached bit got stuck and all attempts to turn the bit and lift the string failed. The frantic lifting attempts, inadvertently, made the cellar slab to provide the reaction system for the applied uplift loads. The efforts to retrieve the drilling tools went on for two days without success before a depression of 150mm was noticed around the cellar pit. As the efforts to retrieve the tools continued, the depression became bigger and bigger. Large cracks developed in concrete at many sections of the platform with some of the broken concrete sliding towards the cellar pit area. The efforts were stopped and the rig lowered to avoid accidents. At the time of the post-failure investigation, the depression had achieved a depth of about 1.5m and filled with rain water around the cellar area.

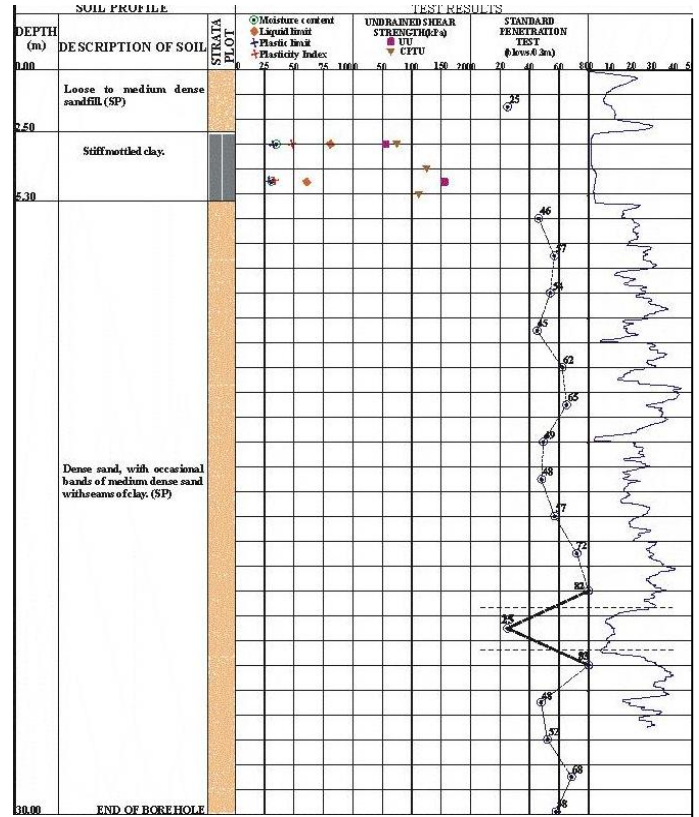
However, some relatively weak zones within the dense sand were noticed. It also appeared that this was typical of the site. The most outstanding was that between depths of 21.4 and 23.4m. The following table gives the details of the layer.

Fig. 7. Soil profile around reference location.

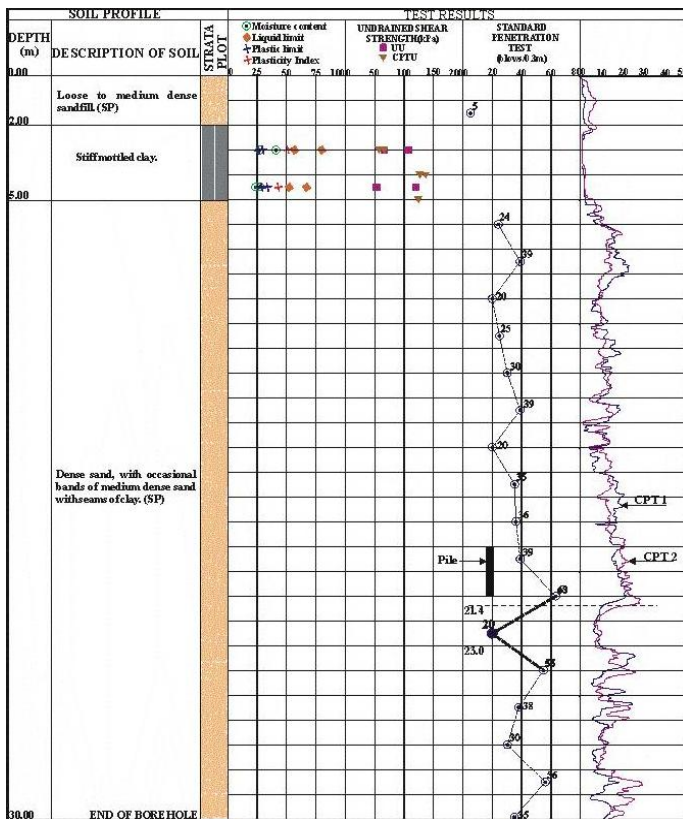
Fig. 6 Soil profile around the cellar slab.

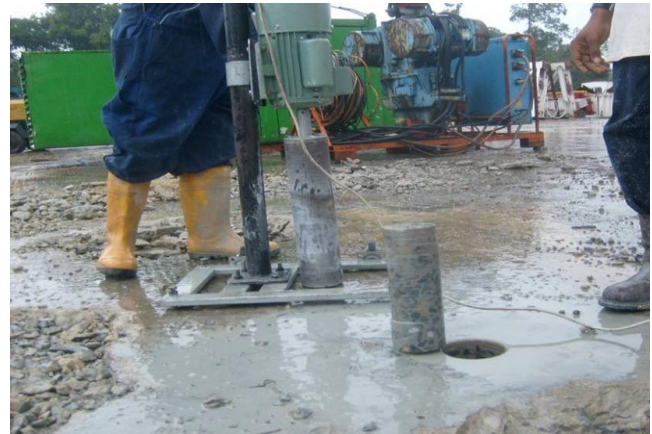
Cylindrical concrete cores 100mm diameter were cut out from various sections of the concrete structures using rotary cutting tool. The cores were tested for their compressive strengths which were found to be relatively low. However, the rebound hammer tests conducted on the cores using the Schmidt hammer showed high compressive strengths for the cores. The results of the tests are shown in Table 4.

Fig. 8. Picture Showing sample after coring

Concrete cores were cut out from various sections of the platform and tested for compressive strength. Rebound hammer tests were also carried out on the cores. The compressive strengths of the cores were comparatively low when subjected to the crushing test. However, the strengths from the rebound hammer tests were high. It is envisaged that the reduction in compressive strength could be due to the effects of the collapse. There was no evidence to show that the collapse of the platform emanated from the concrete.

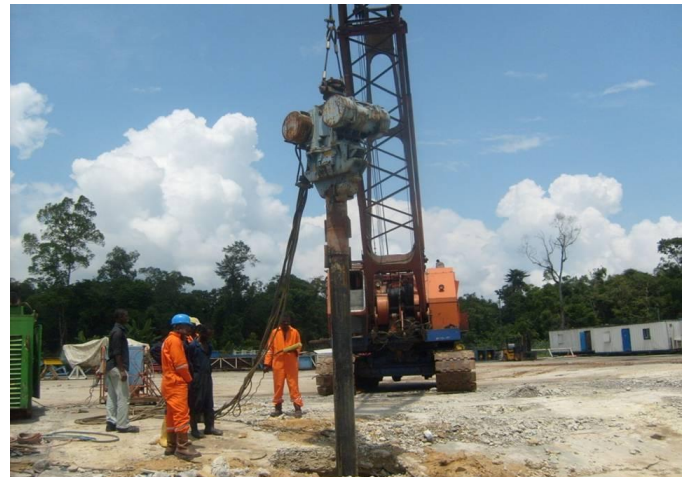
The tubular steel piles used for the foundation were installed by driving to the required depth of 21.0m. Damage to some of the piles during driving could be possible and that would reduce the load capacity of the affected piles. Five of the working piles were extracted from the ground randomly under the cellar slab for examination. All the piles were reasonably straight and there was no indication that the piles had suffered some damage.

Fig. 9. Picture showing extraction of pile.

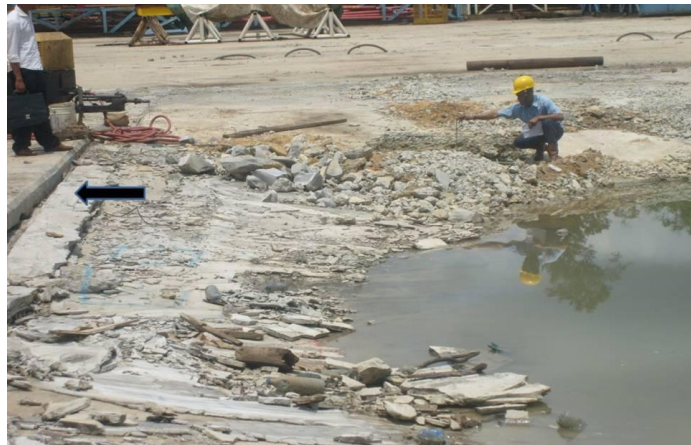
All evidence pointed to the fact that the collapse of the platform and all the support structures began when the drilling bit got stuck in the hole. Since this happened suddenly, frantic attempts were made to retrieve the bit and the drilling string. The attempts achieved no success. However, the attempts continued. Unintentionally, the platform began to provide the reaction needed for the uplift loads to turn and lift the drilling tools in the hole. Consequently, the cellar slab became highly overloaded. This caused the relatively small diameter piles supporting the cellar slab to be subjected to excess loading. The soil profile obtained from the second investigation revealed that a weak soil zone existed just beneath the tips of the piles around the cellar pit. The piles began to move into weak zone. The initial downward movement was 150mm. This served as a warning and the rig was lowered and removed from the platform. Nevertheless, efforts to retrieve the drilling string and bit persisted. The higher applied loads caused the piles to punch through the top dense sand into the weak layer just beneath the pile tips. The downward movement of the piles and the slab produced a depression of about 1.8m in depth around the cellar pit area and also imposed high lateral loads on the remaining piles and other connected structures causing a large portion of the platform to yield and collapse.

Fig. 10 Picture showing collapse area.

1. The collapsed platform should be lifted and the site cleaned.
2. All the piles in the ground should be extracted.
3. Another geotechnical investigation should be conducted using few borings and more cone penetration tests.
4. Heavier cone penetrometer that can penetrate to depths in excess of 30.0m be used.
5. The new geotechnical investigation should characterize the site adequately for the new drilling program.

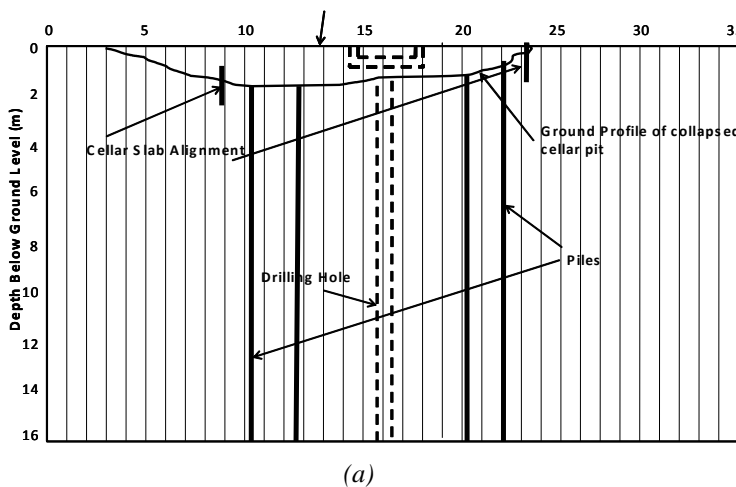
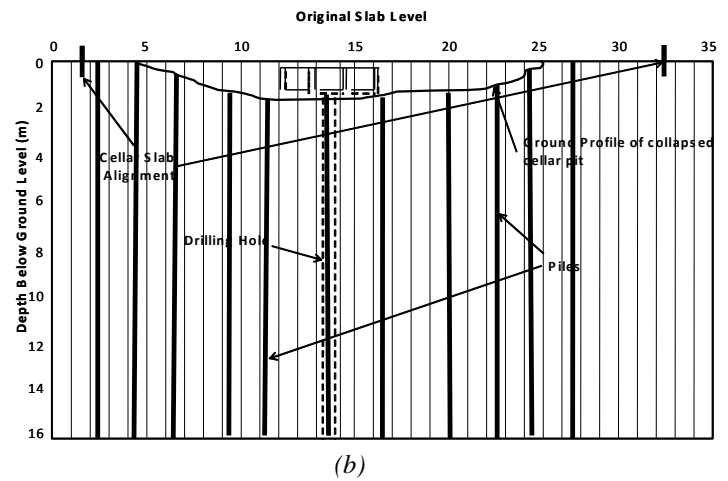
Fig. 11. Sections showing depression at cellar pit Area

A case history of the collapse of an oil drilling platform in the deltaic plains of the Niger River is presented in this paper. The post-failure investigation traced the main cause of the collapse to the plunging of the piles under the cellar slab into a weak zone of the soil column just beneath the tips of the piles. The plunging of the piles was caused by the overloading of the drilling platform and the overloading originated from the uncontrolled attempts to free the drilling string and bit that got stuck in the hole.
