Failure of Buildings on Mound- A Case Study

U. N. Sinha

Central Building Research Institute, Roorkee, India

Paper No. I.42

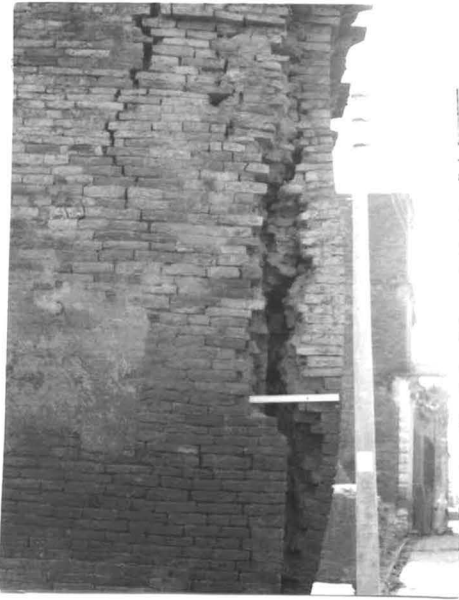
Fig. 2 Collapsing Wall

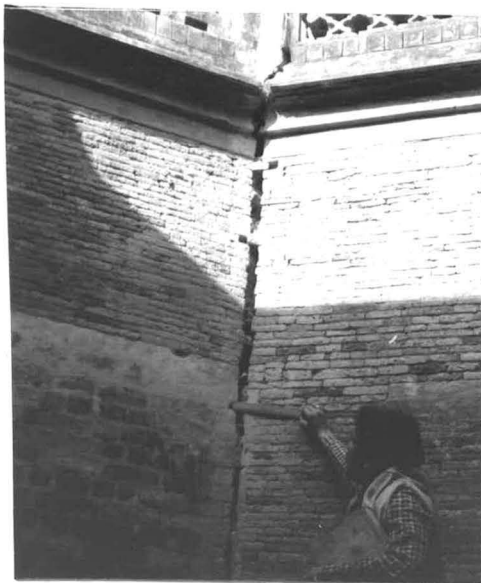
Fig. 3 Separation of Walls at Corner

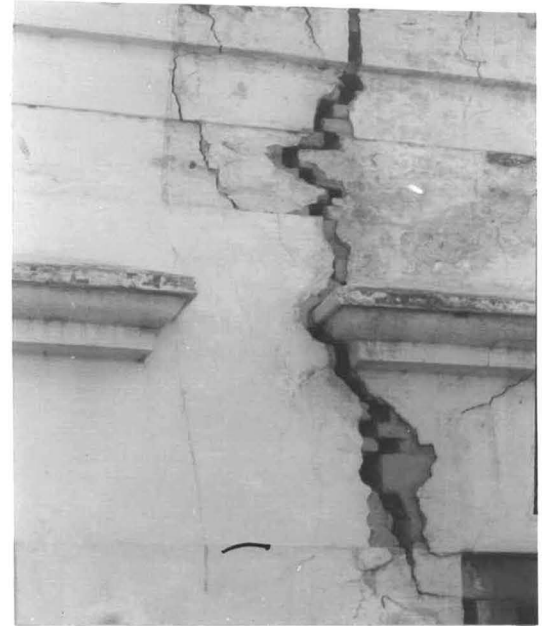
Fig. 4 Severe Cracking near Lintel

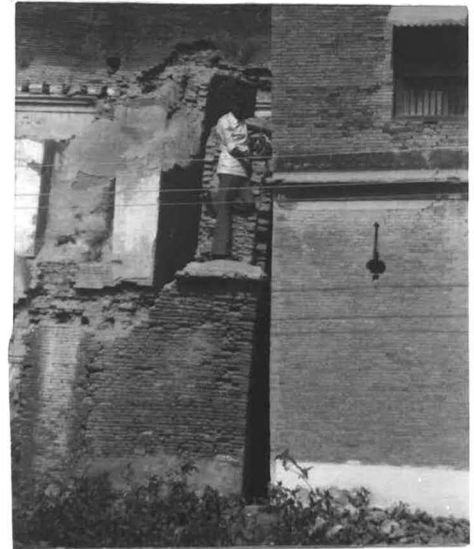
Fig. 5 Tilt in building due to settlement and tilt measurement

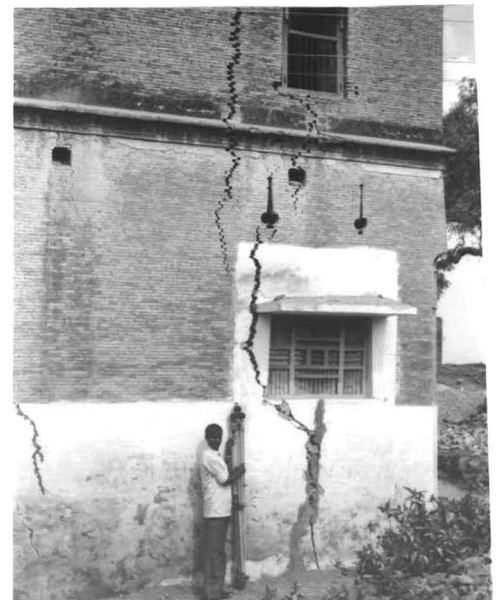
Fig. 6 Cracking in Wall and tilt measurement

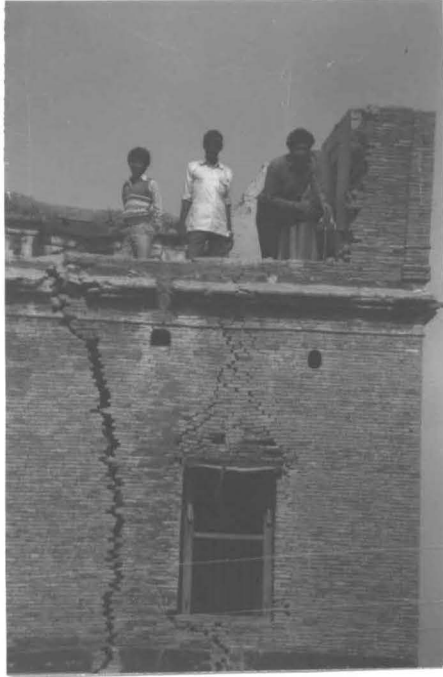
Fig. 7 Wide Crack in wall and tilt measurement

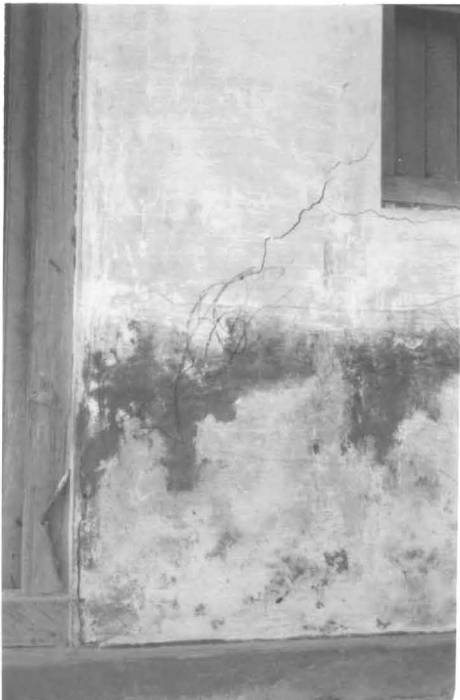
Fig. 8 Cracks in newly constructed building showing seepage in wall

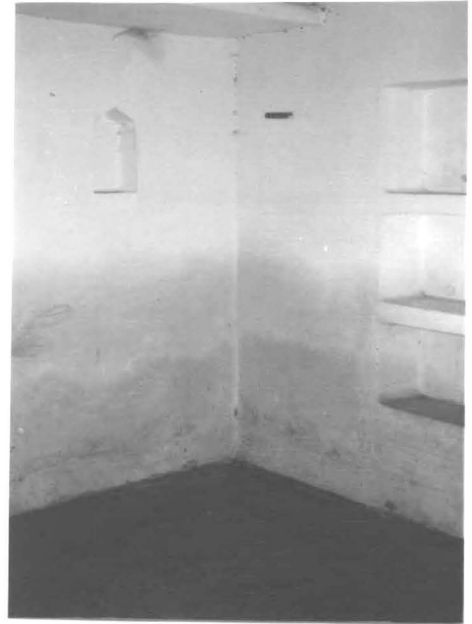
Fig. 9 Capillary rise and dampness in walls

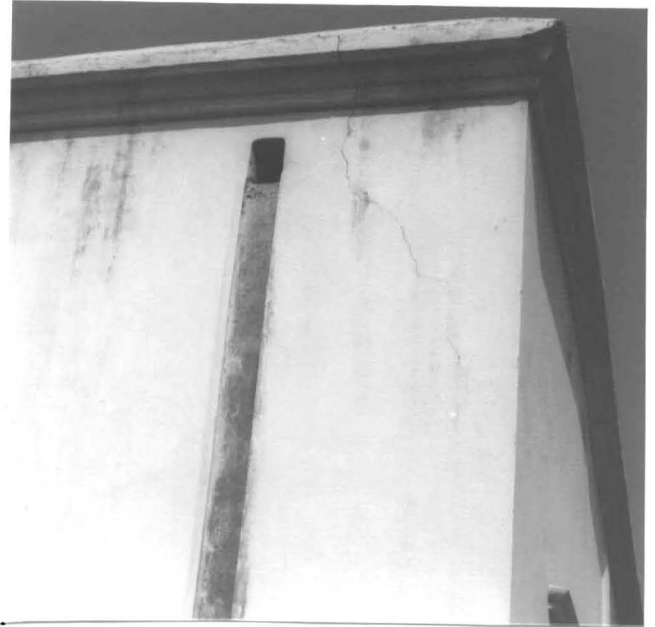
Fig. 10 Repaired cracks in building
