## Evaluation and Remediation of a Small Landslide in Colluvium

**SYNOPSIS:** A landslide in colluvium near Grafton, West Virginia was evaluated for cause and remediation. Monitoring was conducted for 15 months to observe further movements prior to remediation. The observed failure surface, slide geometry and groundwater conditions were used to back-solution for an effective residual friction angle ( $\phi_r'$ ). The  $\phi_r'$  was found to agree well with index property correlations cited in the literature. Slope failure resulted from excessive pore water pressures due to seasonably high groundwater levels. Stability analyses using the back-solutioned  $\phi_r'$  were performed to design and position seepage cutoff drains for slope remediation. As of this writing, September 1992, the drains have performed well and the slope has remained stable for three (3) years.

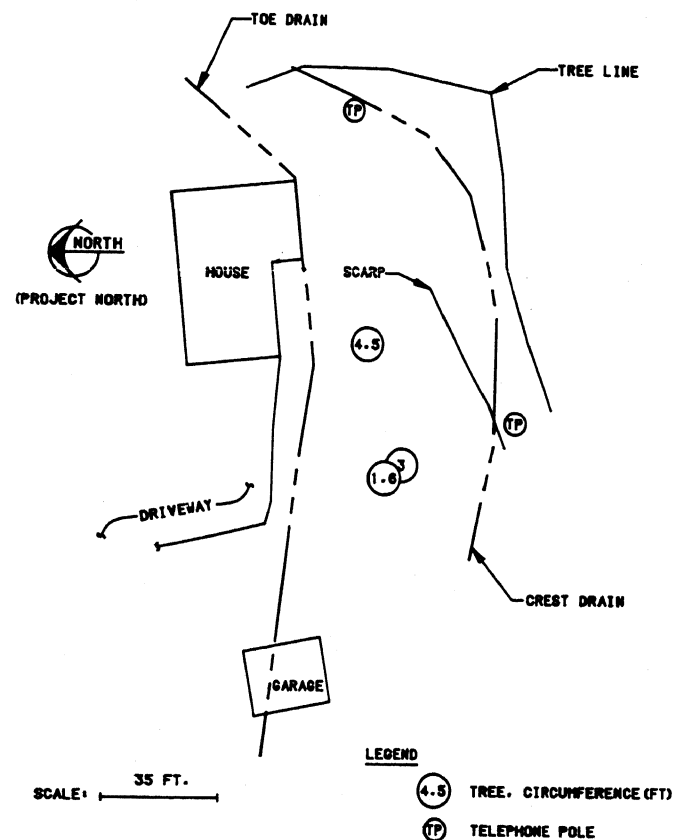
Figure 1: Site Plan

The site of the slope failure is located in Taylor County, West Virginia approximately 1 mi. north of Grafton, on the east side of U.S. Rt. 119, at an elevation of about 1300 ft. A site plan is shown in Figure 1. The failure occurred in the backyard of a local resident, in late December 1987. The owner's residence, a two-story wood frame building, was constructed on a bench cut into the slope.

The slope rises behind the home (south) to an elevation of approximately 1450 ft. and descends northwardly to the stream valley at elevation 1200 ft. The slope averages 3.7(H):1(V). The area of the failure has a slope of 3.3:1, and was grass covered with several trees as shown on Figure 1. Forested areas bordered the slide to the east, south and west.

North of the slide area lay the owner's residence and driveway/parking area. Horizontal slide movement was to the north. A well defined scarp, oriented east to west, was formed on contour and the maximum vertical movement was about 1.0 ft. The scarp was located 50 ft. south of the owner's residence (Fig. 1). The slide area was located between two natural drainage courses. Consequently, infiltration and subsurface sources were the primary means for entrance of water into the slide area. During the investigation, the toe of the slide, near the driveway, was often saturated.

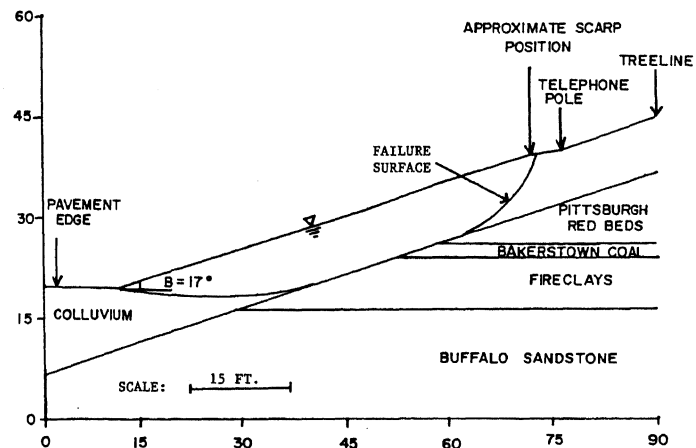
The lithologic profile for the site was constructed from references (Cardwell, et.al., 1968 and Hennen and Reger, 1913) and limited exposures near the site. The profile was typical for the area, consisting of the alternating beds (cyclothem) as described by Cardwell, et.al., (1968), D'Appolonia, et.al., (1966) and Hennen and Reger, (1913). A key feature of the profile was the occurrence of a red shale layer (Pittsburgh Red Beds) near the elevation of the slide area, Figure 2. This sequence has been associated with many slides in WV (Hall, 1974).

Using the measured undrained shear strength (700 psf), the calculated factor of safety was 3.9 for the observed failure surface (Figure 2). Thus an undrained ( $\phi=0$ ) analysis for the site was not

The failure surface was selected based on the observed scarp and toe position and the fact that failures in colluvium are often bedrock controlled (Jacobson, 1986; Pascucci, 1983; Varnes, 1978; and Hall, 1974). Depth to bedrock (8 ft.) was established based on excavations at the site for drainage installation.

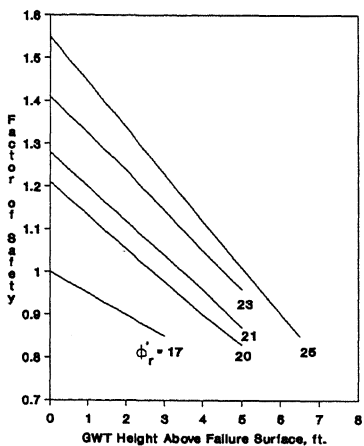
Figure 3: Results of the Effective Stress Analysis

Effective stress analysis for the failure surface was performed using the simplified Janbu method. A range of  $\phi_r'$  was selected and the position of the groundwater table (GWT) over the failure surface was varied for each. The results are summarized in Figure 3.

Beverage and Yoakum (1980) gave GWT positions as being generally greater than 3 ft. below the surface in the area of the slide, i.e., the GWT would likely be at least 5 ft. above the failure surface. From Fig. 3 then, it is clear that  $\phi_r'$  must be within the range of 23-25 degrees for marginal stability ( $1.1 < FS < 1.2$ ).

The intent of the cutoff drains was to intercept subsurface seepage and maintain the GWT  $< 5$  ft. above the failure surface to obtain stability (Fig.3). It was recommended to install the drains to bedrock and extend the perforated pipes to discharge into the natural drainage courses to the east and west of the site. Figure 1 shows the geometry of the installed drainage. Spatially, the installation was satisfactory; however, the contractor wrapped the filter fabric around the pipe which can expedite geotextile clogging due to the limited surface area. Also, the authors were not consulted as to the selection of the proper fabric. Total cost to the owner was approximately \$5600.

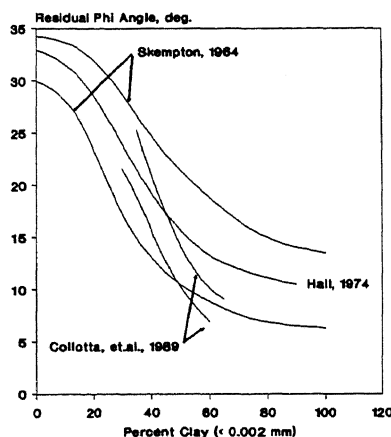
Figure 4: Correlations of Residual Friction Angle with Percent Clay ( $<2\mu$ )

The range of  $\phi_r'$  (23-25 deg.) was checked against several published correlations of Atterberg Limits data and percent clay ( $<2\mu$ ) with residual friction angle. All the correlations could be considered to have given estimates within the margin of error for this study. The correlations with percent clay ( $<2\mu$ ) from Skempton (1964), for various clays and Collotta, et.al., (1989), for Italian Apennine silty clayey soils, produced values closest to the 23-25 degree range. Table 2 summarizes the estimates and Fig. 4 contains plots of the Collotta, et.al., (1989), and Skempton, (1964) data as well as that from Hall (1974).

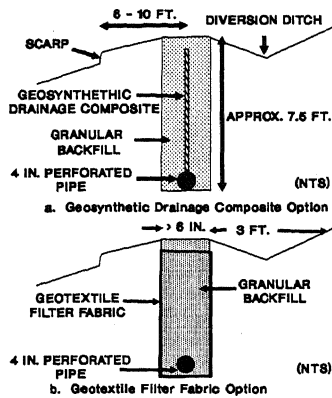
Figure 5: Recommended Cutoff Drain Designs

The writer returned to the site on 27 July 1992 during a light rain following a day of heavy showers. Outflow at the drains was measured and the turbidity of the outflow observed. Approximately 2-3 times more outflow was occurring at the east drain outlets than at the western ones. Effluent was very turbid (opaque in color) indicating that the filter fabric was allowing passage of fines. This may be a precursor to eventual clogging of the geotextile.

The proposed remediation included installation of subsurface flow cutoff drains and limited regrading to divert surface runoff. Recommended drain design was either perforated pipe placed into a trench with a geosynthetic drainage composite extending vertically from the pipe into granular backfill or a perforated pipe in granular fill, wrapped in a geotextile. Schematic diagrams of these designs are shown on Figure 5.
