Wadi Qattarah Dams Case History

SUMMARY

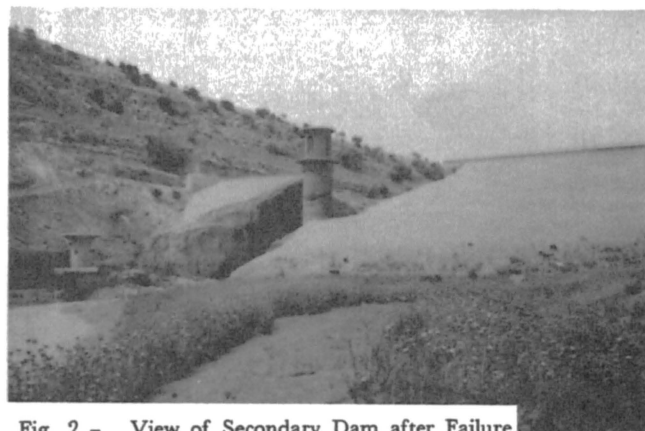
Fig. 2 - View of Secondary Dam after Failure

The upstream portion of the Project was formed mainly by the Main Dam and the Secondary Dam some 10 km farther downstream which were built from 1969 to 1972. The first filling started in May 1972 but the reservoir levels very seldom exceeded a third of the head and never reached the normal water level (NWL) at either dam. On 21 December 1977, the Secondary Dam failed with a water level well below NWL but fortunately major damage was avoided by a rather slow rate of retrogressive erosion of the embankment (about 6 hours) and by the relatively moderated volume of water stored, some $3.5 \times 10^6 \text{ m}^3$ (Fig. 2).

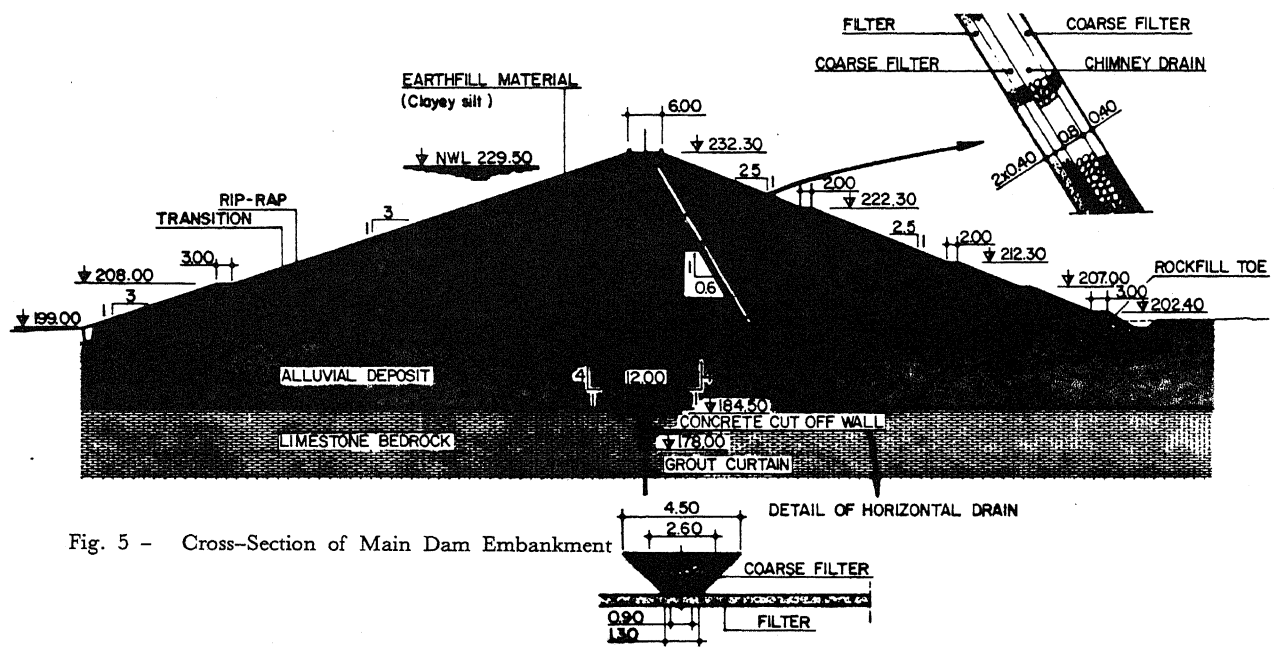
Fig. 5 - Cross-Section of Main Dam Embankment

The maximum height of the embankment is 33.0 m and its crest length is 305 m. Fig. 5 shows the typical cross section of the embankment. The upstream slope of the embankment is 3.0 horizontal for 1.0 vertical (3:1). A 3-metre wide berm is located at El. 208.00 ; it was the crest of the upstream cofferdam. With this berm, the mean upstream slope becomes

3.1 horizontal for 1.0 vertical (3.1:1). The mean downstream slope of the embankment is 2.7 horizontal for 1.0 vertical (2.7:1) including the three 2-m wide berms.

This embankment is an homogenous earthfill whose design includes an inside drainage network in the downstream portion of the embankment :

- A chimney drain including successively from upstream to downstream a fine filter layer 0.40 m thick, a coarse filter layer 0.40 m thick and a drain layer.

- This chimney drain is connected at its base with a horizontal drainage system generally resting on the foundation under the downstream portion of the fill. This horizontal drainage system includes a continuous layer of the fine filter material, 0.40 m thick, and six finger drains approximately 30 m apart, forming the horizontal outlets from the chimney drain. The core of these finger drains (area 1.40 m^2 each) is made of the drain material wrapped in the coarse filter material 0.40 m thick without any fine filter between the coarse filter and the earthfill.

- The horizontal drainage system is connected downstream to a rock-fill drain founded at variable levels below the foundation level of the embankment. A fine filter layer 0.40 m thick has been placed underneath this rock fill toe drain in contact with the foundation. This drain collects the flow from the horizontal drains and also from surface runoff.

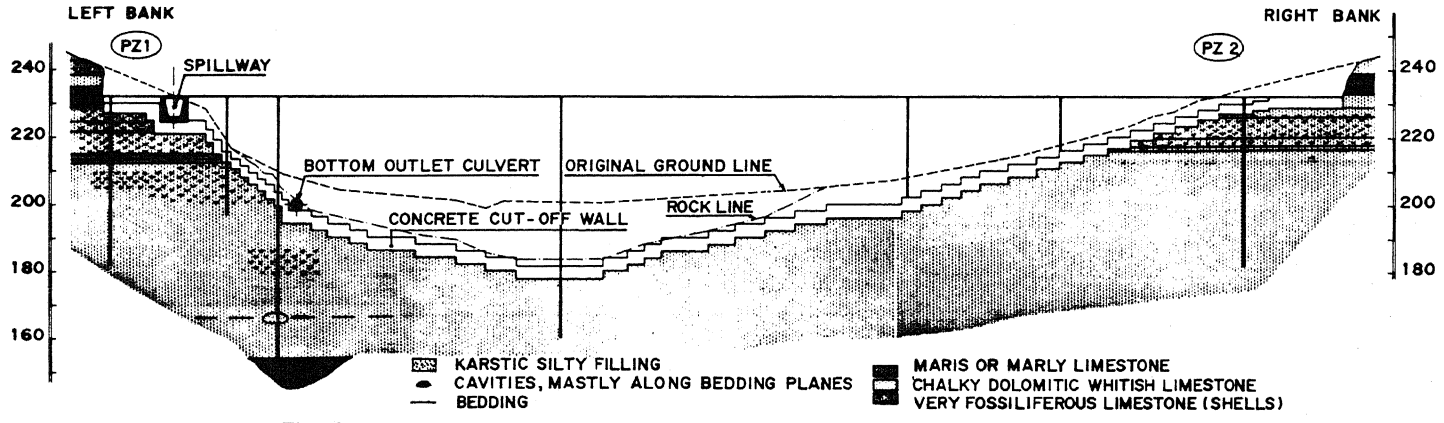
Fig. 6 - Longitudinal Cross-Section of Main Dam Embankment

The condition of placing earthfill around the bottom outlet culvert has also to be mentioned. Both faces of the excavated trench in which the conduit lies are only 1 m from the concrete, which does not allow proper compaction of the backfill even by small hand-operated machines. This applies to the downstream portion of Main Dam culvert (Fig. 6).

In addition no particular drainage was provided around the downstream portion of the culvert. The filter blanket, part of the drainage system, appears to be located 1 m or 2 m above

the outlet culvert as well as the rockfill toe drain, whose base is about 3 m above the culvert.

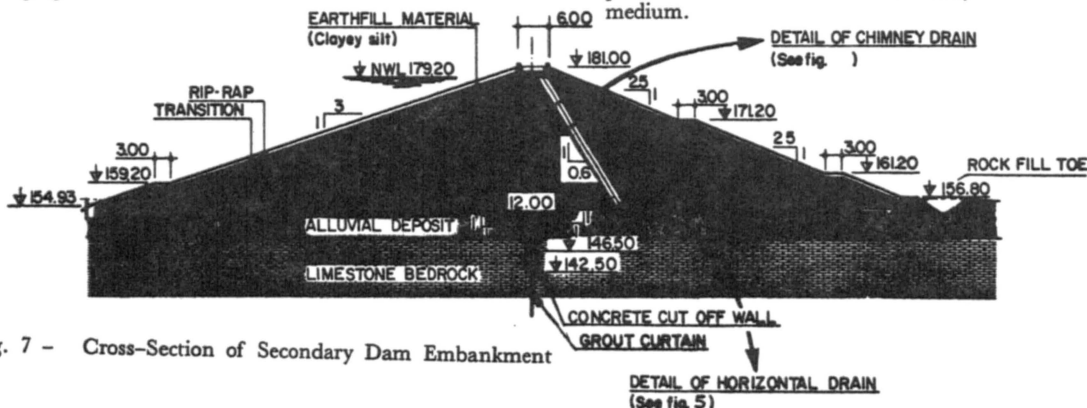
Fig. 7 - Cross-Section of Secondary Dam Embankment

The design of Secondary Dam is very similar to that of Main Dam. The crest length of the embankment is about 217 m and the maximum height is 28.6 m. Fig. 7 shows the typical cross section of the embankment.

The upstream and downstream slopes are the same as at Main Dam. Secondary Dam was constructed simultaneously with Main Dam. In this case too, the embankment is an homogeneous earthfill whose design includes features identical to those described previously for Main Dam, except that in this case the alluvial deposit has a maximum depth of 9 m.

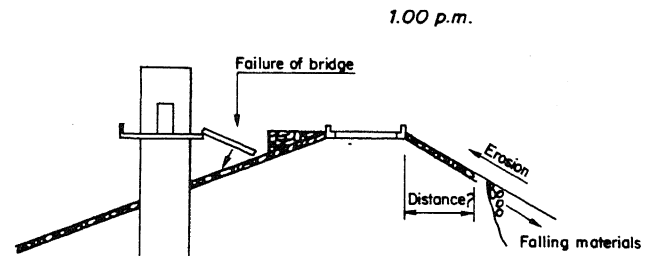
Fig.11 - Sequence of failure at Secondary Dam (1.00 p.m.)

At about 1 p.m., the service bridge between the crest of the dam and the gate tower fell down (see Fig. 11) and ten minutes later the retrogressive erosion broke through this crest, opening a breach to the reservoir; It took until 17 hours for the complete emptying, while the breach was widening and deepening; at no time, vortices or eddies were observed on the water surface in the reservoir.
