Failure of a Twenty-Foot High Retaining Wall

R. E. Olson
University of Texas, Austin, Texas

SYNOPSIS A cantilever retaining wall, designed in apparent accord with provisions in a civil engineering handbook, failed soon after construction. Analyses of the causes of the failure are presented.

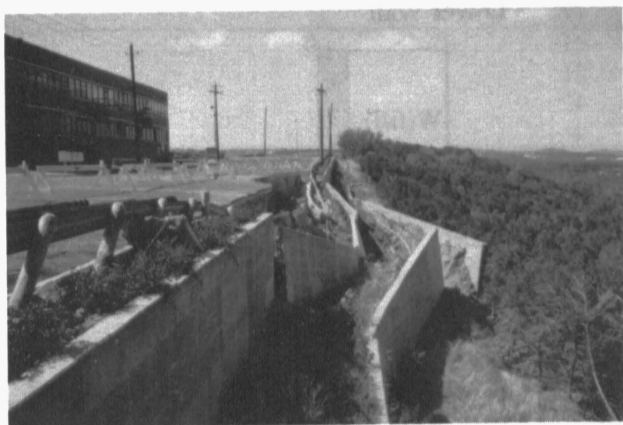
In late July, after a period of heavy rain, a section of the lower rear wall, with a length of about 135 feet (41 m), suddenly began to displace horizontally. My first site inspection was about seven hours after the failure apparently began and, at that point, the lower wall had displaced horizontally about fifteen feet (5 m) (Fig. 2). A substantial vertical scarp had formed in the fill because the upper wall had dropped into the void formed when the lower wall displaced. The lower wall continued to displace horizontally at a slow rate. Some months later, when the wall approached the property line, the damaged portion of the wall was removed.

Fig. 2 View of the Failed Section of Wall

The exposed fill was mostly limestone gravel but there were several layers of clay. Water was leaking out of the most pervious layers in the fill.

Vegetation in front of the lower wall was dry and dead but vegetation that had been between or above the walls was green. The soil directly in front of the wall, and the slumped fill, was soft. Broken irrigation pipes could be seen in the fill between and above the walls.

Based on the lack of stains, many of the weep holes had apparently not functioned. Attempts to drive rods through them often failed. It appeared that the fill side of some of the holes was blocked with concrete. Water was spurting out of the top part of one of the weep holes, in a stream

with a diameter about the size of a pencil. Apparently, the back side of the weep hole was blocked except for one small hole, and there must have been a substantial water head behind the wall.

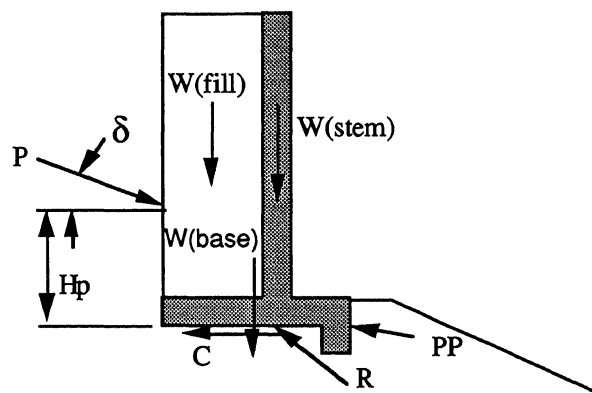
In the second phase, the force P was applied to a free body composed of the lower wall and soil above its heel slab (Fig. 5) and factors of safety were calculated for various failure modes.

Fig. 5 Assumed Conditions for the Lower Wall Analyses to Obtain P

Stability of the lower wall (Fig. 5) was analyzed for overturning, sliding, and bearing capacity. Equations for overturning and sliding are found in most books on foundation engineering and need not be repeated.
