Distress – Cause and Effect: A Diagnostic Study

Distress - Cause and Effect: A Diagnostic Study

SYNOPSIS: Detailed site investigation, rigorous analysis and smart design of any engineering project prove to offer a successful product provided Quality Control and Quality Assurance are enforced during the construction phase. Failure to comply with QA/QC led to premature distress and extensive damage. A typical case, where negligence to address extenuating problems that arose during the construction stage resulted in severe damage is investigated and reported. Post-construction diagnostic study to unravel the cause and effect is presented.

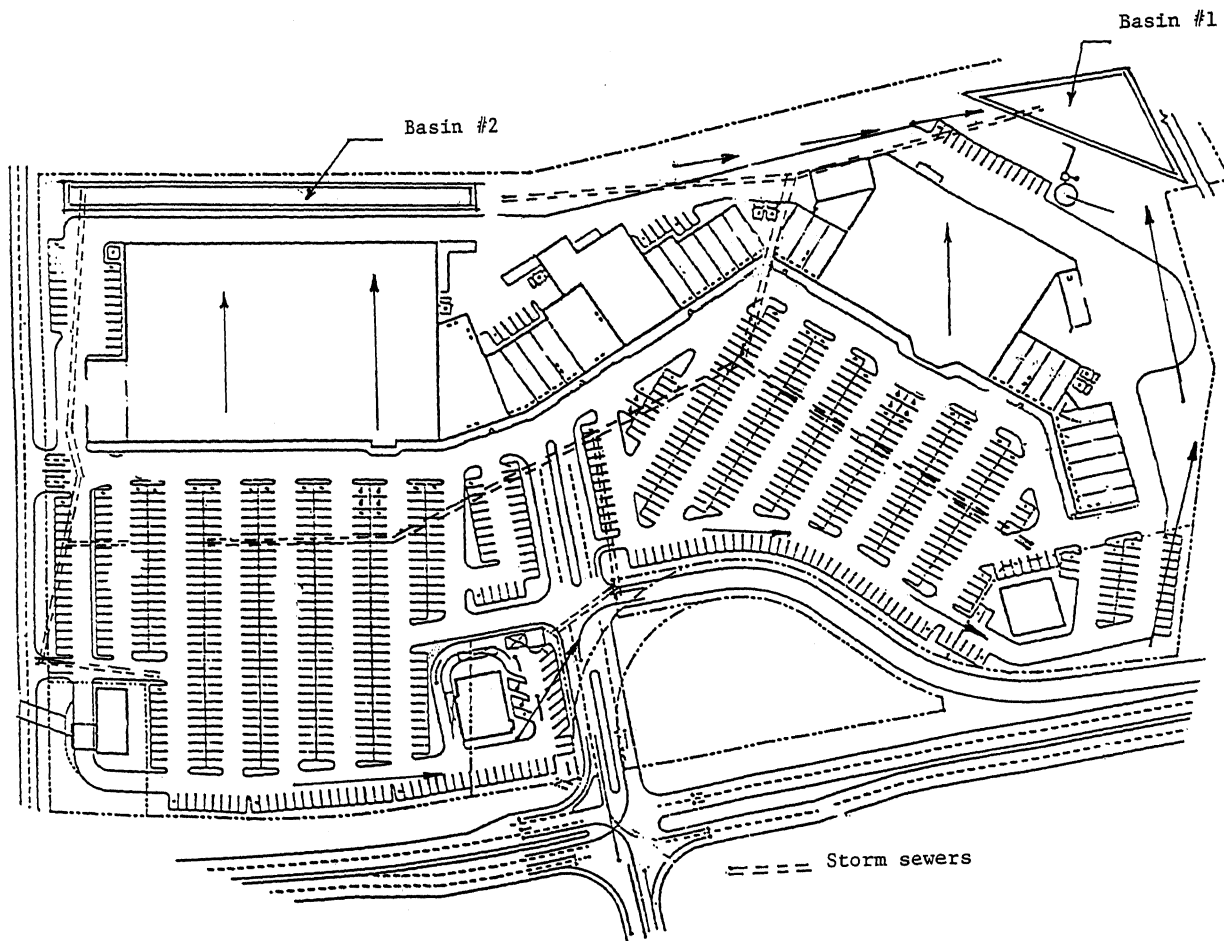
Figure 3 - Arrangement of catch basins and direction of drainage during construction.

Photos taken during construction showed water stagnation at several locations in the parking lot. The arrangement of catch basins, and drainage during construction are shown in Figure 3. Water stagnation was cited due to clogging of gravel around temporary raisers in the catch basin. Four inches of water from Basin 1 was pumped out in July 1990 to complete the final stabilization of the basin itself. The presence of the increased moisture content could have resulted in adverse effects on site compaction and its strength.

The immediate need to install a subdrainage system was greatly stressed. A "Poroswall" concrete pipe system for subdrainage was suggested. Continued observation of the performance of the system for at least some time was strongly recommended. Radial bleeders which were in the original plan were proposed to either repair or reinstall as the situation demands. The recommendations also included undercutting of the asphalt surface course at the problem areas of the pavement and resurfacing.
